# Third Party Inspection Form

# RoxWind LLC

## Horseshoe Valley Road, Roxbury

**Date:** Monday, 04-26-2021      **Time:** 10:30 AM      **Report:** 34  
**Inspected by:** Steve Roberge, PE      **Company/Agency:** SJR Engineering Inc.

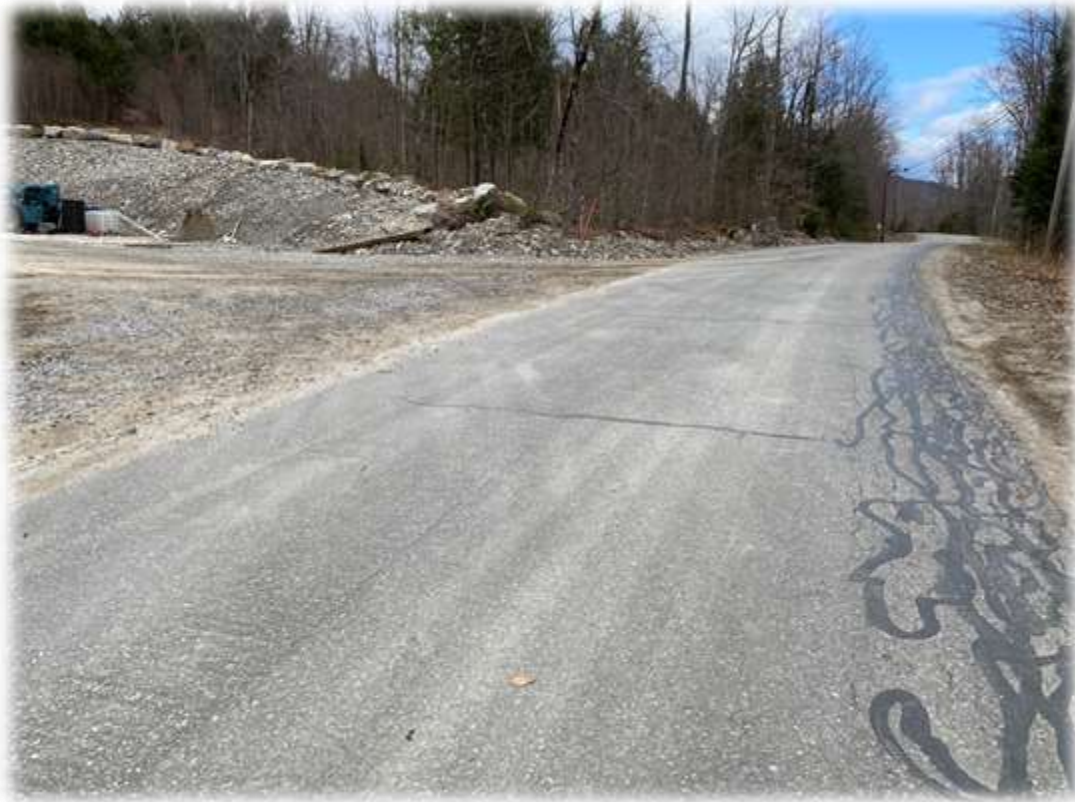
Photo #1: Horseshoe Valley Road is clear of soil debris from the project. The stabilized construction entrance still has some life left to the crushed rock entrance.

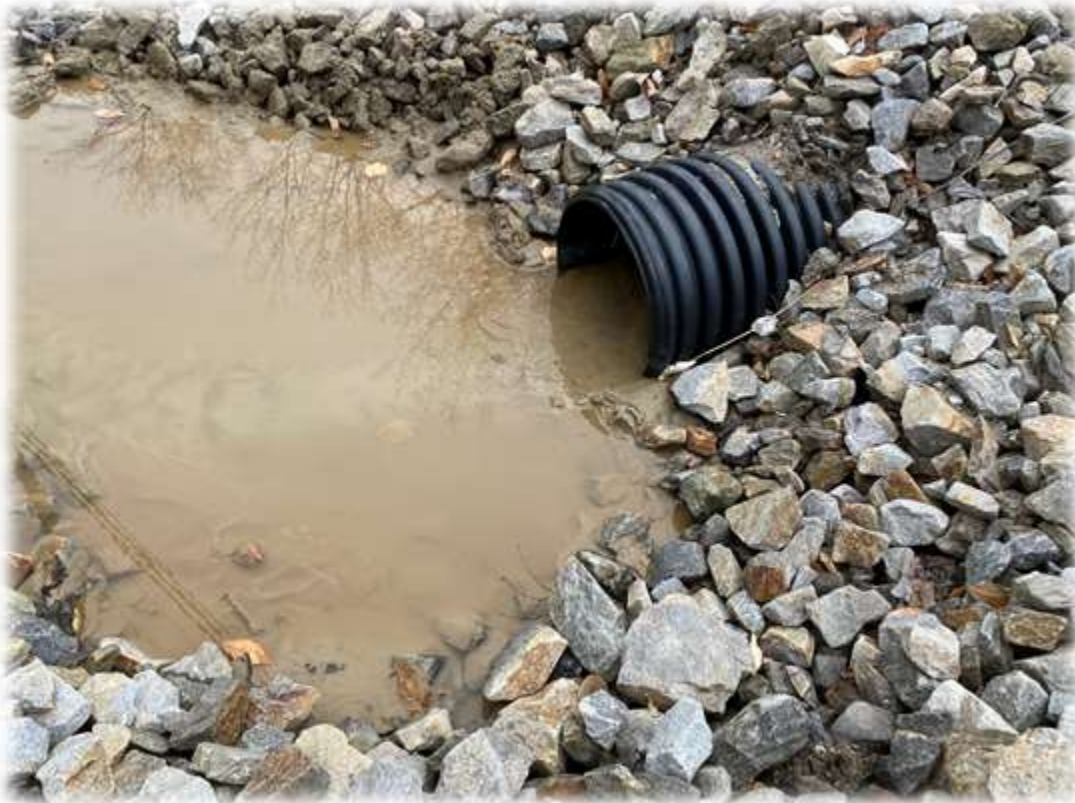
Photo #2: Water discharging from the Horseshoe Valley culvert near the entrance is crystal clear but there is significant sediment within the plunge pool and culvert. Sargent is onsite and is working to clear the winter sands from the upslope ditch and will clear (or reconstruct) this location last.

1. The winter sand within the ditches needs to be cleaned and vacuumed from the installed check dams and plunge pools, particularly near the entrance along Horseshoe Valley Road. Sargent is onsite and addressing the winter sand in ditches issue at the entrance to the project.
2. There are several culverts that have significant sediment/rock in inlets and outlets that need to be cleaned. Sargent is onsite and will address the winter sand/sediment in culverts as they work their way up the hill.
3. I strongly recommend numerous water bars with stabilized outlets be re-installed along the access road up the mountain. Sargent is onsite and will address the reconstruction of water bars with stabilized outlets as they work their way up the hill.

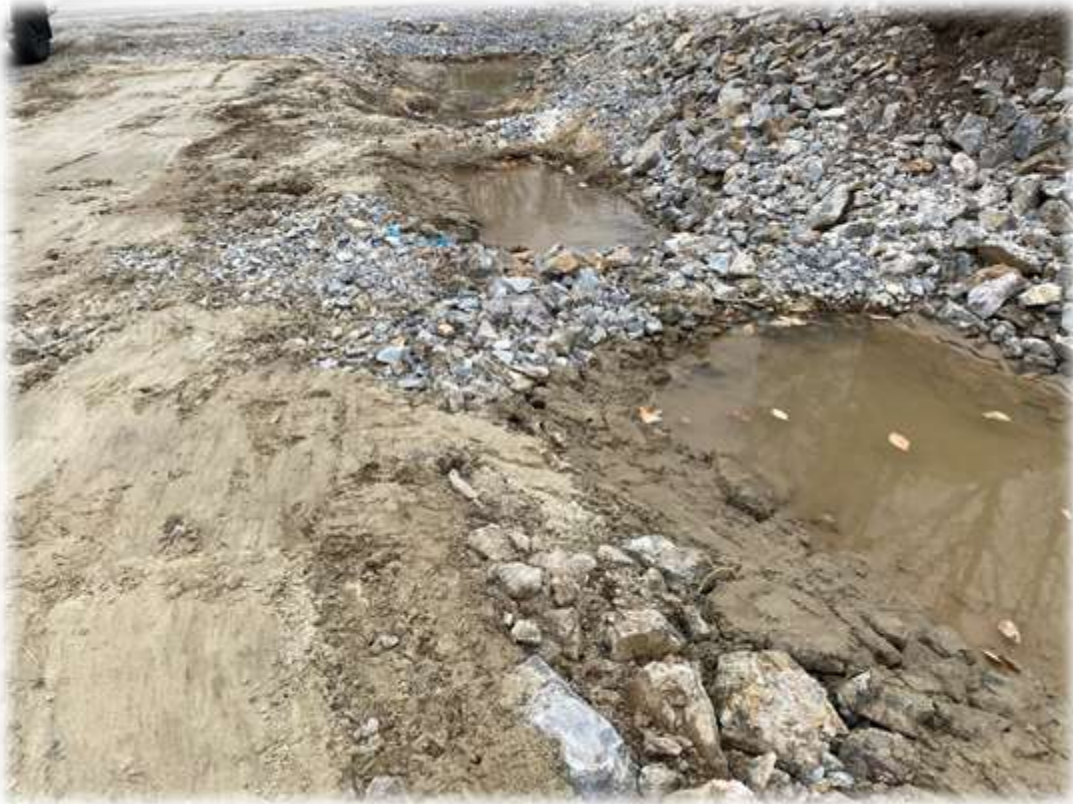
Photo #3: Water within the ditch is clear. Sargent is to clean the ditches of sediment (winter sand accumulation) from the top of knoll to Horseshoe Valley road as a first work priority.

**14. Ditches/Swales:** New ditches have been created during the construction of the new rocked driveway leading up the hill. Much of the previous ditch erosion has been eliminated. Winter sands have infiltrated the rocked ditches and will be a source for turbid water during the Spring rains. The ditches will need to be cleaned up (Sargent work in progress).

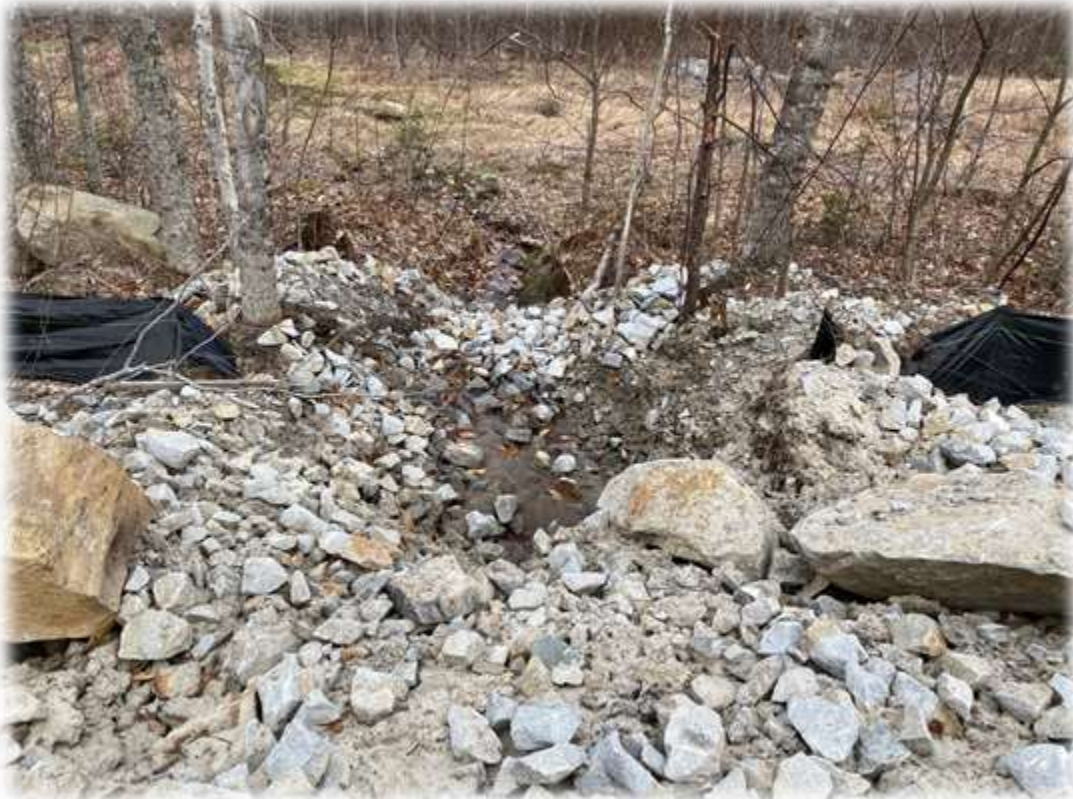
Photo #4: All of the culverts along the access road up to the top of the mountain are discharging clear water. Sargent is onsite and will check and clear sediment/debris at the inlets and outlets of each pipe as they work themselves up the mountain.

**10. Culverts/Riprap:** Sargent has upgraded some of the existing culverts and has installed new culverts going up the mountain. New proposed culverts have been installed along the access driveway. Ditches/pipes need to be cleaned and made functional at the close of each day. Several of the culverts need to be cleaned of sediment and rock at the entrances/exists of the pipe (Sargent work in progress).

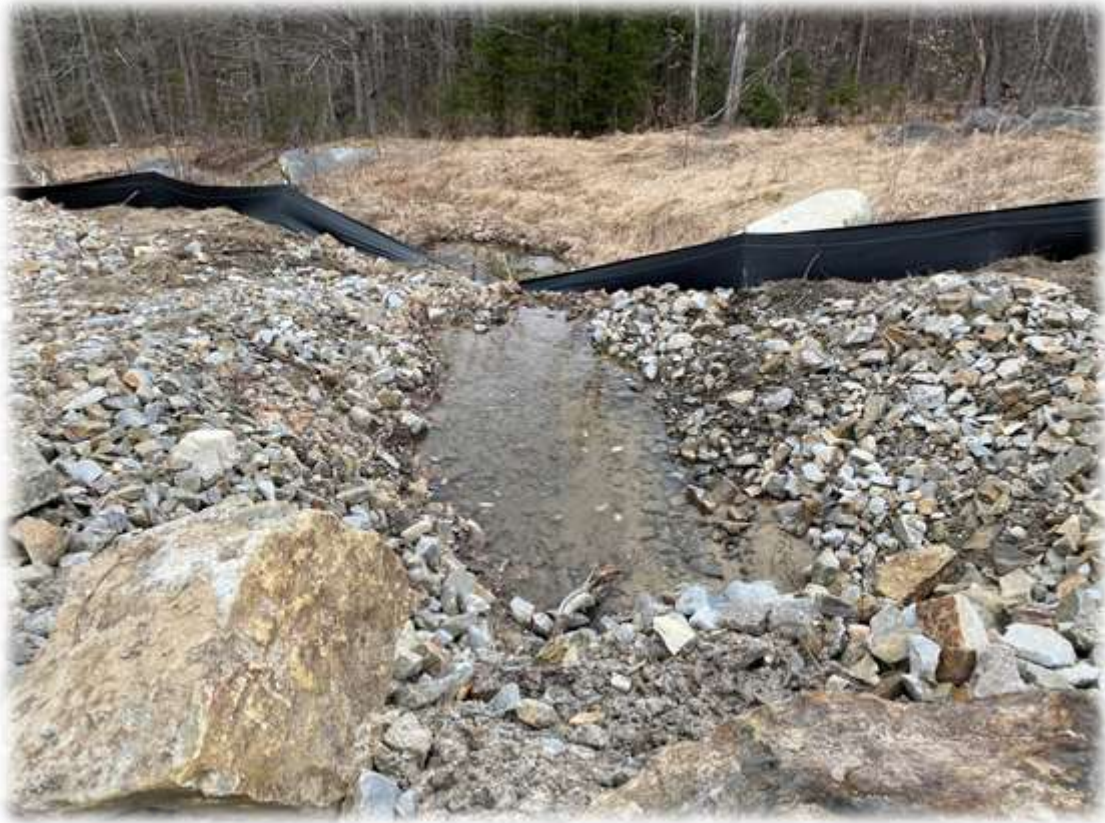
Photo #5: In general, all culverts are discharging clear water.
