# Third Party Inspection Form

# RoxWind LLC

## Horseshoe Valley Road, Roxbury

**Report:** 35

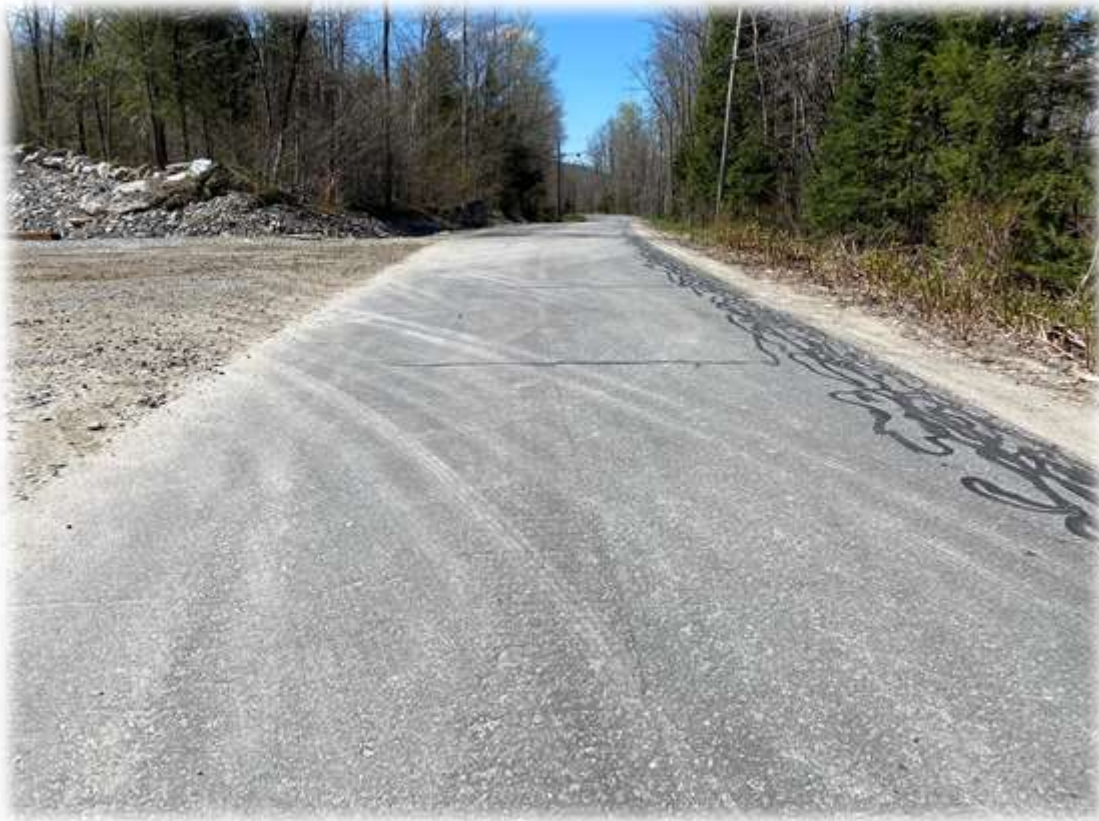
Photo #1: Horseshoe Valley Road is clear of soil debris from the project. The stabilized construction entrance still has some life left to the crushed rock entrance.

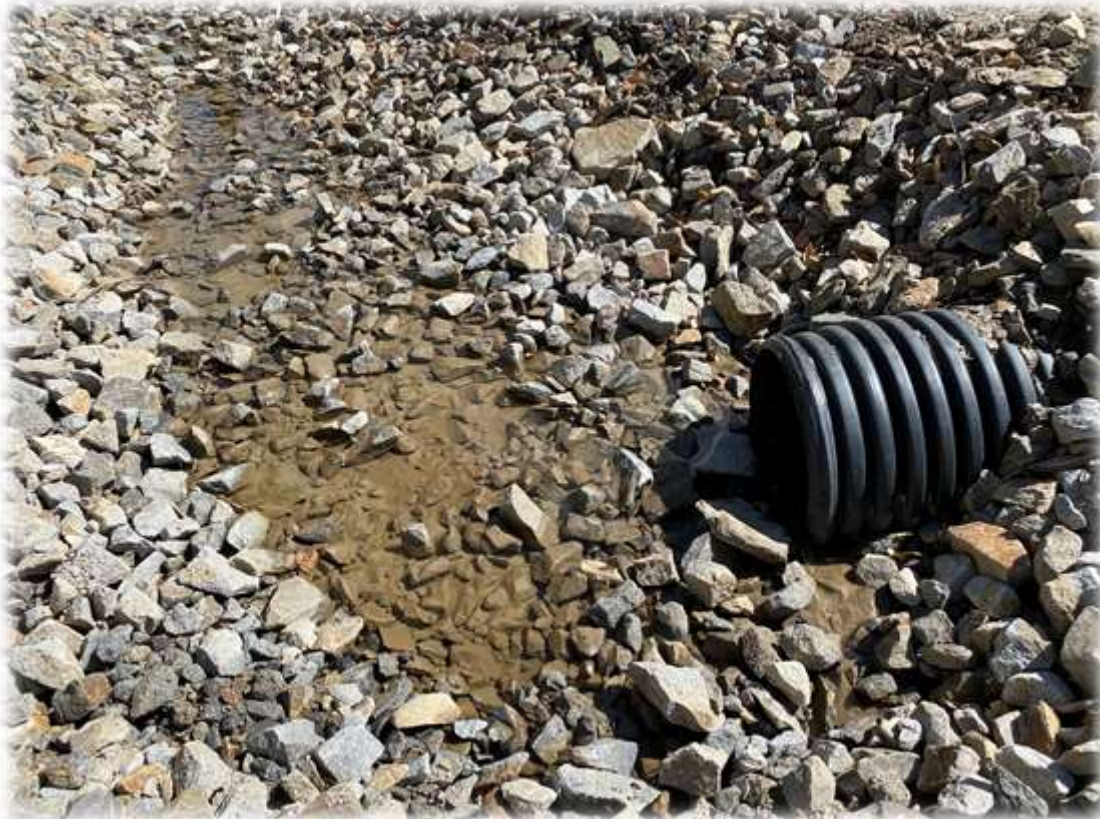
Photo #2: Water discharging from the Horseshoe Valley culvert near the entrance is crystal clear. There is some insignificant sediment within the plunge pool and culvert.

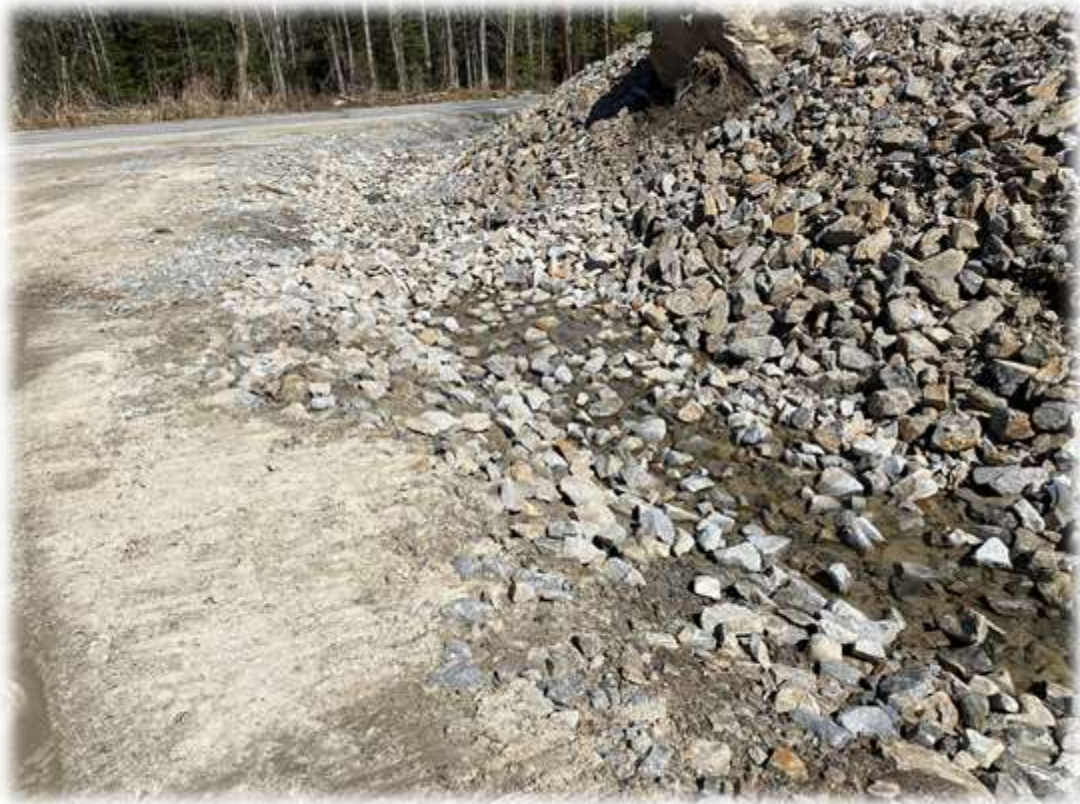
Photo #3: Water within the ditch is clear. Sargent has cleaned the ditches of sediment (winter sand accumulation) from the top of knoll to Horseshoe Valley road as a first work priority.

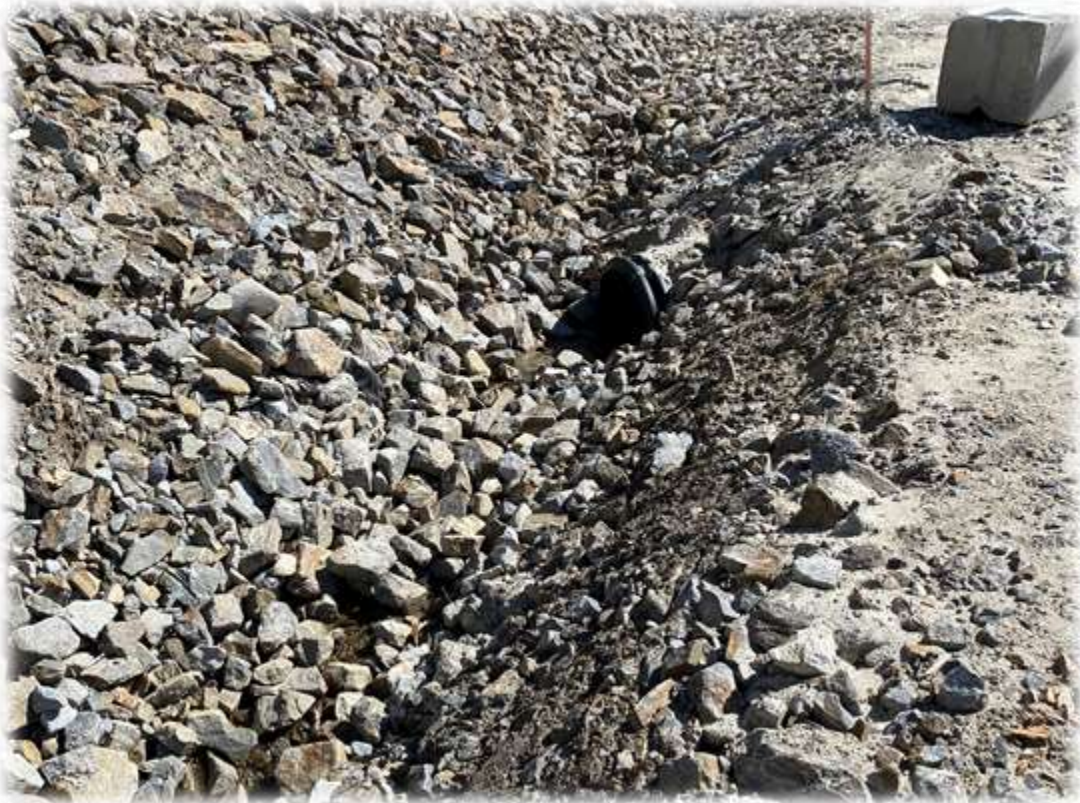
Photo #4: All of the culverts along the access road up to the top of the mountain are discharging clear water. Sargent is onsite and has cleared sediment/debris at the inlets and outlets of each pipe.

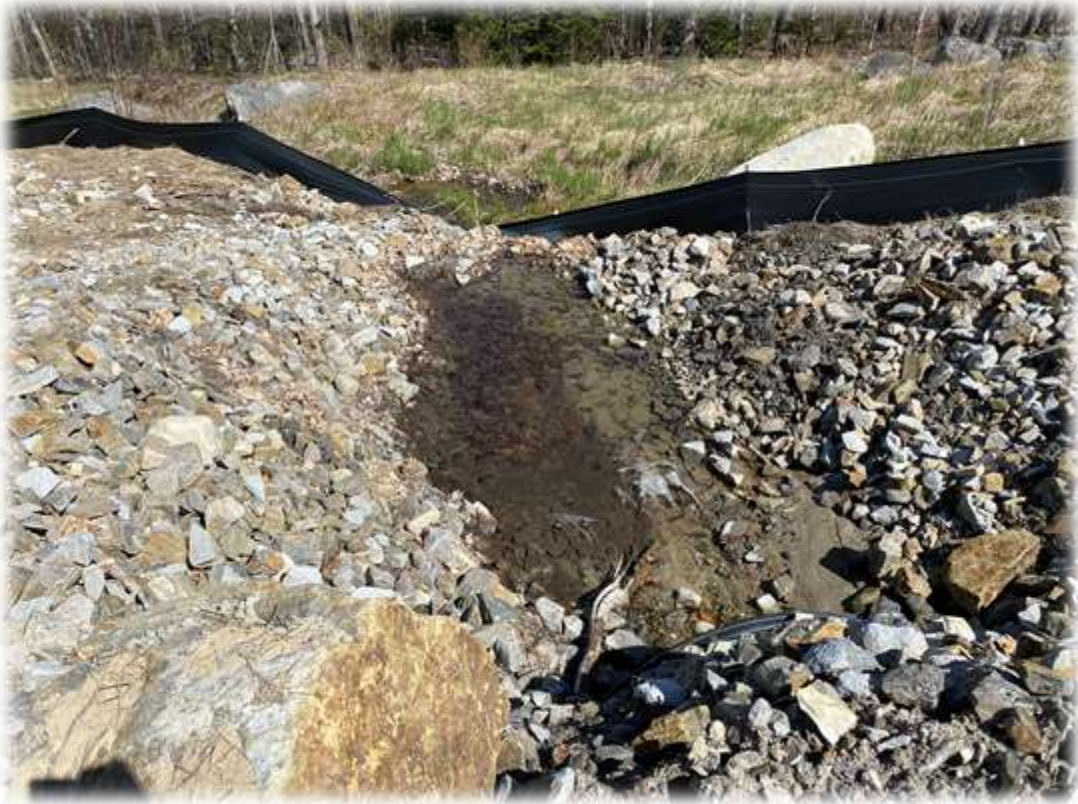
Photo #5: All of the culverts along the access road up to the top of the mountain are discharging clear water. Sargent is onsite and has cleared sediment/debris at the inlets and outlets of each pipe.

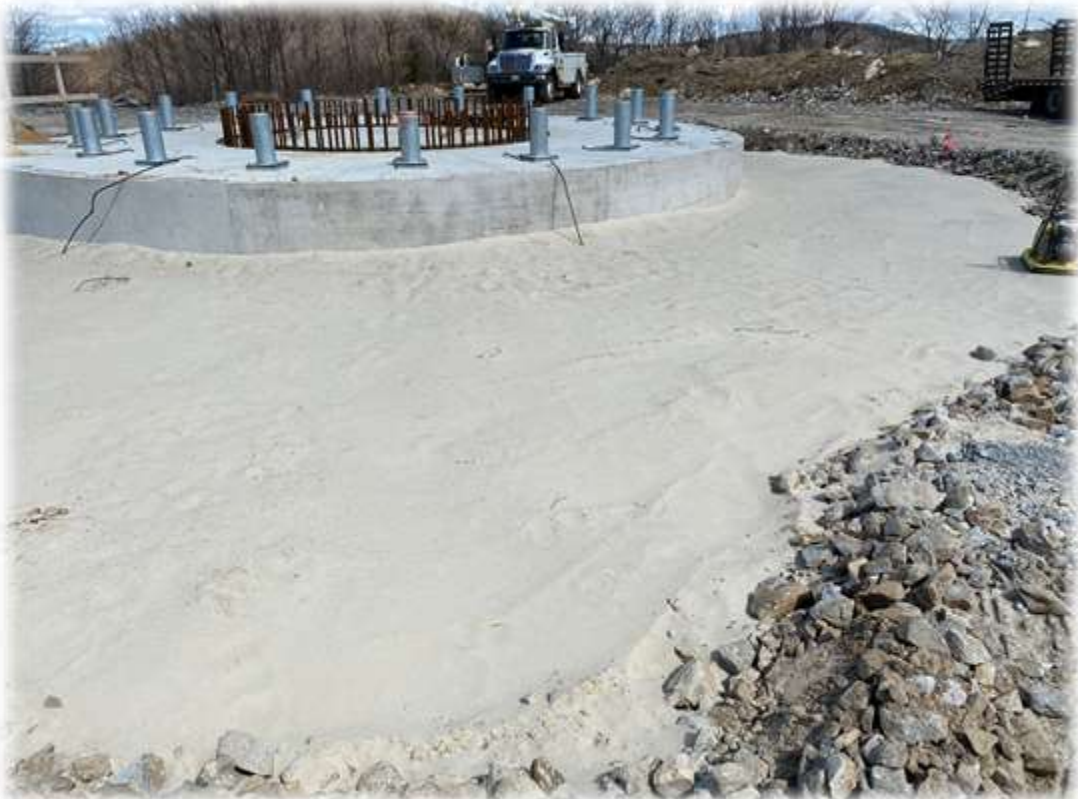
Photo #6: Tower 1 base have been backfilled and grounding system installed.

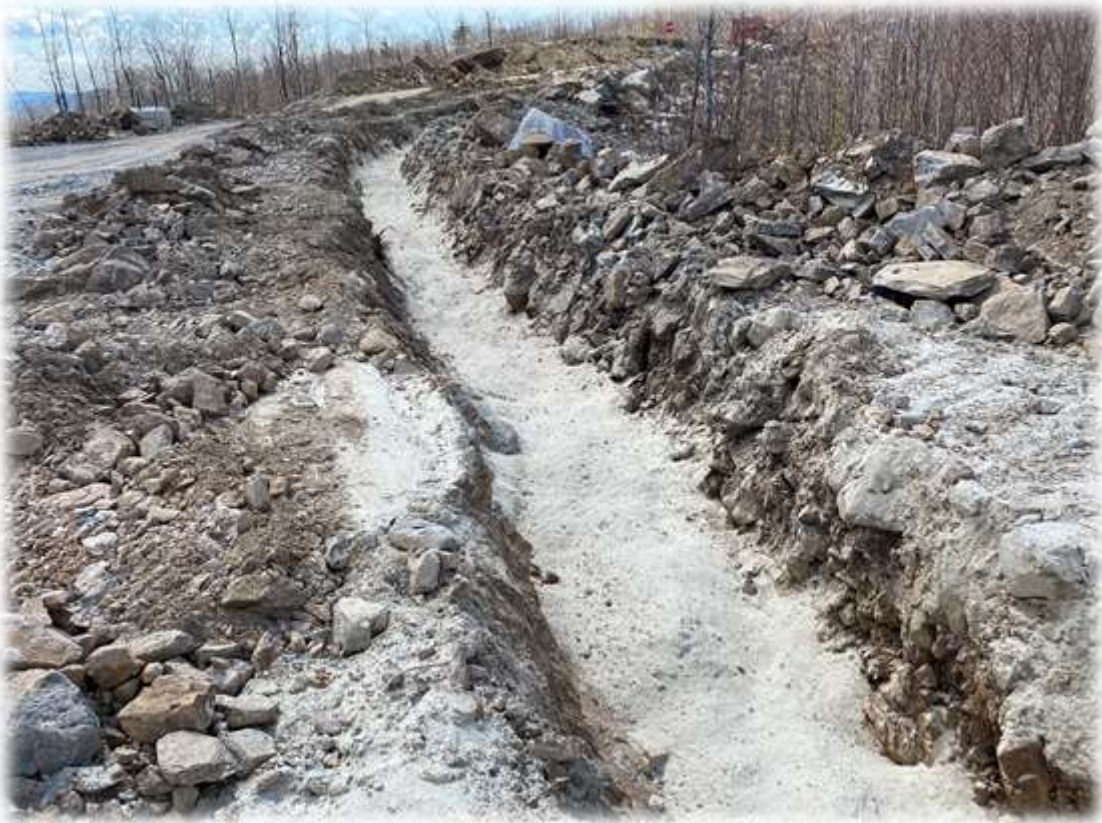
Photo #7: Trenching for the electrical cable conduit and backfill with sand has been completed to Tower 4. The trench backfill to final road grade is being performed this week.

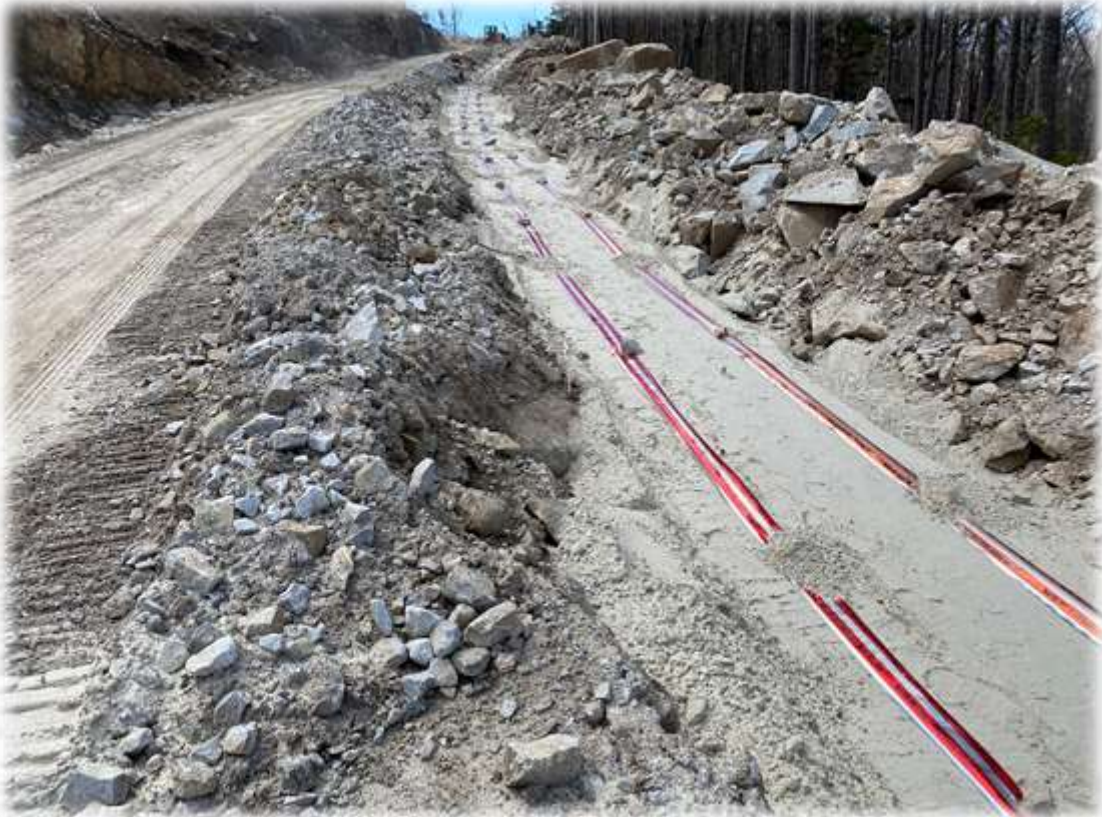
Photo #8: Marking tape for the buried electrical has been installed along the top of sand layer.

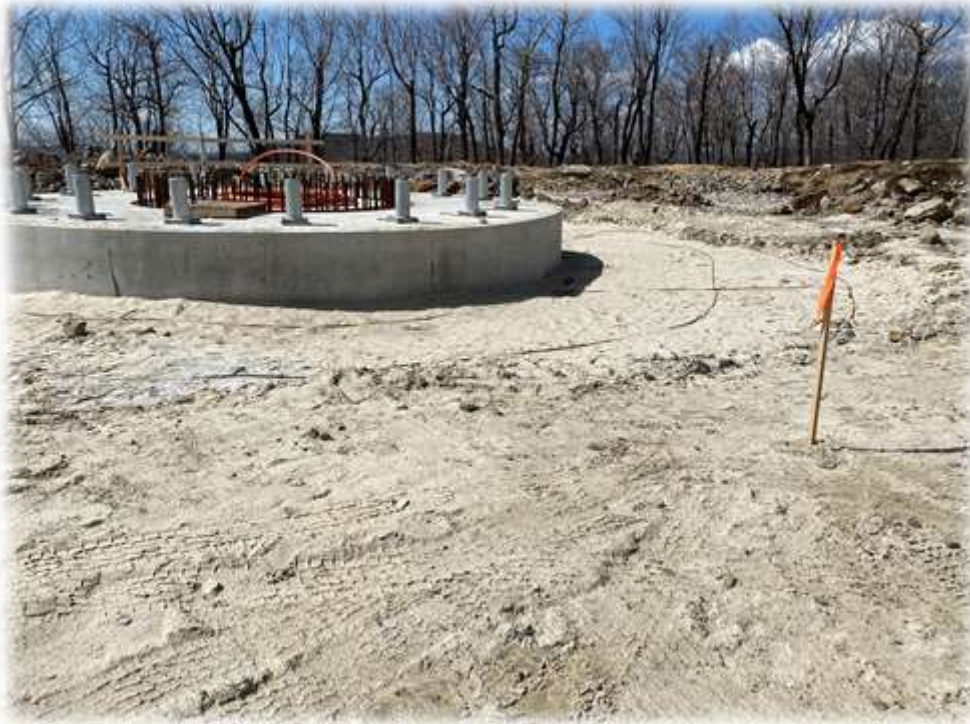
Photo #9: The Tower 4 base has been backfilled with sand and the grounding wire installed.

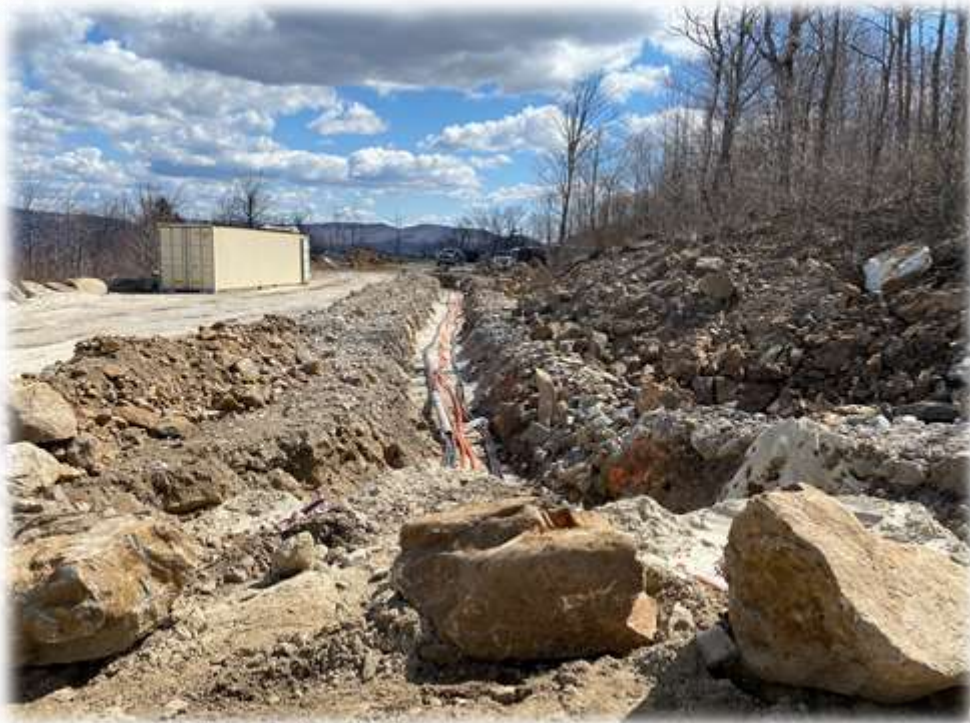
Photo #10: Conduit and direct bury electrical cables have been laid in the excavated trench and bedded in sand leading to Tower 2.
