# Third Party Inspection Form

# RoxWind LLC

## Horseshoe Valley Road, Roxbury

**Date:** Tuesday, 05-25-2021      **Time:** 8:30 AM      **Report:** 37  
**Inspected by:** Steve Roberge, PE      **Company/Agency:** SJR Engineering Inc.  
**Weather Conditions:** 60 degrees, Sun  
**Owner Rep:** Palmer Management Corp (Sumul Shah)  
**Construction Site/Project Manager:** Reed-Reed (Kate Doughty, Jake Hall)  
**Engineer:** Sewall (Jody Dube-Oneal)  
**Site Earthwork Contractor:** Sargent Construction (Tim LePage, Pete Broberg, Mark Wright)  
**Clearing Contractor:** Comprehensive Land Technologies (CLT)  
**Onsite Environmental Inspections:** Jared (Sargent)  
**Contact onsite today:** **Owner Rep:** NA, **Reed/Reed:** Kate Doughty, **Sargent:** NA  
**MD+B:** NA **CMP:** NA  
**Date of Last Inspection:** 05-17-2021  
**Estimated # of days since last rainfall over  $\frac{1}{2}$ ":** 0.5" rainfall 03/28/2021  
**Photographs taken:** 7 photos included in report

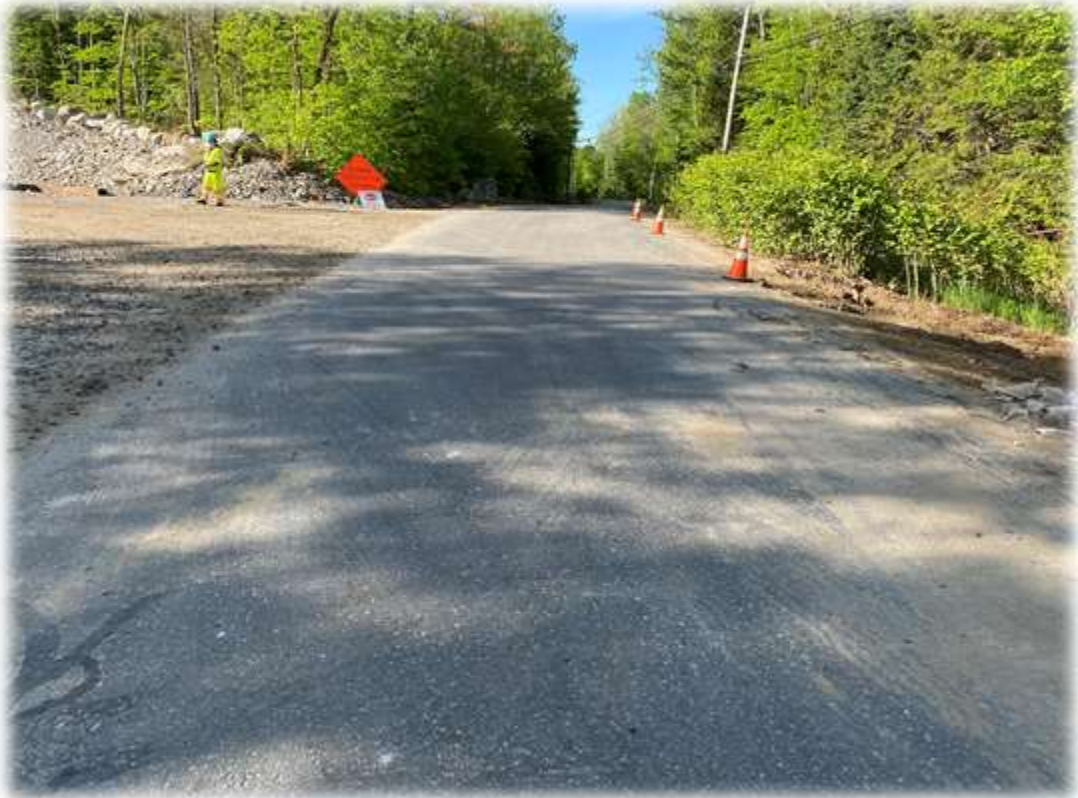
Photo #1: Horseshoe Valley Road is clear of soil debris from the project. The stabilized construction entrance still has some life left to the crushed rock entrance.

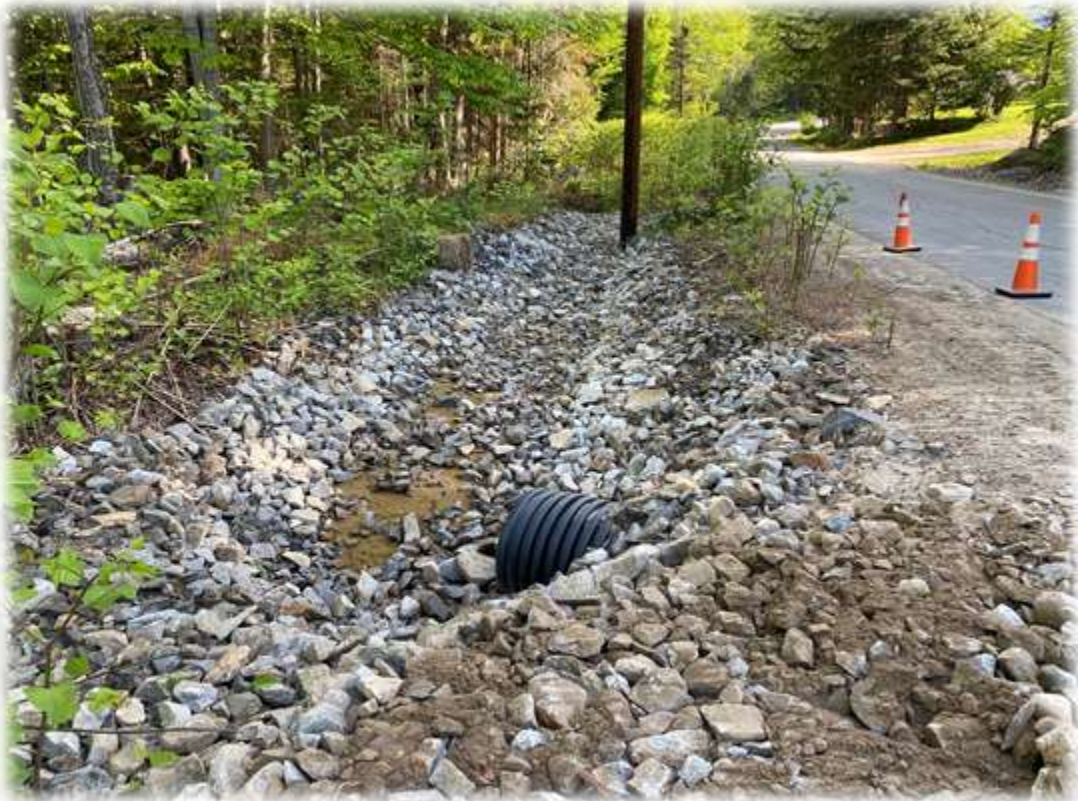
Photo #2: Water within the ditch flowing from Horseshoe Valley Rd culvert near the entrance is clear.

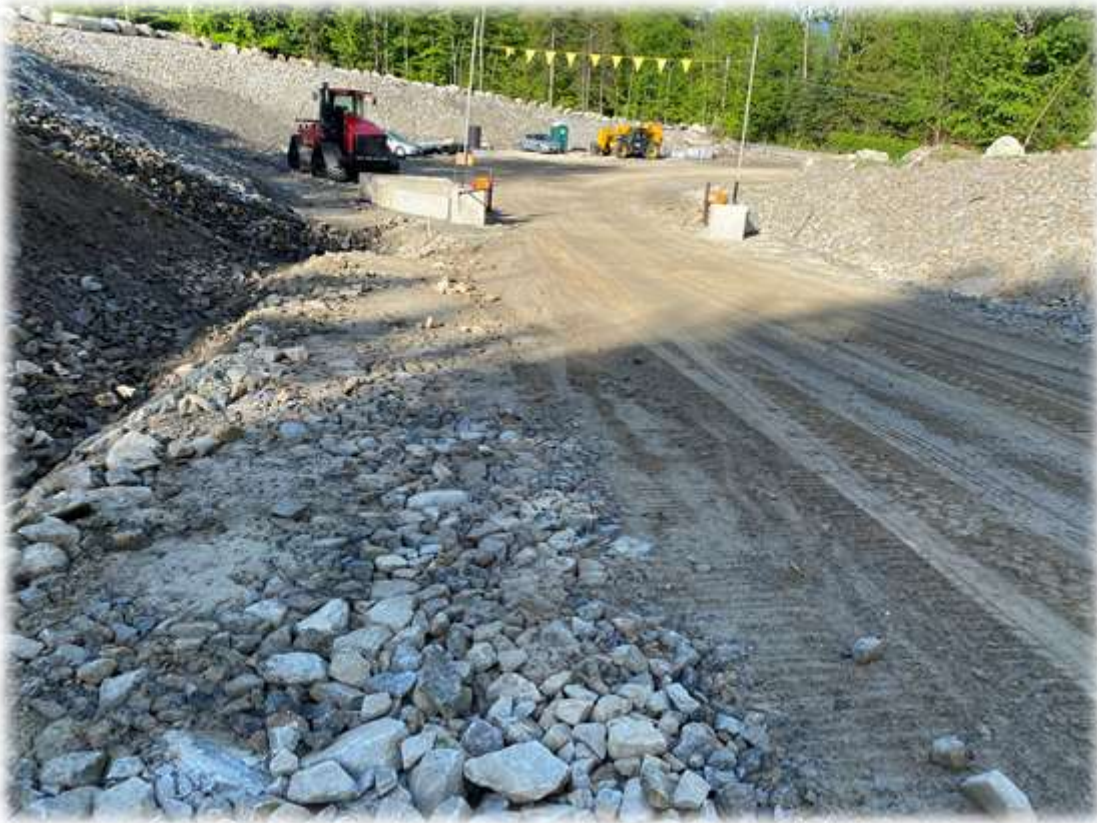
Photo #3: A groundwater breakout near the entrance gate along the access road has been repaired.

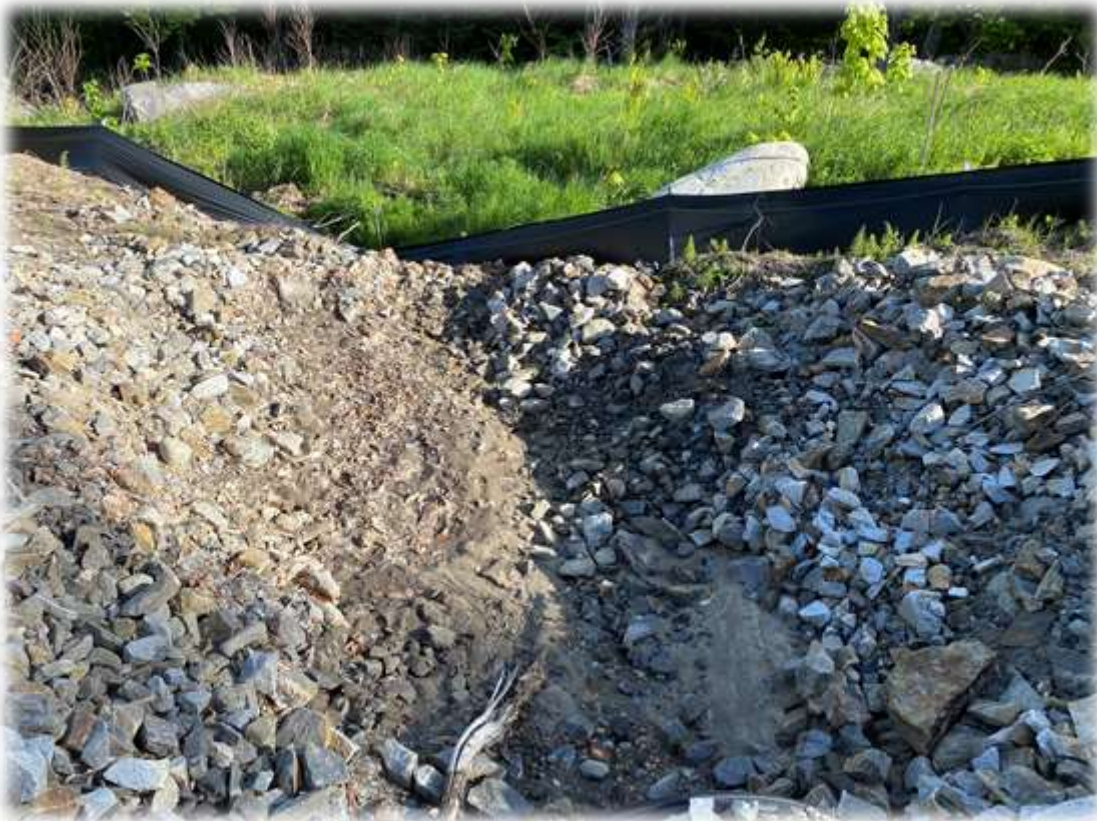
Photo #4: Water flows passing through culverts are clear where the water is flowing...Many of the water sources are low flow at this time.

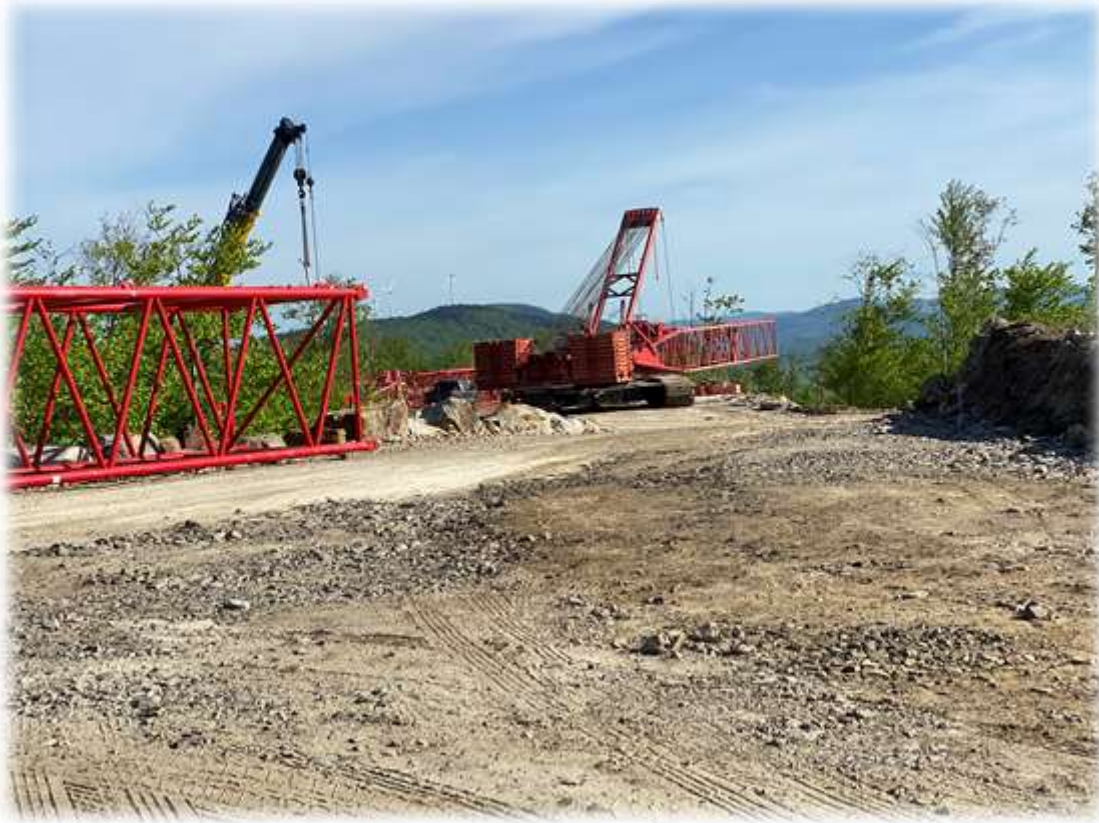
Photo #5: Action at Tower 1 includes assembling another big crane for tower work.

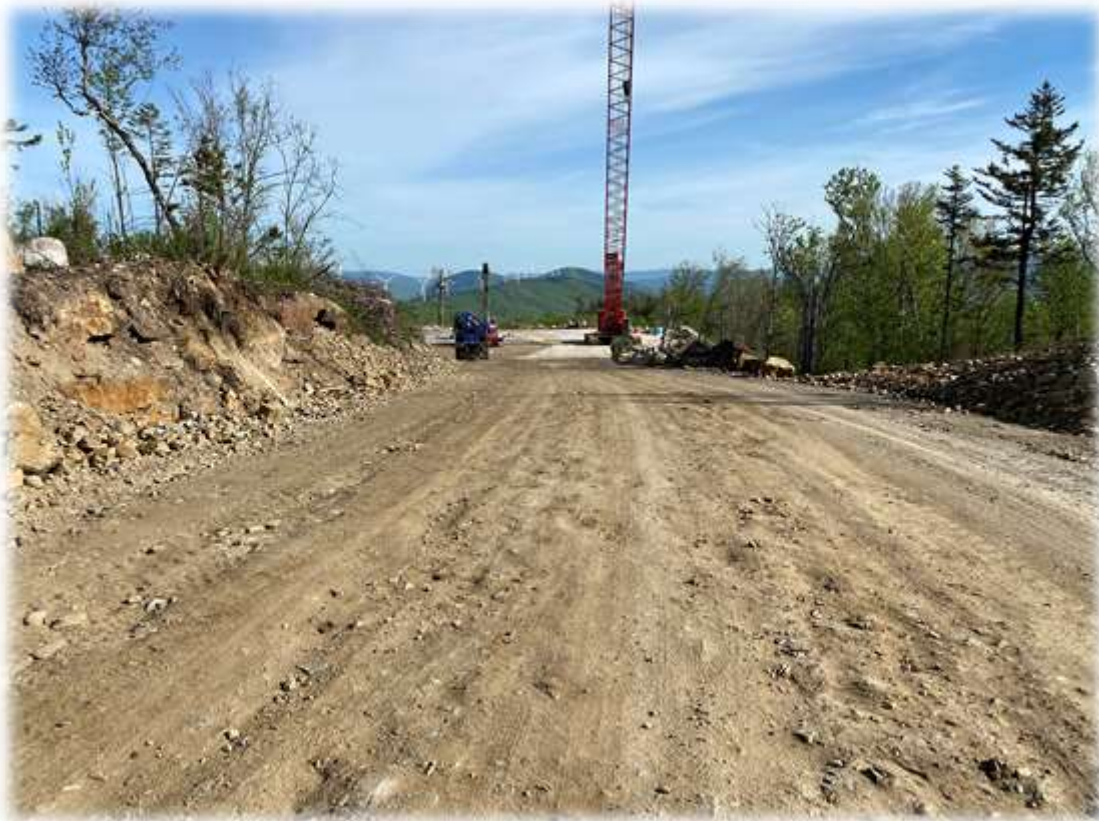
Photo #6: A large crane has been assembled at Tower 3.

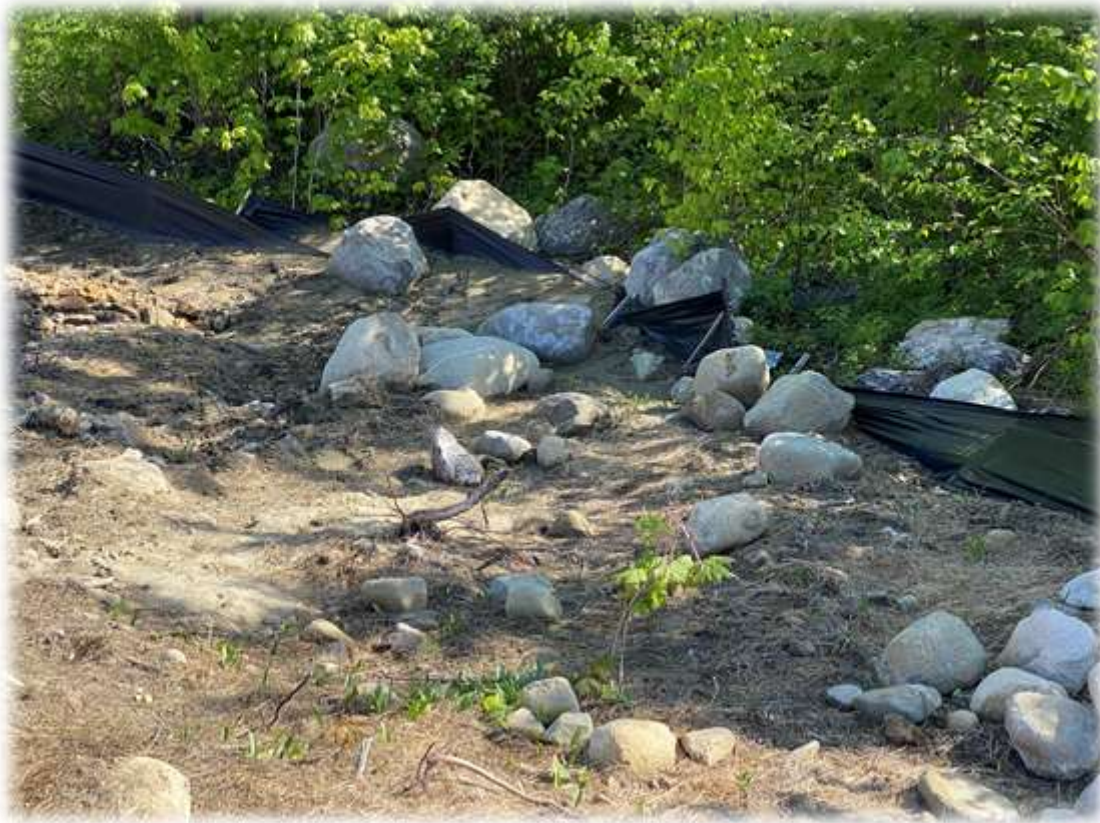
Photo #7: The silt fence has captured sediment (and large rocks) near the entrance to the corridor. It needs to be cleaned and silt fences reset to be functional again.

1. The silt fence near the corridor and sharp bend in the access road near Tower 1 needs maintenance to remove collected sediment.
2. Some of the culverts along the access road have not had the sediment removed from the pipe to provide full capacity of the pipe during intense rain events (work in progress).
