Third Party Inspection Form

TO: Erle Townsend, Dawn Hallowell PROJECT NAME/ LOCATION: RoxWind LLC DATE OF INSPECTION: 06-02-2021 WEATHER: Sun, 60 deg.	FROM: Steve Roberge DEP #: L-27863-ES-A-N, L-27863-NJ-B-N, L-27863-TG-C-N DATE OF REPORT: 06-03-2021 CONDITIONS: Good
---	--

RoxWind LLC

Horseshoe Valley Road, Roxbury

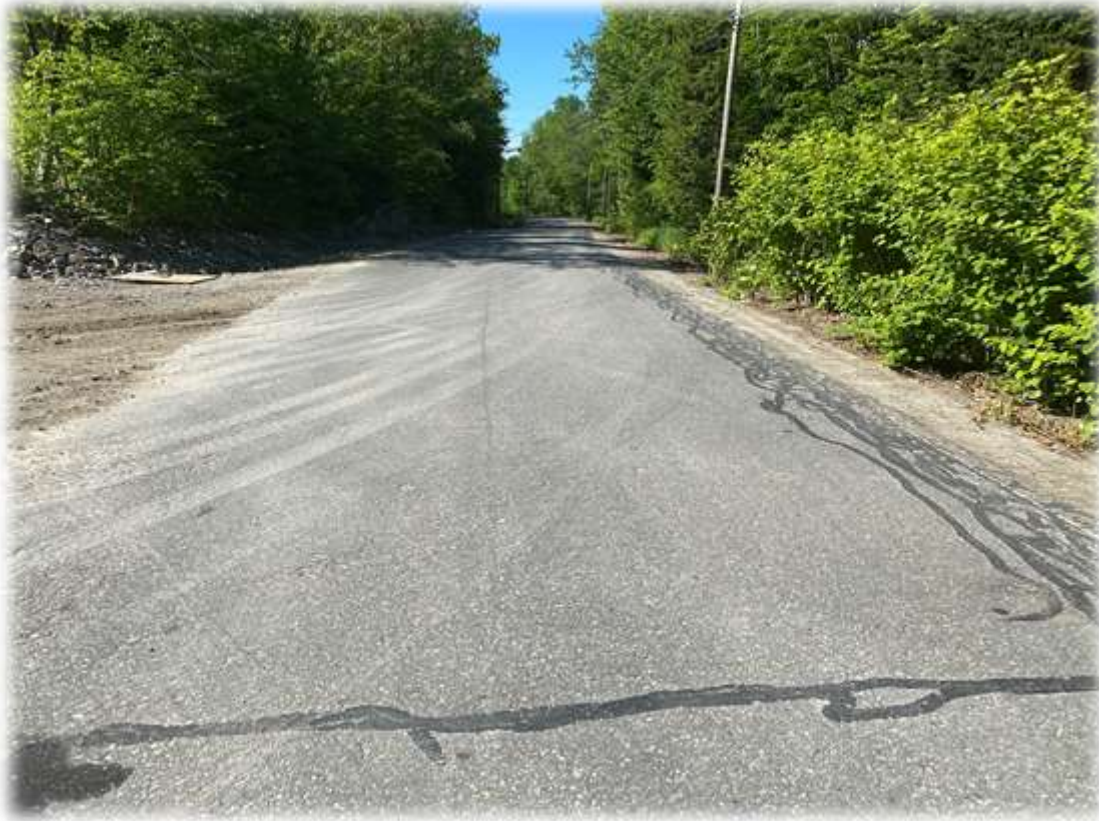
Photo #1: Horseshoe Valley Road is clear of soil debris from the project.

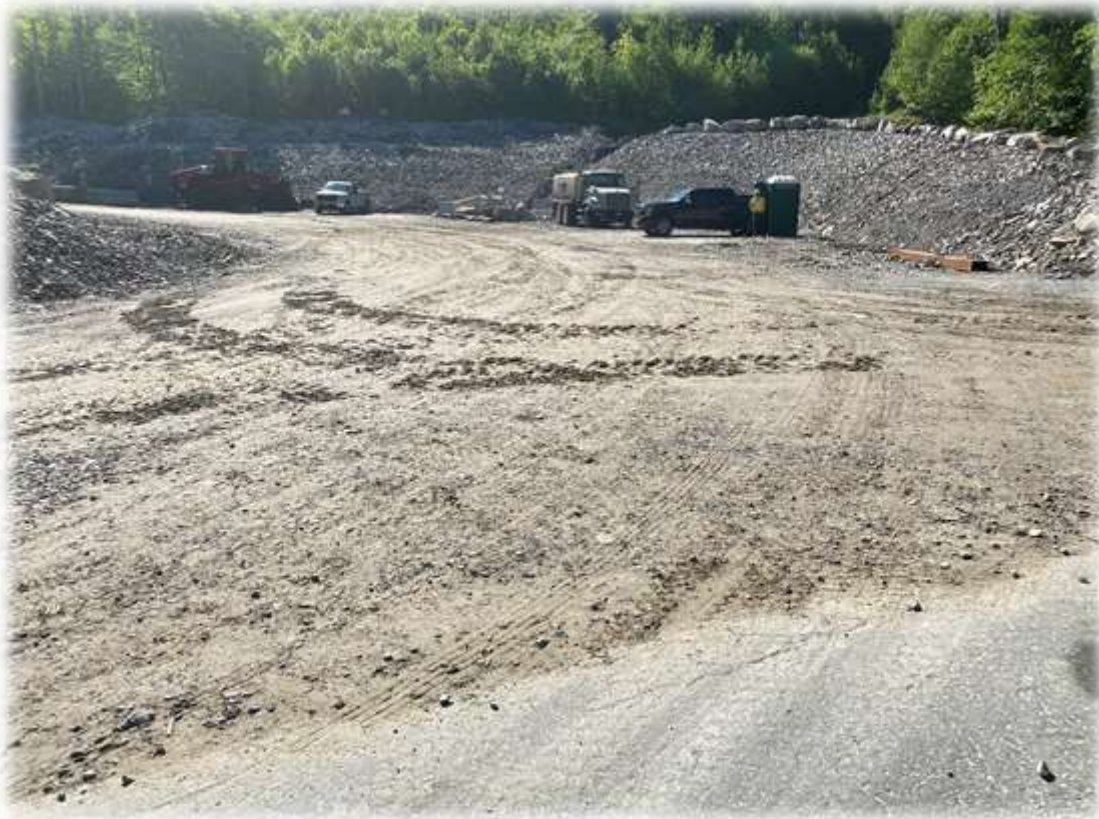
3. Stabilized Entrance: Sargent has temporarily removed the stabilized entrance to receive tower parts. No significant soils are being tracked onto Horseshoe Valley Road.

Photo #2: The stabilized construction entrance been removed in order to bring tower sections and blades into the project.

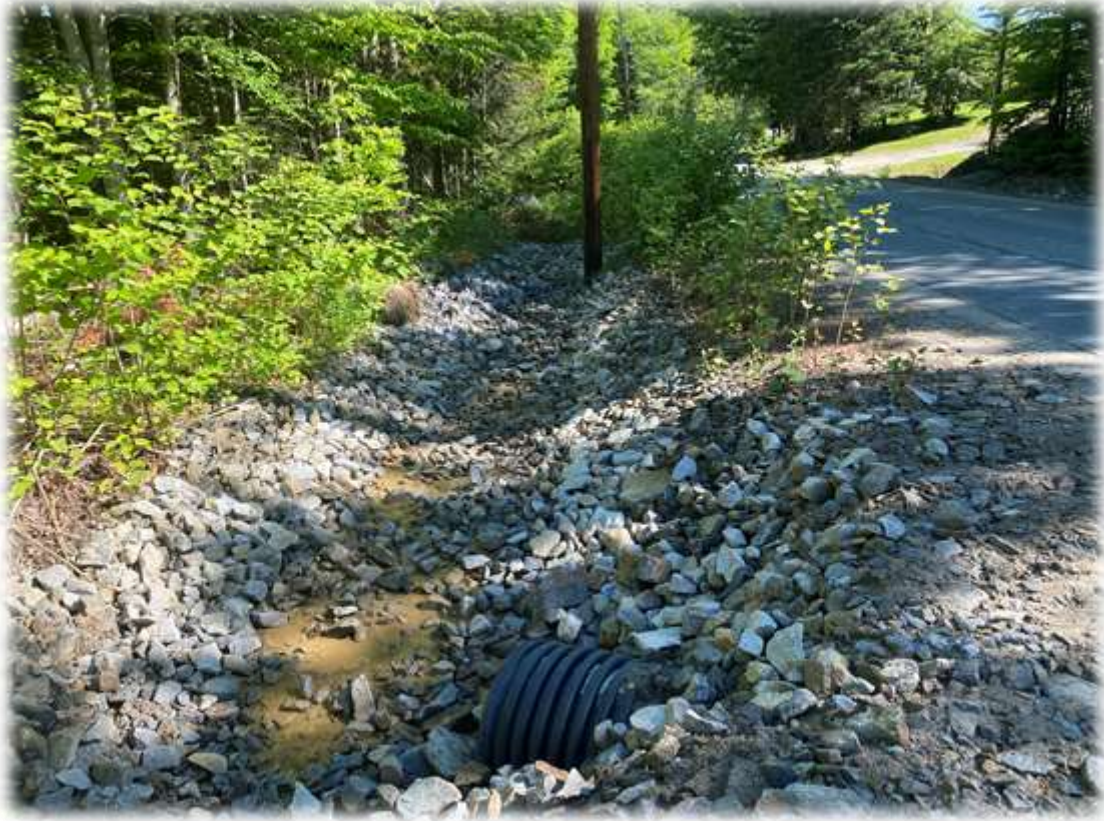
Photo #3: Water within the flow path along Horseshoe Valley Road is flowing as clear water. Some sediment lies along the top of stone.

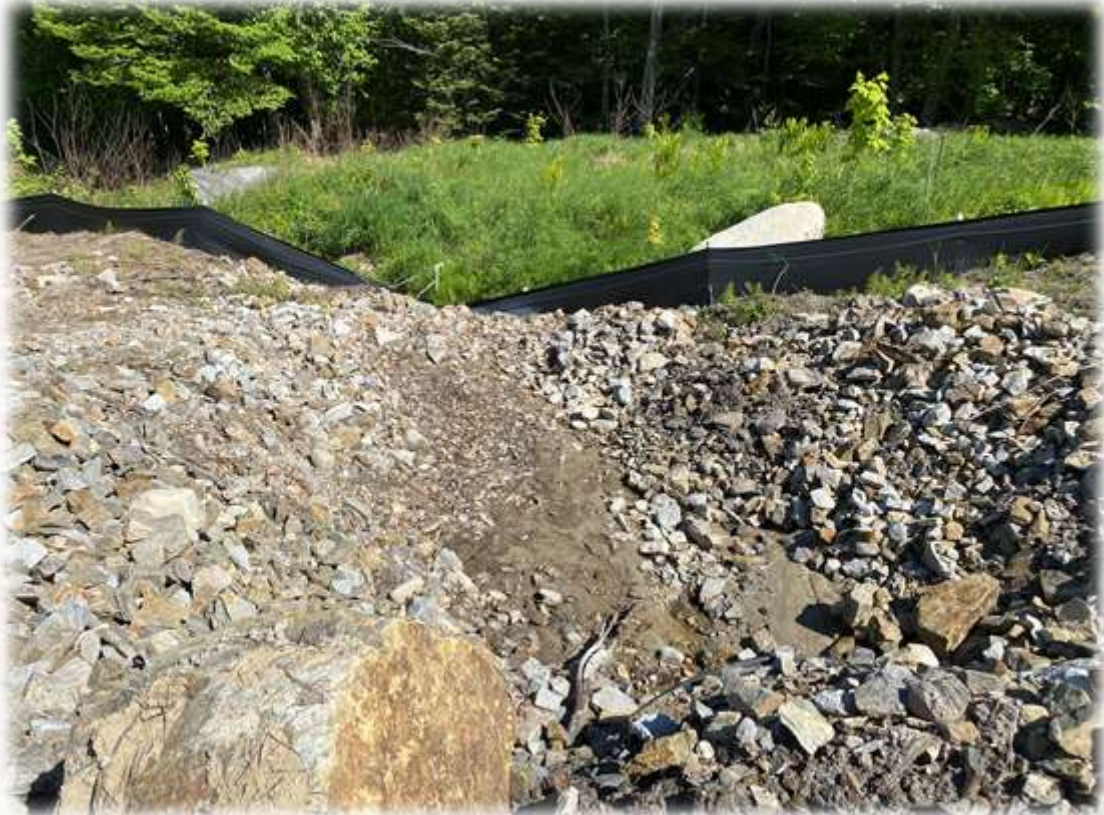
Photo #4: Even with some rain from this weekend and last night, many of the streams have no, or little, water flowing.

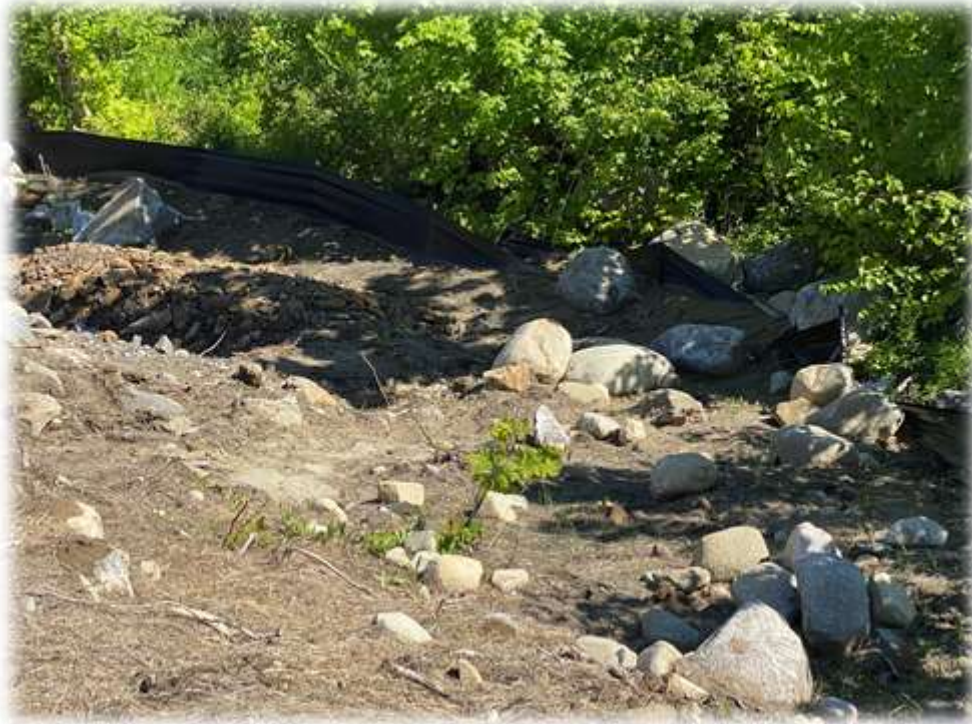
Photo #5: The silt fence along the toe of embankment along the access road curve near Tower 1 has captured significant sediment and needs to be cleaned. The sediment has topped the silt fence.

1. Sediment has collected within the silt fence between Tower 1 and the collector line and should be removed.

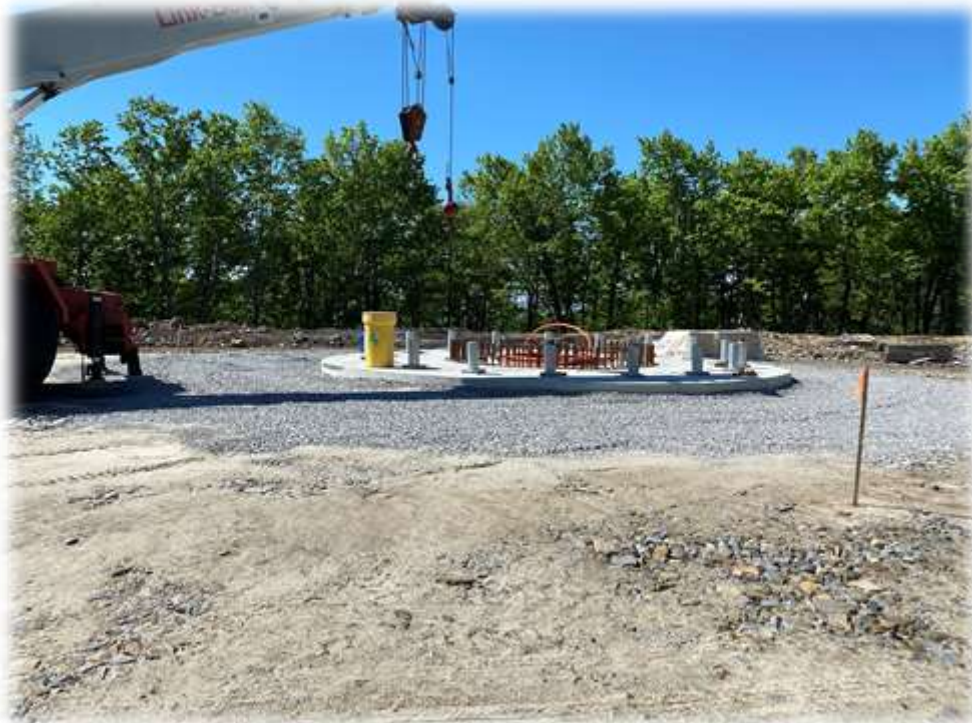
Photo #6: No significant earthwork is ongoing at the tower portion of the project. Backfill at Tower 4 has been completed.
