# Third Party Inspection Form

# RoxWind LLC

## Horseshoe Valley Road, Roxbury

**Date:** Monday, 06-07-2021      **Time:** 10:00 AM      **Report:** 39  
**Inspected by:** Steve Roberge, PE      **Company/Agency:** SJR Engineering Inc.  
**Weather Conditions:** 80 degrees, Sun  
**Owner Rep:** Palmer Management Corp (Sumul Shah)  
**Construction Site/Project Manager:** Reed-Reed (Kate Doughty, Jake Hall)  
**Engineer:** Sewall (Jody Dube-Oneal)  
**Site Earthwork Contractor:** Sargent Construction (Tim LePage, Pete Broberg, Mark Wright)  
**Clearing Contractor:** Comprehensive Land Technologies (CLT)  
**Onsite Environmental Inspections:** Jared (Sargent)  
**Contact onsite today:** **Owner Rep:** NA, **Reed/Reed:** Kate Doughty, **Sargent:** Aaron, **MD+B:** NA **CMP:** NA  
**Date of Last Inspection:** 06-02-2021  
**Estimated # of days since last rainfall over  $\frac{1}{2}$ "**: 0.64" rainfall 06/01/2021  
**Photographs taken:** 5 photos included in report

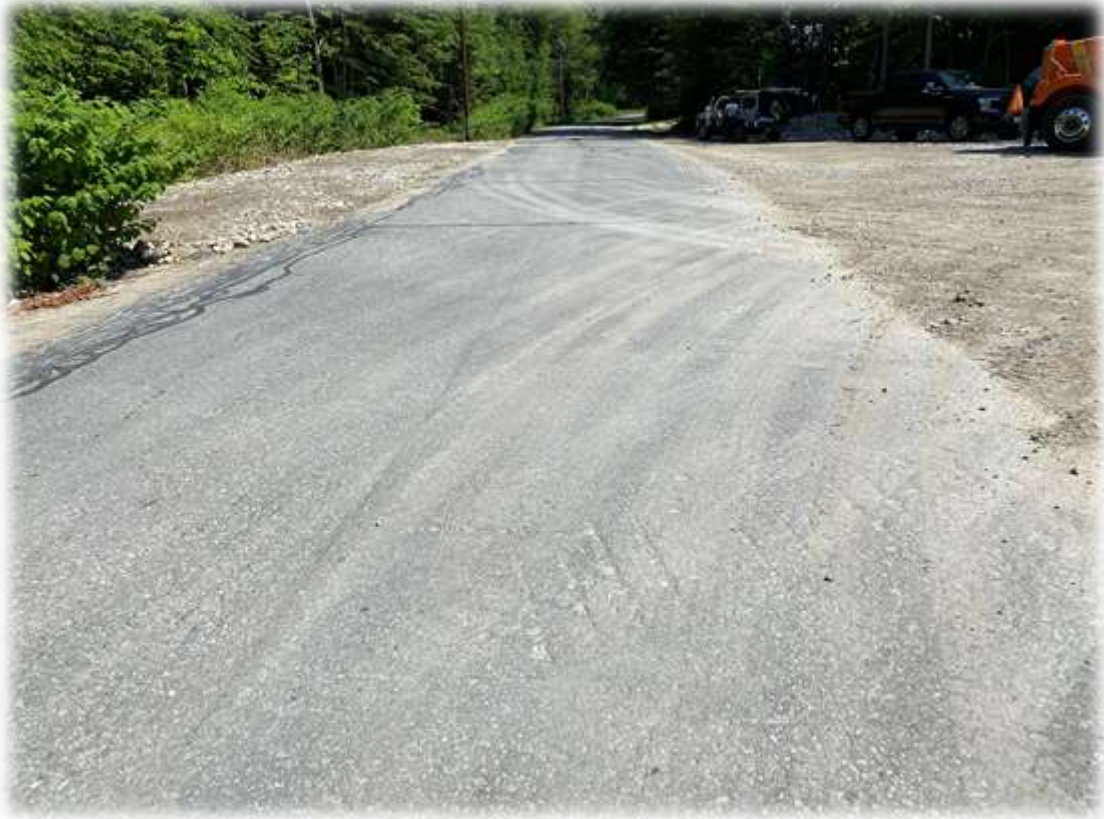
Photo #1: Horseshoe Valley Road is clear of soil debris from the project.

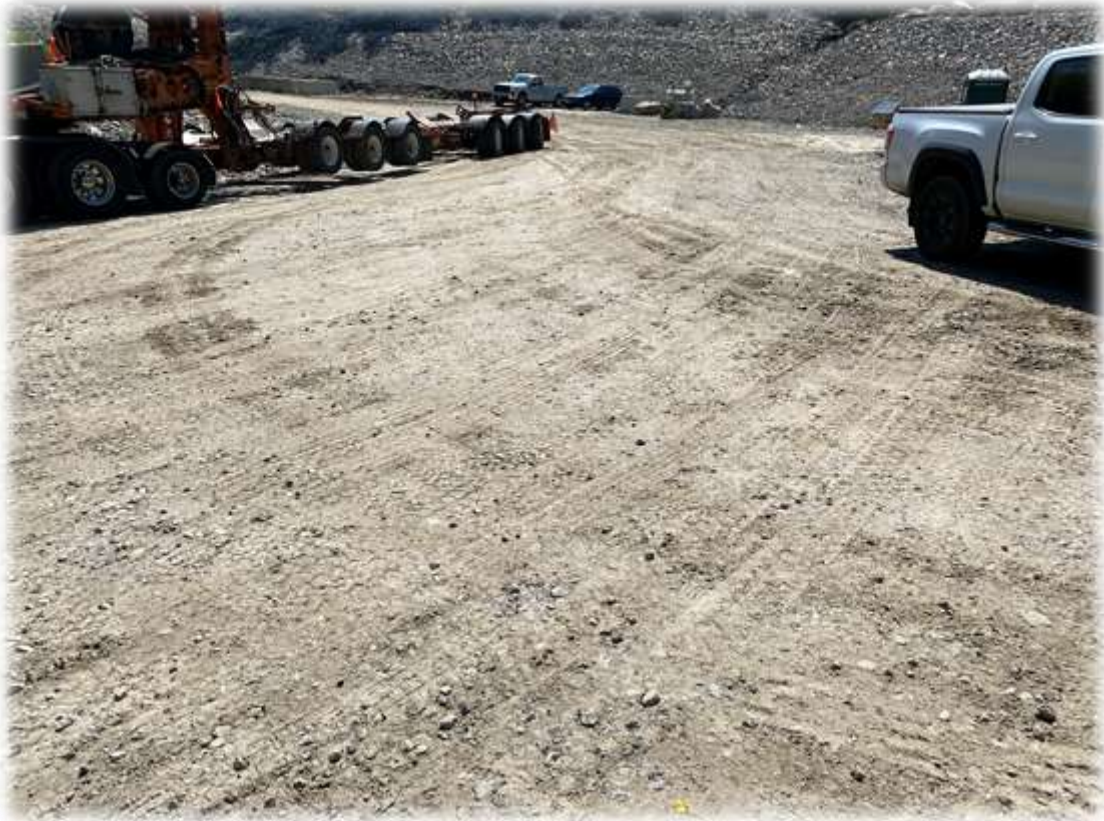
**3. Stabilized Entrance:** Sargent has temporarily removed the stabilized entrance to receive tower parts. No significant soils are being tracked onto Horseshoe Valley Road.

Photo #2: The stabilized construction entrance been removed in order to bring tower sections and blades into the project.

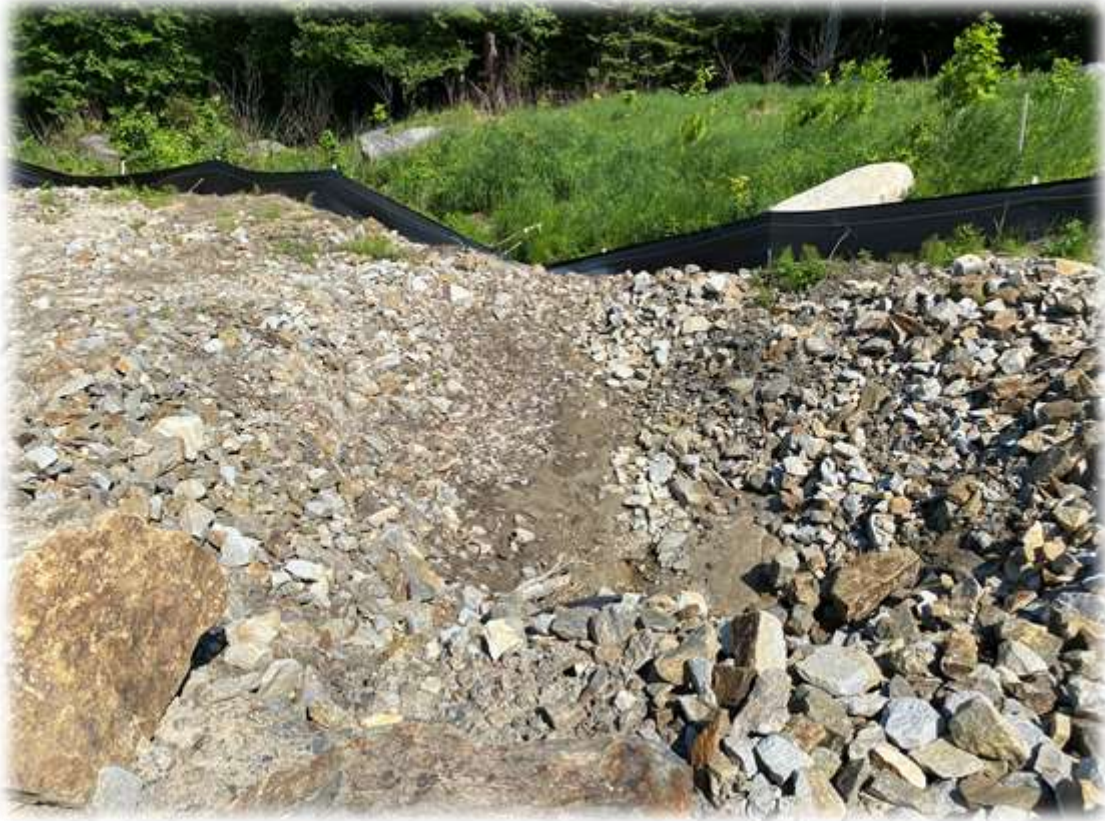
Photo #3: Even with popup showers, many of the streams/drainage swales have no, or little, water flowing.

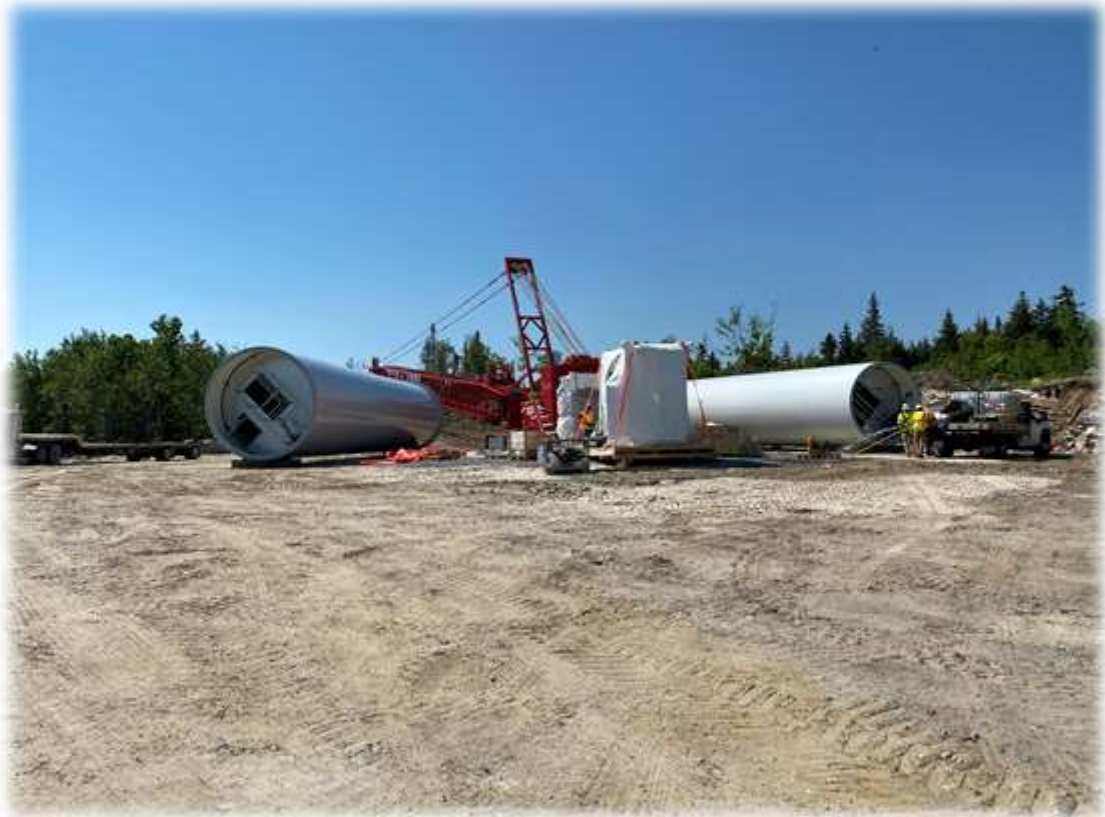
Photo #4: Sections of Tower 3 have been delivered to the site.

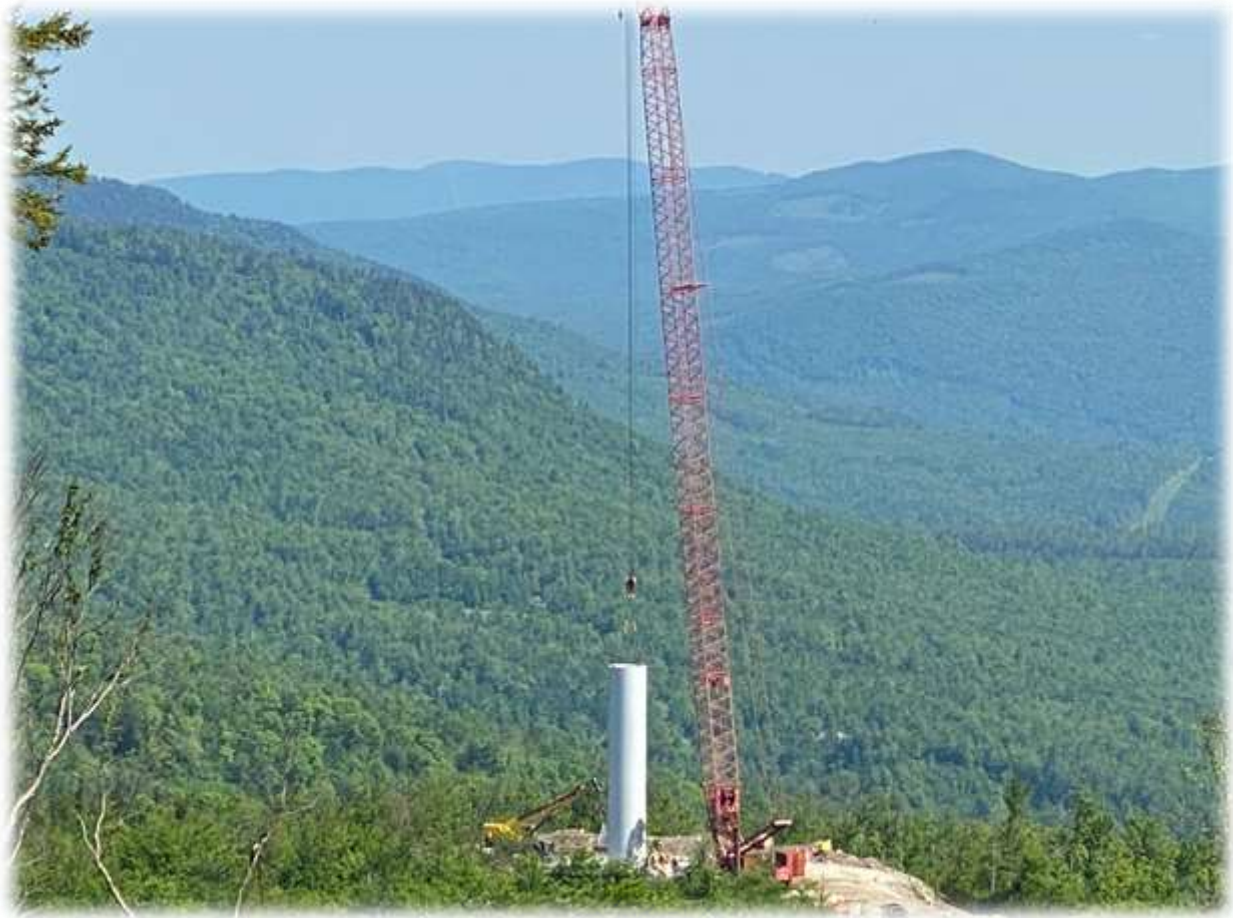
Photo #5: The base section of Tower 1 is being installed.
