Third Party Inspection Form

TO: Erle Townsend, Dawn Hallowell PROJECT NAME/ LOCATION: RoxWind LLC DATE OF INSPECTION: 06-15-2021 WEATHER: Fog, Heavy Mist, 60 deg.	FROM: Steve Roberge DEP #: L-27863-ES-A-N, L-27863-NJ-B-N, L-27863-TG-C-N DATE OF REPORT: 06-15-2021 CONDITIONS: Good
--	--

RoxWind LLC

Date: Tuesday, 06-15-2021 **Time:** 8:00 AM **Report:** 40
Inspected by: Steve Roberge, PE **Company/Agency:** SJR Engineering Inc.
Weather Conditions: 60 degrees, Fog, Heavy Mist
Owner Rep: Palmer Management Corp (Sumul Shah)
Construction Site/Project Manager: Reed-Reed (Kate Doughty, Jake Hall)
Engineer: Sewall (Jody Dube-Oneal)
Site Earthwork Contractor: Sargent Construction (Tim LePage, Pete Broberg, Mark Wright)
Clearing Contractor: Comprehensive Land Technologies (CLT)
Onsite Environmental Inspections: Jared (Sargent)
Contact onsite today: **Owner Rep:** NA, **Reed/Reed:** Kate Doughty, **Sargent:** NA, **MD+B:** NA, **CMP:** NA
Date of Last Inspection: 06-07-2021
Estimated # of days since last rainfall over $\frac{1}{2}$ ": 0.64" rainfall 06/01/2021
Photographs taken: 5 photos included in report

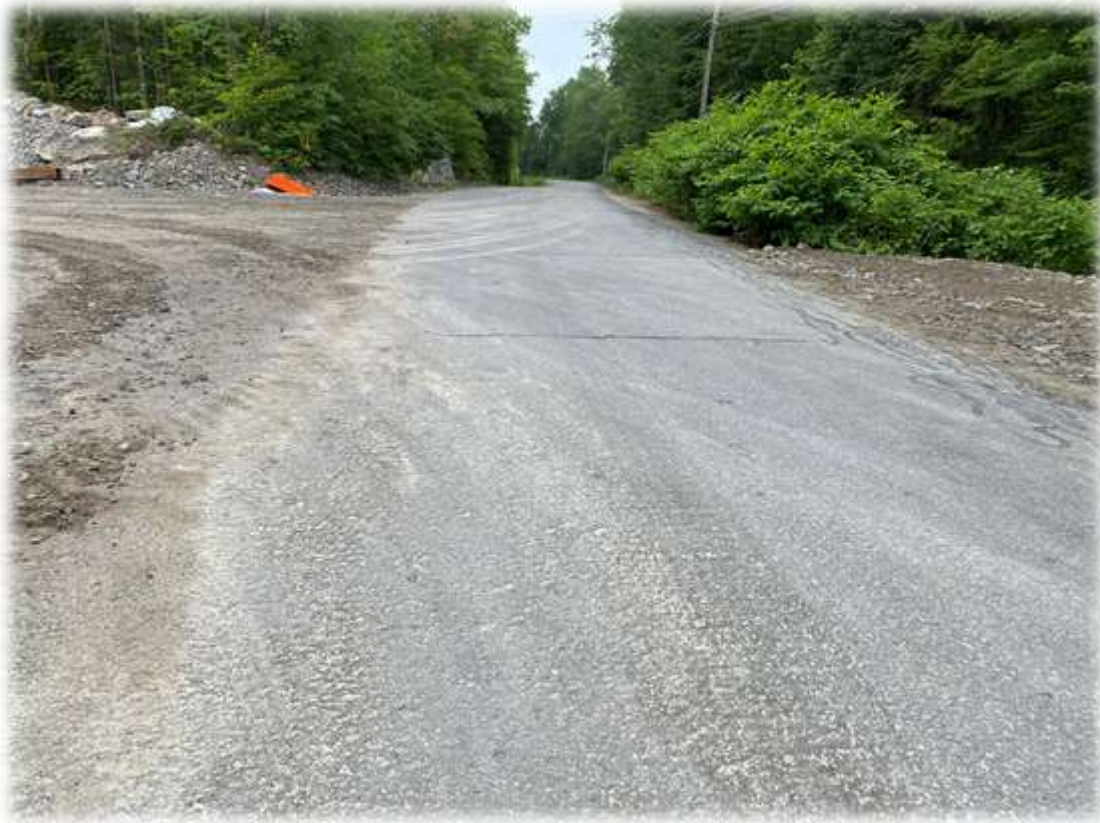
Photo #1: Horseshoe Valley Road is clear of soil debris from the project.

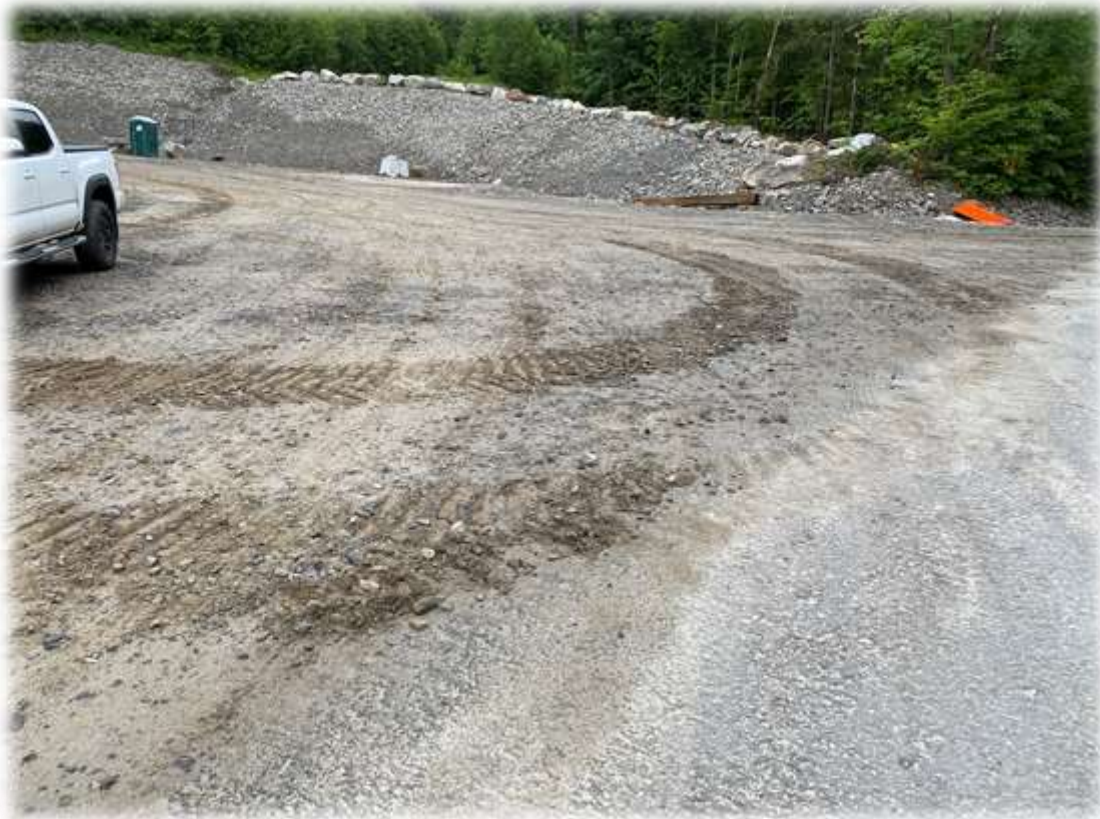
3. Stabilized Entrance: Sargent has temporarily removed the stabilized entrance to receive tower parts. No significant soils are being tracked onto Horseshoe Valley Road.

Photo #2: The stabilized construction entrance been removed in order to bring tower sections and blades into the project.

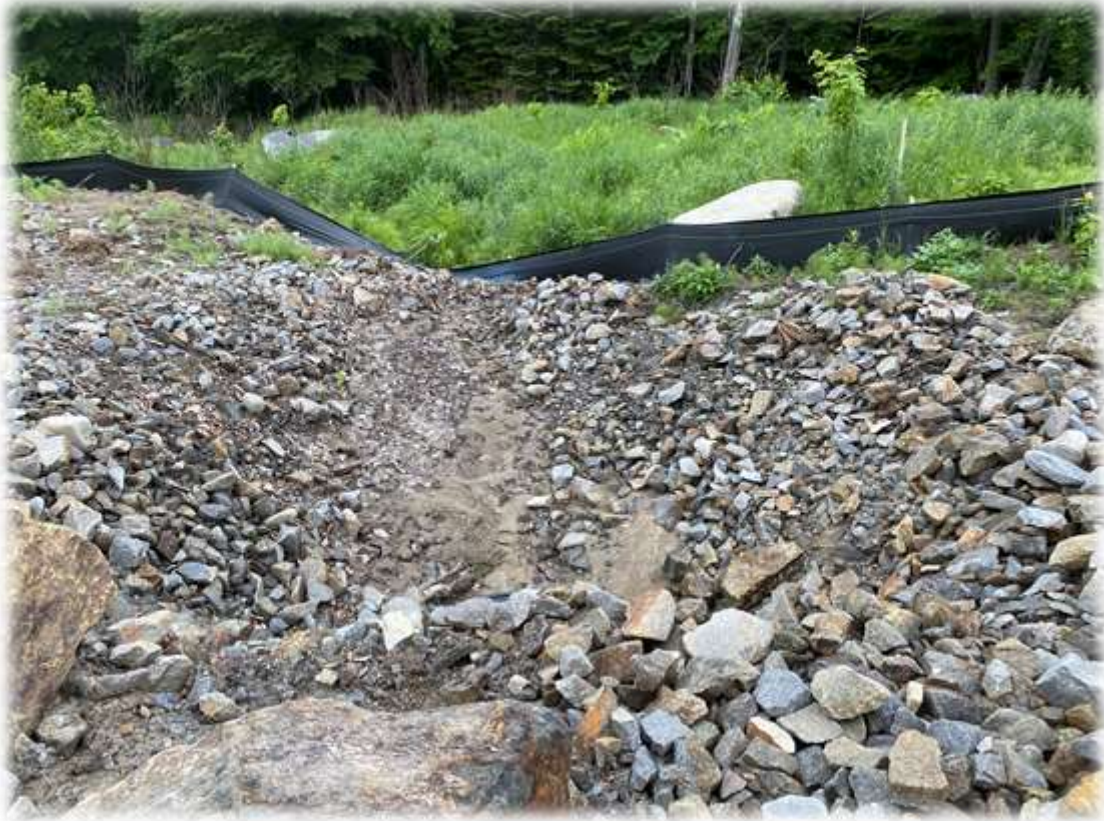
Photo #3: Even with a little rain last night, many of the streams/drainage swales have no, or little, water flowing.

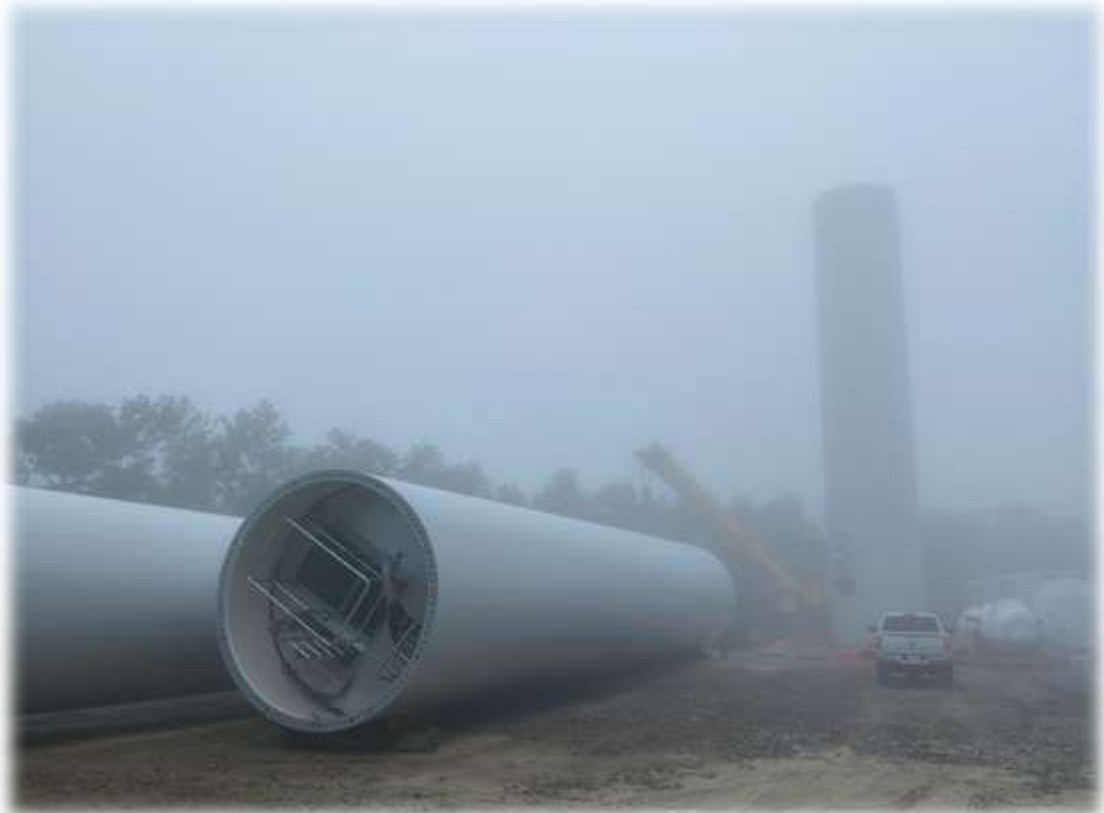
Photo #4: The base section of Tower 4 has been set. All of the tower sections have been delivered to the site. Many of the blades have been delivered to the site.

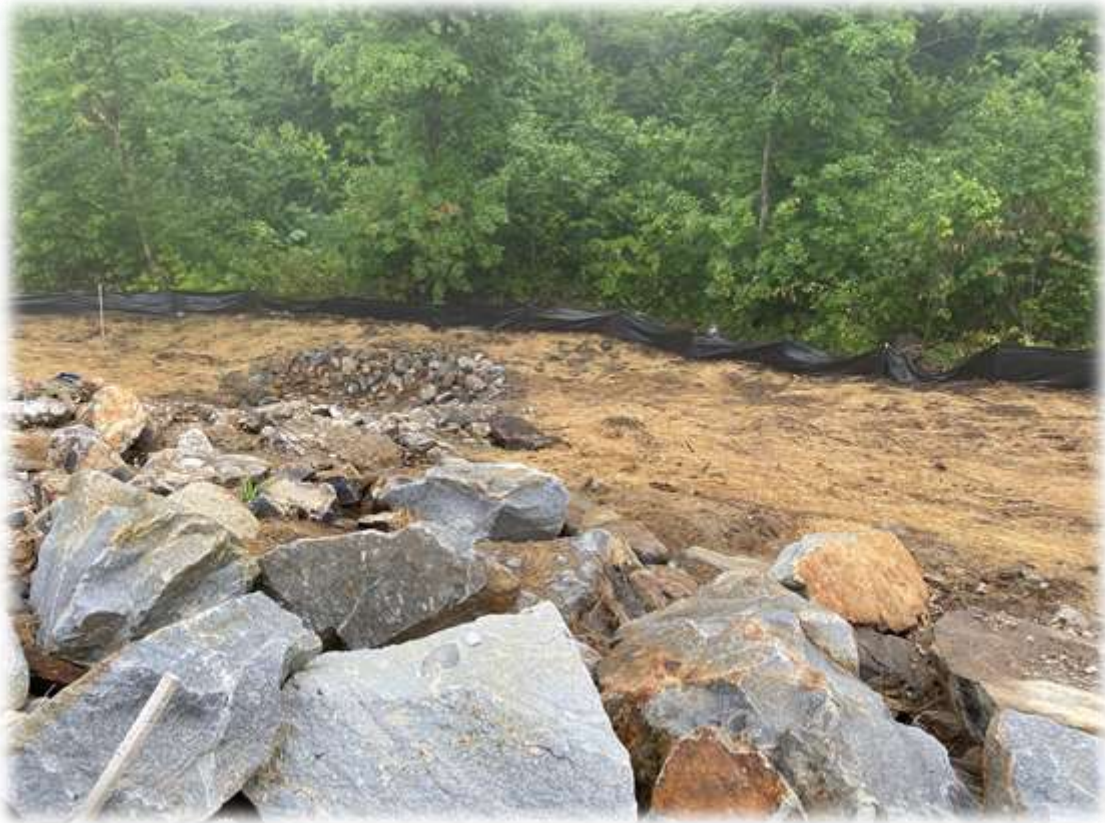
Photo #5: The former silt fence between Tower 1 and the corridor has been removed, the area cleaned of collected sediment, and new silt fence installed. Disturbed areas have been mulched.
