Third Party Inspection Form

TO: Erle Townsend, Dawn Hallowell	FROM: Steve Roberge
PROJECT NAME/ LOCATION: RoxWind LLC	DEP #: L-27863-ES-A-N, L-27863-NJ-B-N, L-27863-TG-C-N
DATE OF INSPECTION: 06-21-2021	DATE OF REPORT: 06-21-2021
WEATHER: Clouds/Lightning in area, 70 deg.	CONDITIONS: Good

RoxWind LLC

Horseshoe Valley Road, Roxbury

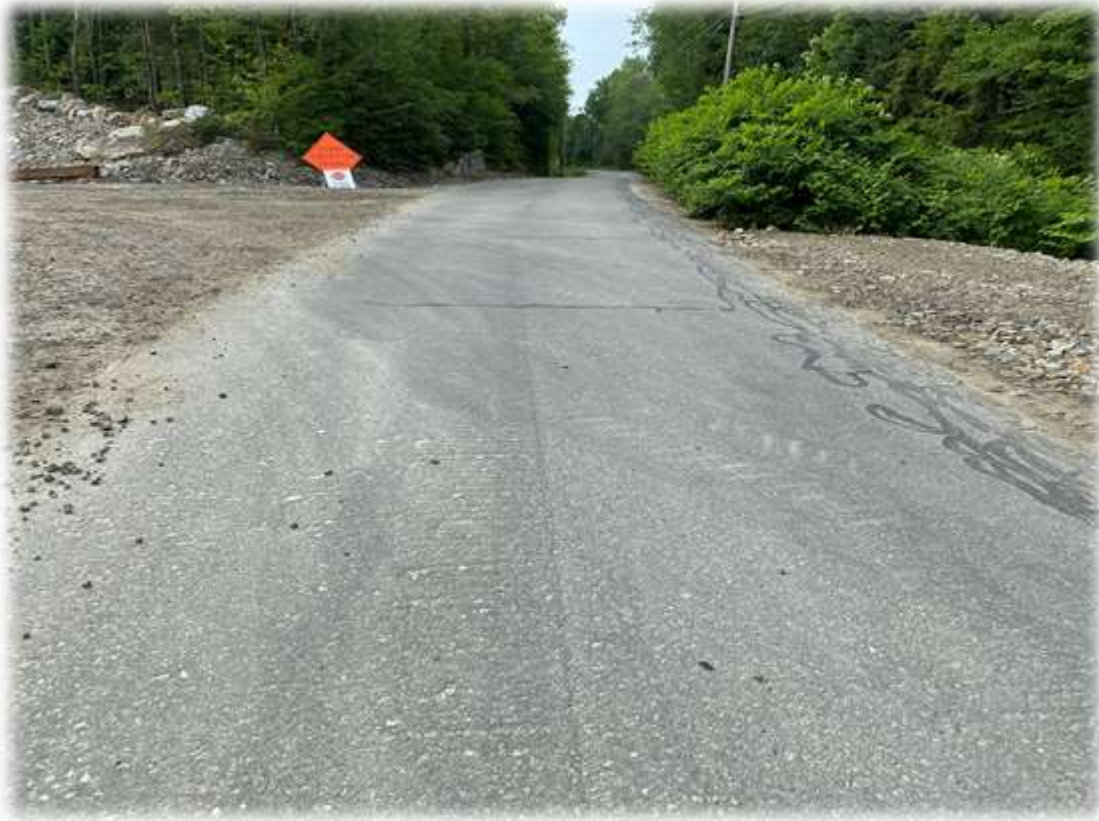
Photo #1: Horseshoe Valley Road is clear of soil debris from the project.

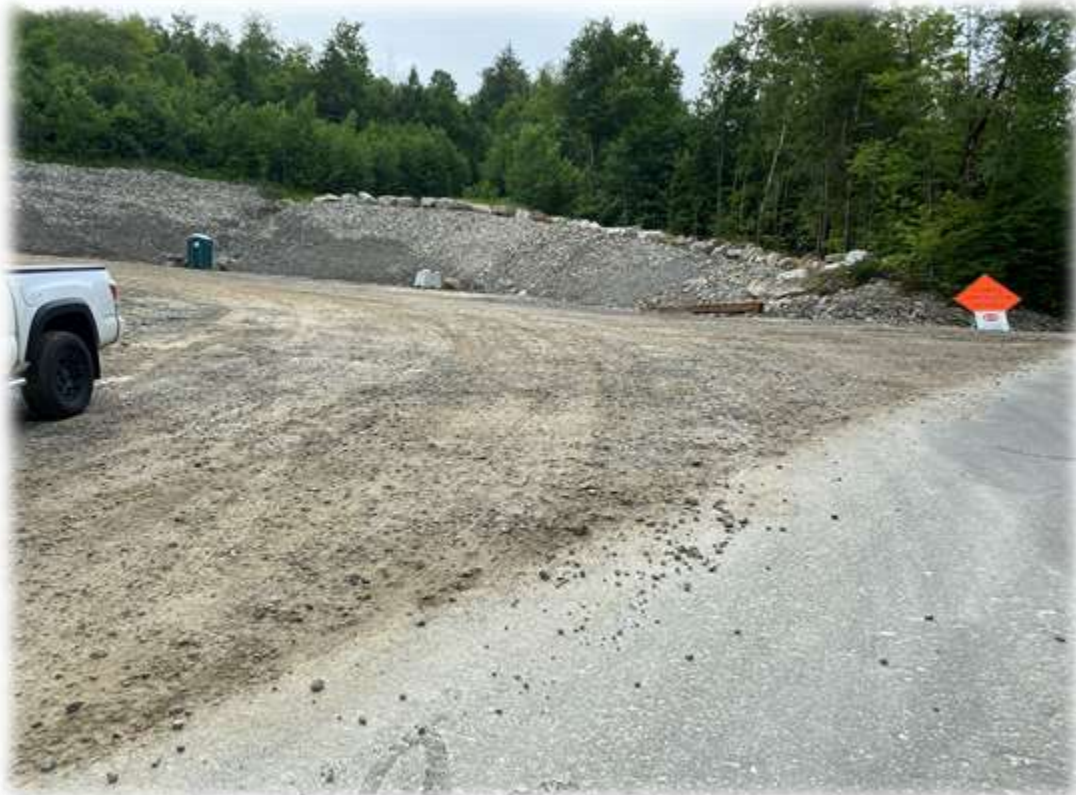
3. Stabilized Entrance: Sargent has temporarily removed the stabilized entrance to receive tower parts. No significant soils are being tracked onto Horseshoe Valley Road.

Photo #2: The stabilized construction entrance been removed in order to bring tower sections and blades into the project. There is no debris being transported onto Horse Valley Road.

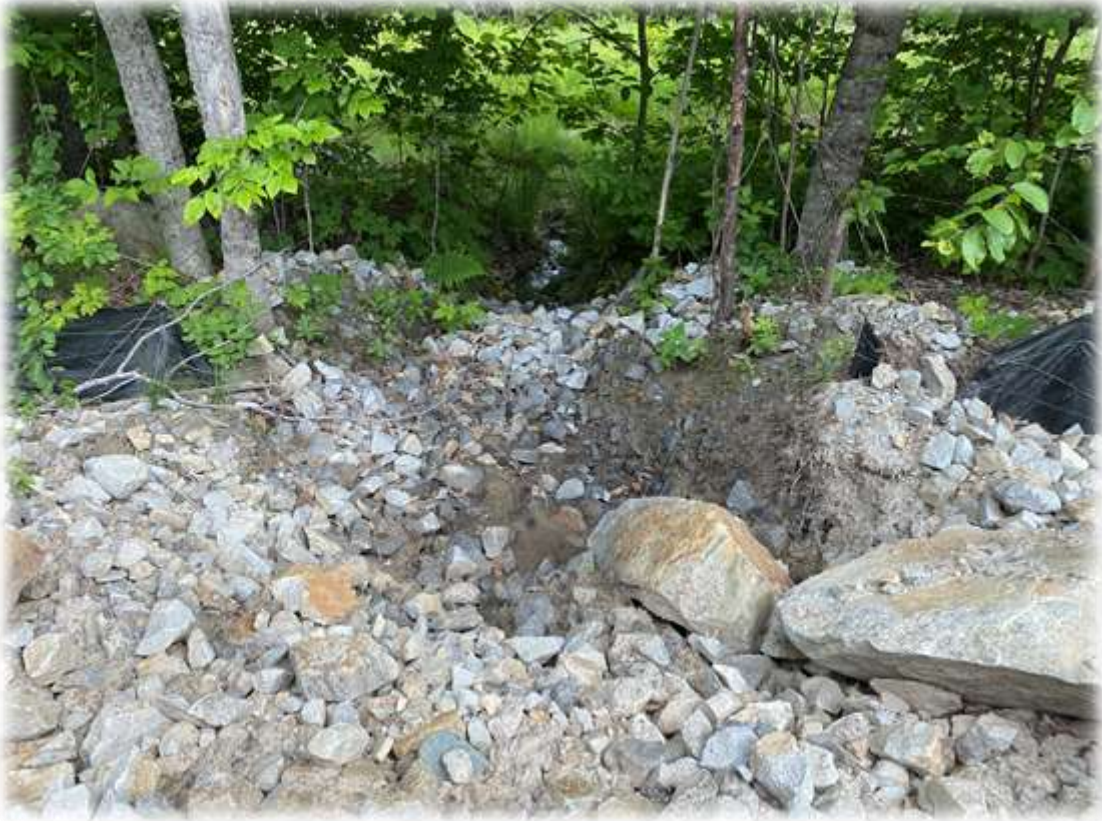
Photo #3: Even with a little rain last night, many of the streams/drainage swales have no, or little, water flowing.

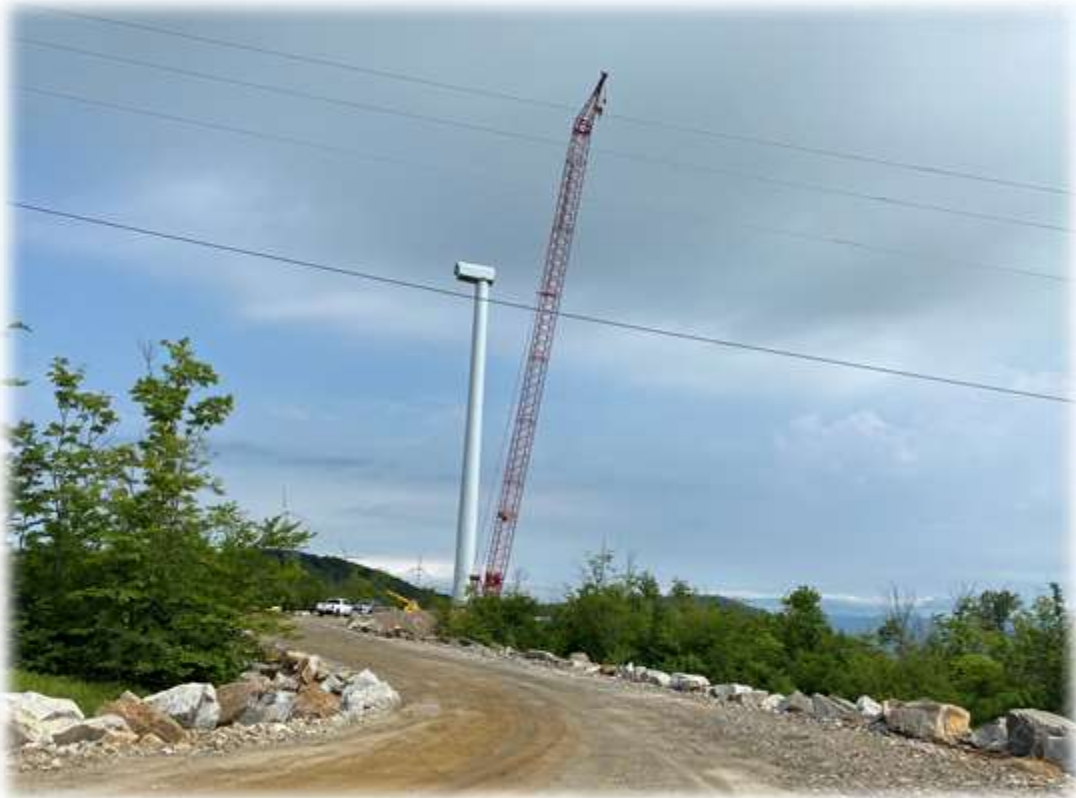
Photo #4: Tower 1 has been set including the Nacelle at the top of the tower.

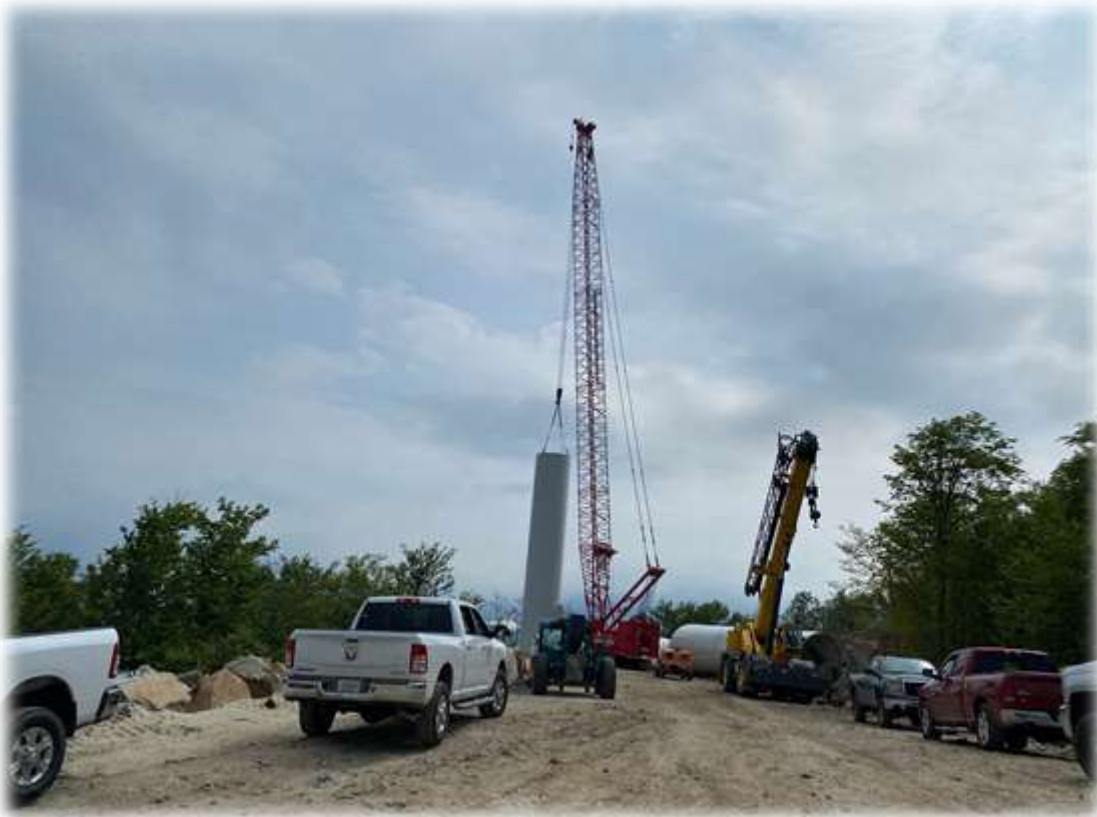
Photo #5: The base section of Tower 2 is being set.

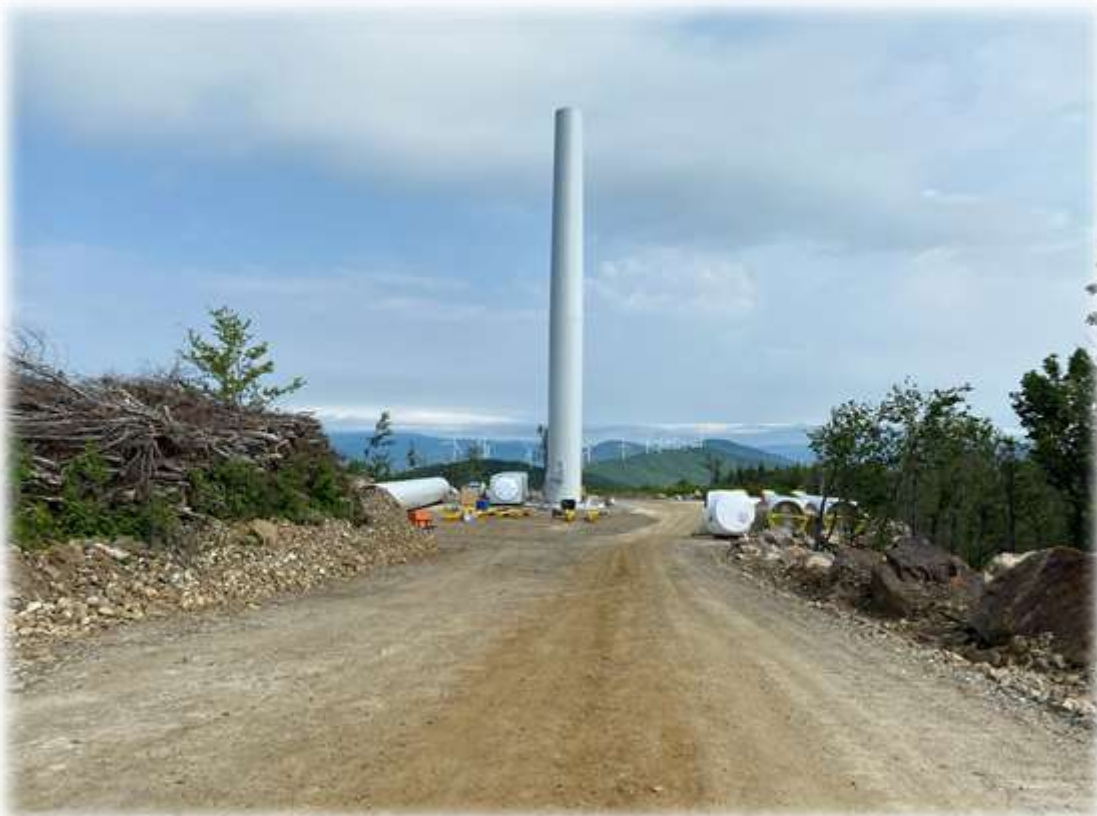
Photo #6: The base and mid-section of Tower 3 has been set.

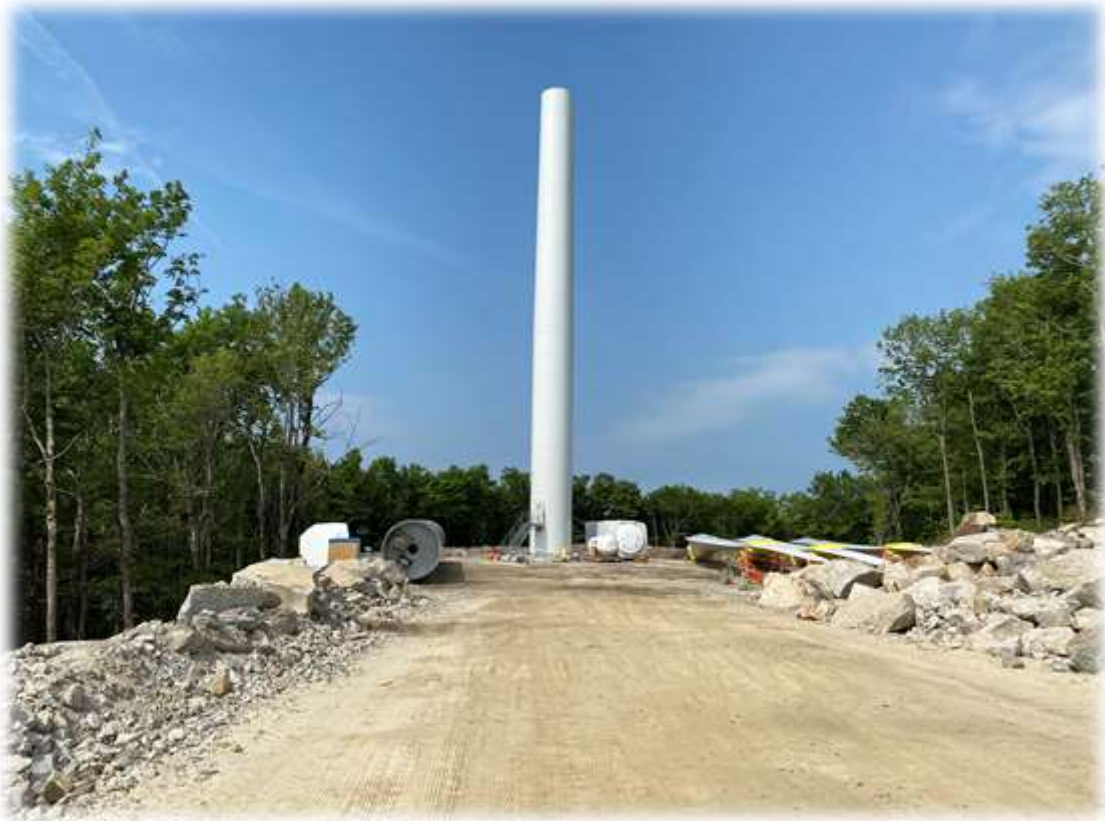
Photo #7: The base and mid-section of Tower 4 has been set.
