Third Party Inspection Form

RoxWind LLC

Horseshoe Valley Road, Roxbury

Date: Monday, 06-28-2021 **Time:** 9:00 AM **Report:** 42
Inspected by: Steve Roberge, PE **Company/Agency:** SJR Engineering Inc.
Weather Conditions: 80 degrees, Sun
Owner Rep: Palmer Management Corp (Sumul Shah)
Construction Site/Project Manager: Reed-Reed (Kate Doughty, Jake Hall)
Engineer: Sewall (Jody Dube-Oneal)
Site Earthwork Contractor: Sargent Construction (Tim LePage, Pete Broberg, Mark Wright)
Clearing Contractor: Comprehensive Land Technologies (CLT)
Onsite Environmental Inspections: Jared (Sargent)
Contact onsite today: **Owner Rep:** NA, **Reed/Reed:** Kate Doughty, **Sargent:** NA, **MD+B:** NA, **CMP:** NA
Date of Last Inspection: 06-21-2021
Estimated # of days since last rainfall over $\frac{1}{2}$ ": 0.64" rainfall 06/01/2021
Photographs taken: 8 photos included in report

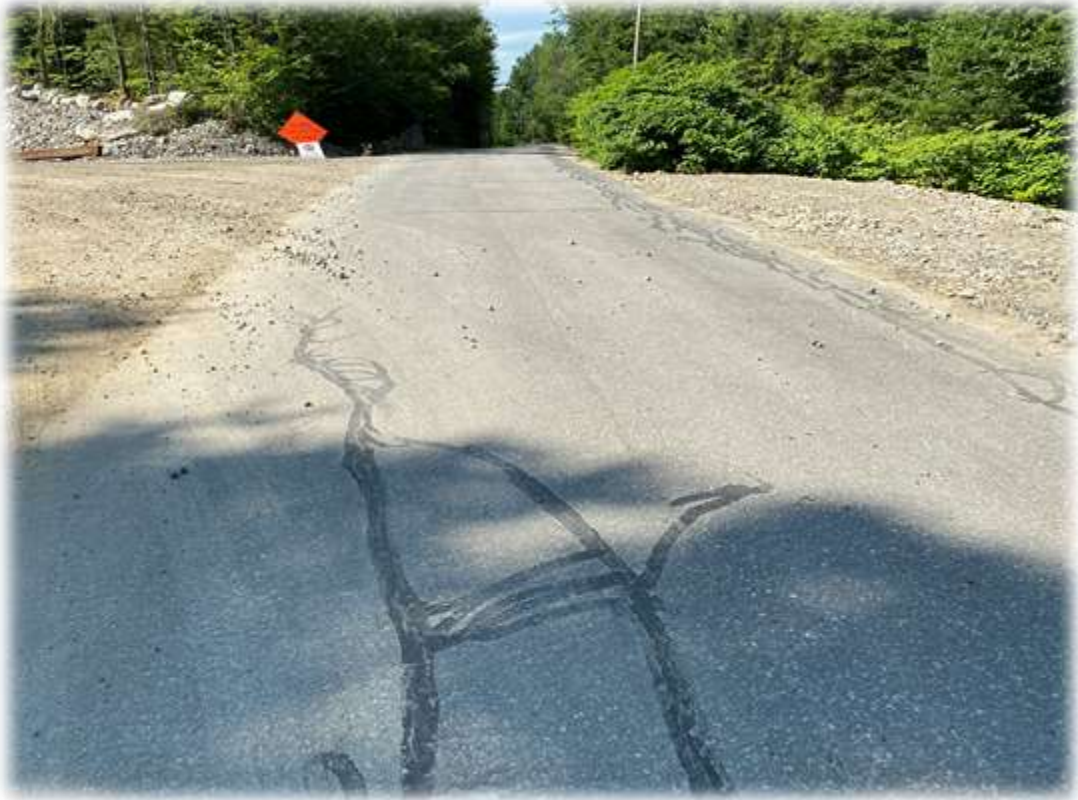
3. Stabilized Entrance: Sargent has temporarily removed the stabilized entrance to receive tower parts. All large parts have been delivered. Some stone/soils are being tracked onto Horseshoe Valley Road and should be cleaned up. The stabilized entrance needs to be recreated again.

Photo #1: Stone is creeping out into Horseshoe Valley Road and needs to be removed.

1. Some spilled stone has made its way onto Horseshoe Valley Road and should be cleaned up...additional clean stone should be placed on the stabilized entrance.
2. Now that all the tower parts have been delivered, water bars should be re-installed along the access road.

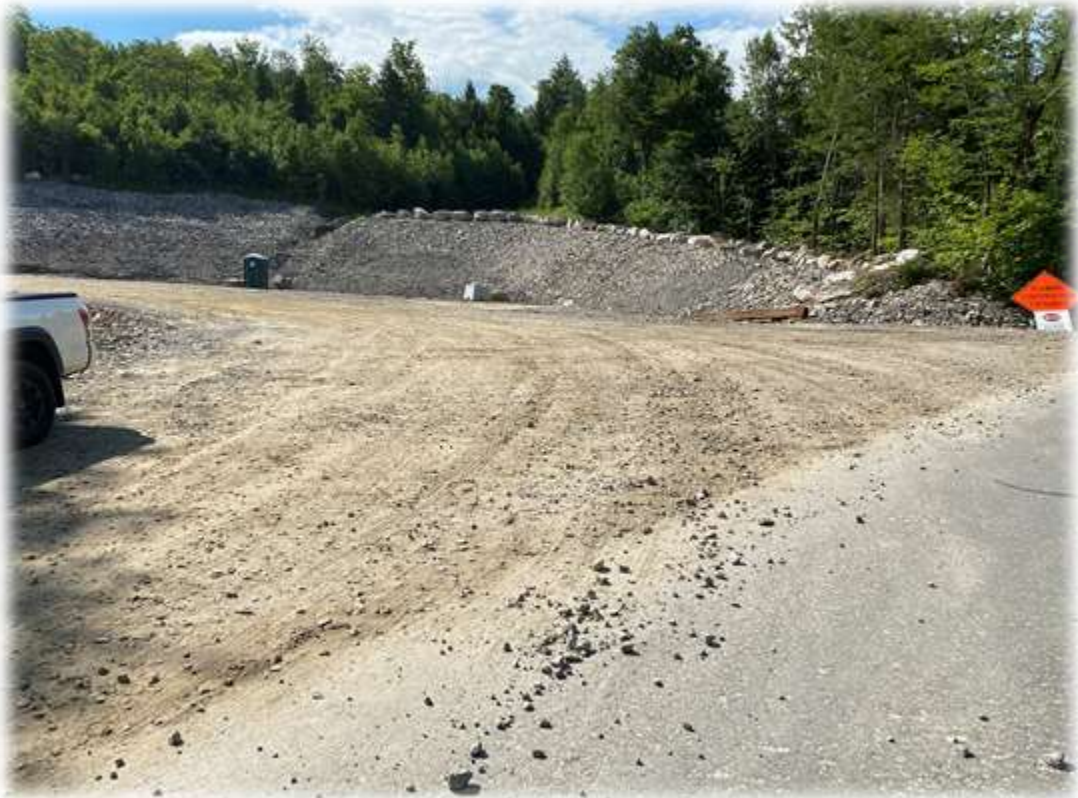
Photo #2: The stabilized construction entrance needs new stone re-installed.

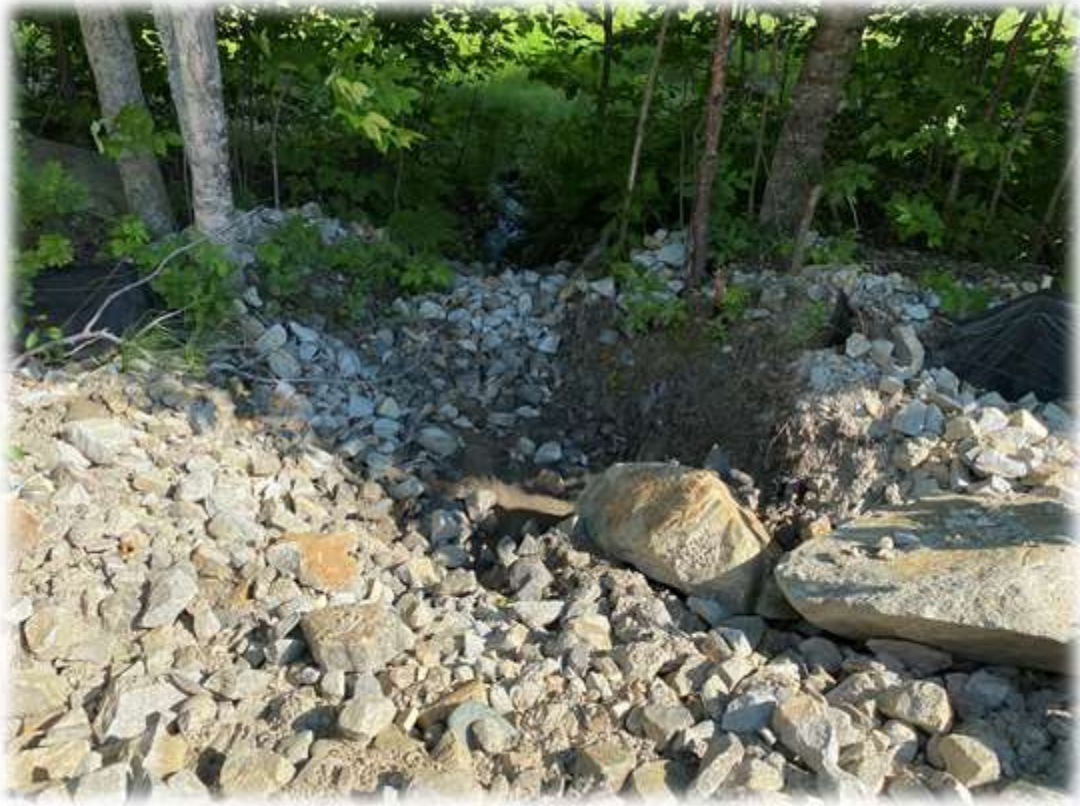
Photo #3: Many of the streams/drainage swales have no, or little, water flowing.

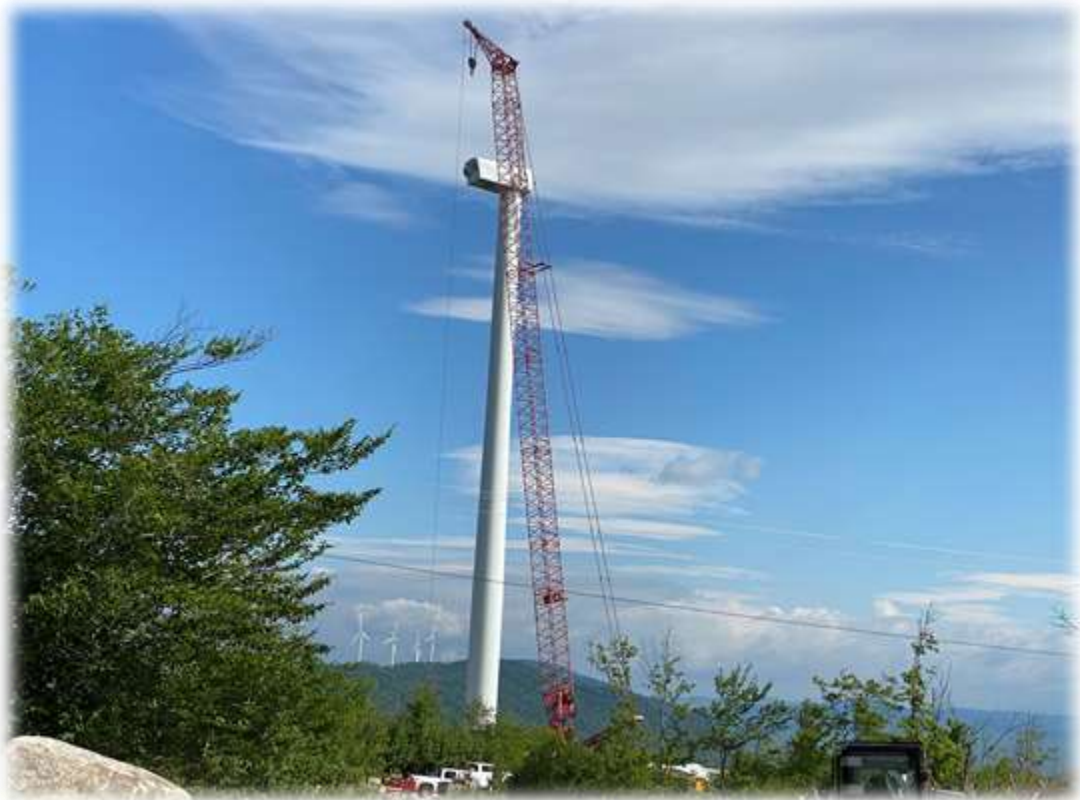
Photo #4: Tower 1 has been set including the Nacelle at the top of the tower.

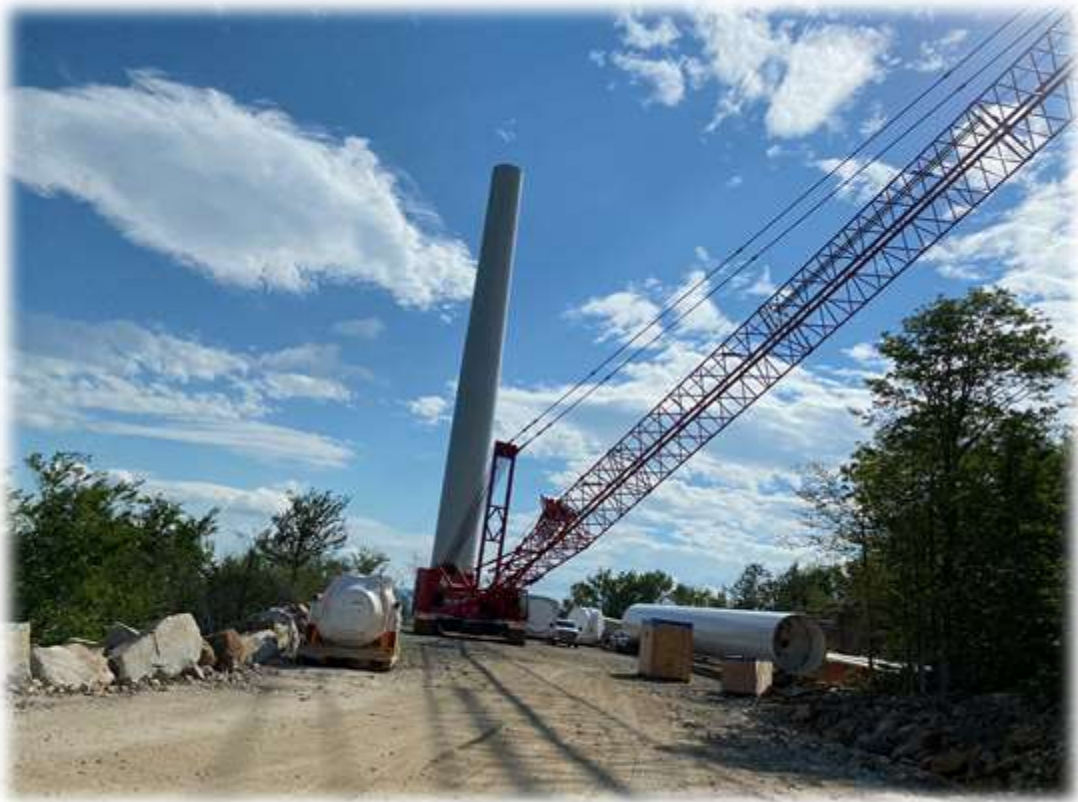
Photo #5: The base and mid-section of Tower 2 has been set.

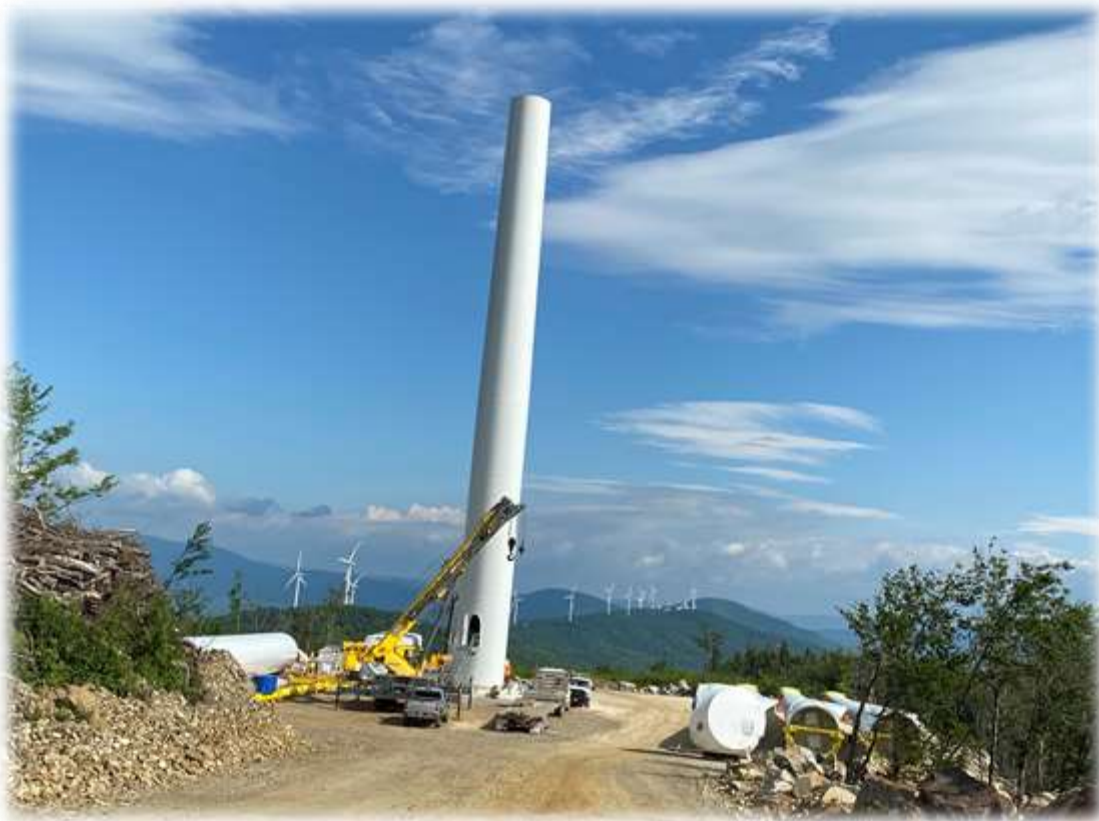
Photo #6: The base and mid-section of Tower 3 has been set.

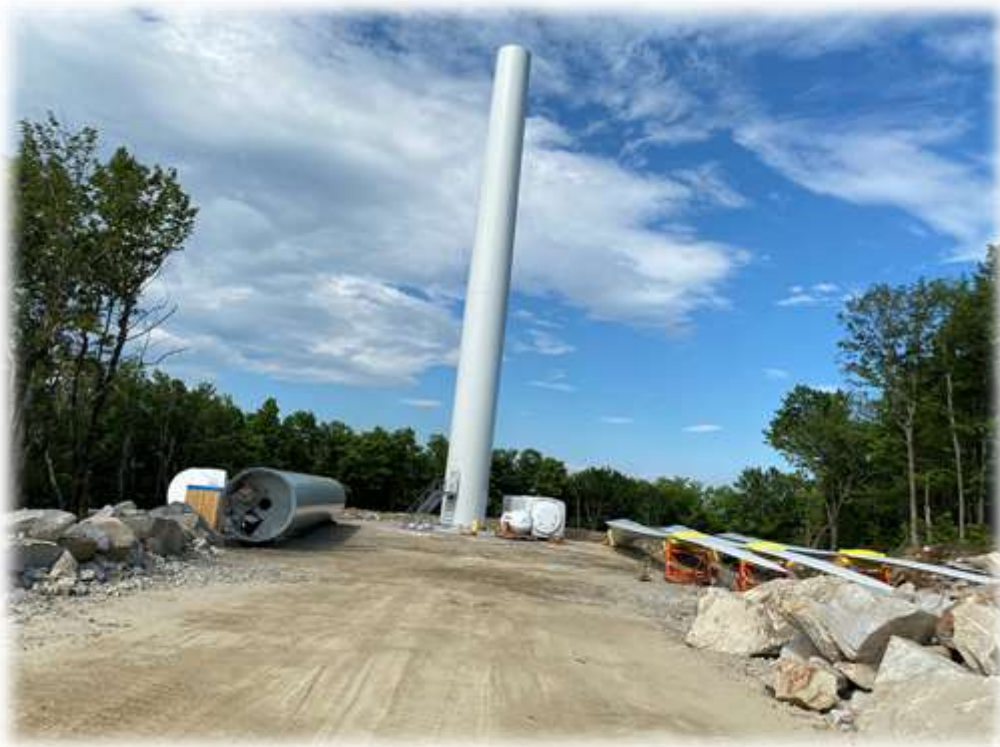
Photo #7: The base and mid-section of Tower 4 has been set.

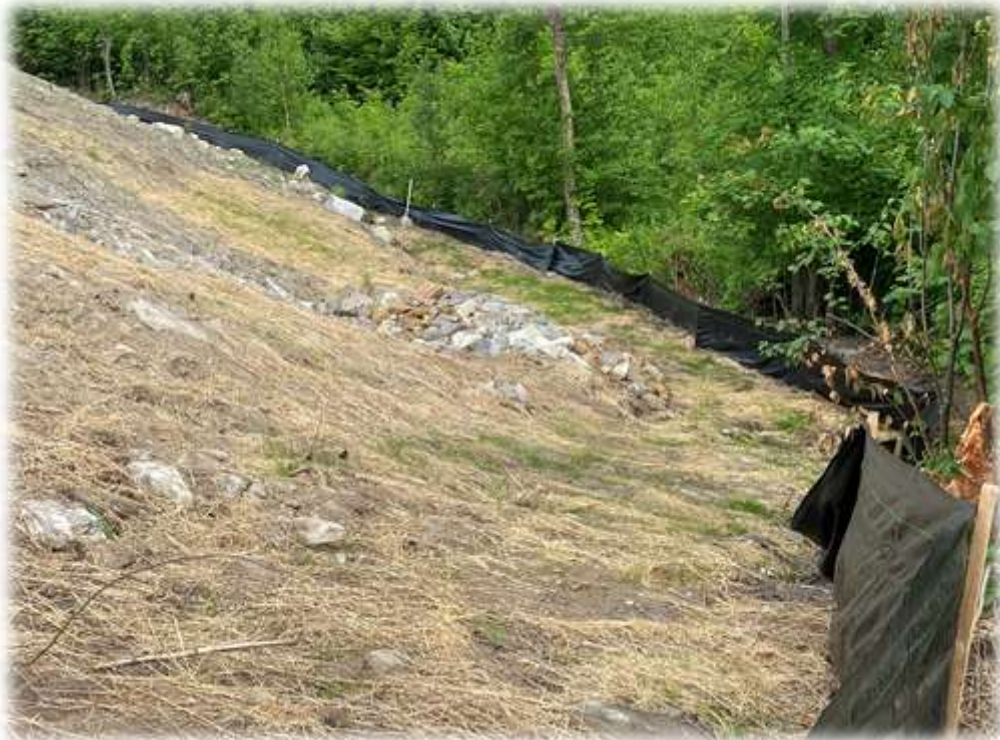
Photo #8: Grass is beginning to establish itself along the 180 degree corner near Tower 1.
