Third Party Inspection Form

RoxWind LLC

Horseshoe Valley Road, Roxbury

Date: Wednesday, 07-07-2021 **Time:** 8:00 AM **Report:** 43
Inspected by: Steve Roberge, PE **Company/Agency:** SJR Engineering Inc.
Weather Conditions: 70 degrees, Sun
Owner Rep: Palmer Management Corp (Sumul Shah)
Construction Site/Project Manager: Reed-Reed (Kate Doughty, Jake Hall)
Engineer: Sewall (Jody Dube-Oneal)
Site Earthwork Contractor: Sargent Construction (Tim LePage, Pete Broberg, Mark Wright)
Clearing Contractor: Comprehensive Land Technologies (CLT)
Onsite Environmental Inspections: Jared (Sargent)
Contact onsite today: **Owner Rep:** NA, **Reed/Reed:** Kate Doughty (phone),
Sargent: NA, **MD+B:** NA, **CMP:** NA
Date of Last Inspection: 06-28-2021
Estimated # of days since last rainfall over $\frac{1}{2}$ ": 0.64" rainfall 06/01/2021
Photographs taken: 7 photos included in report

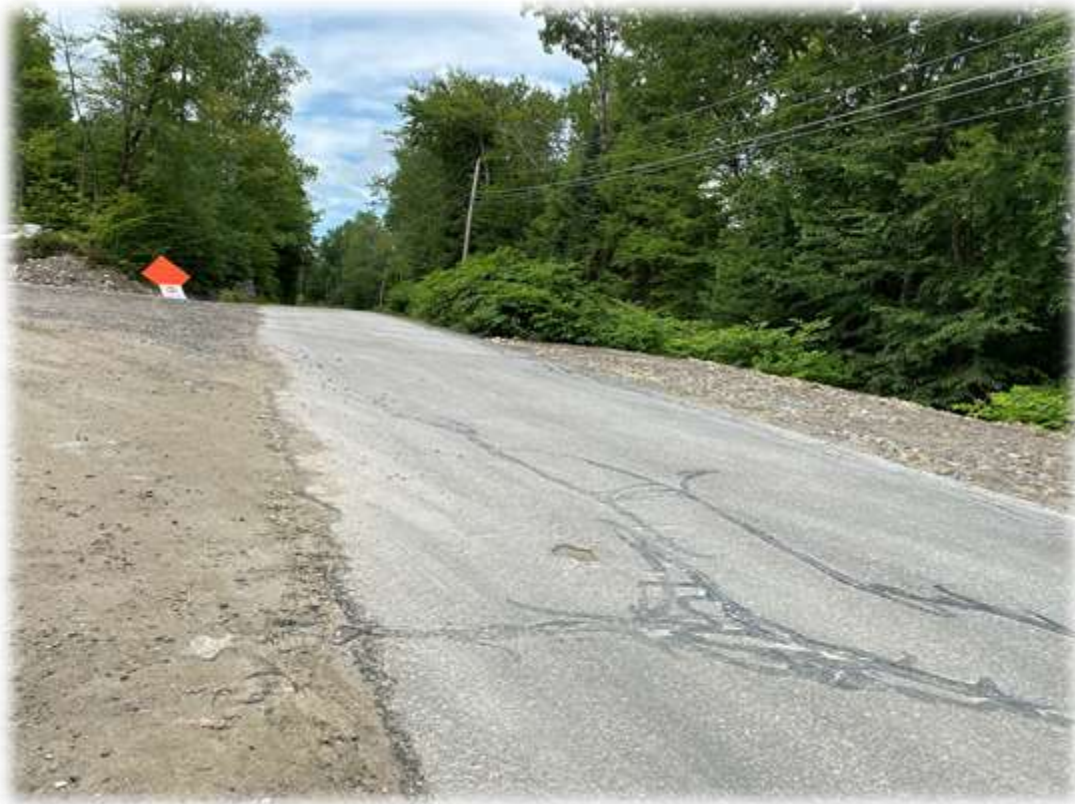
Photo #1: Stone has been removed from Horseshoe Valley Road.

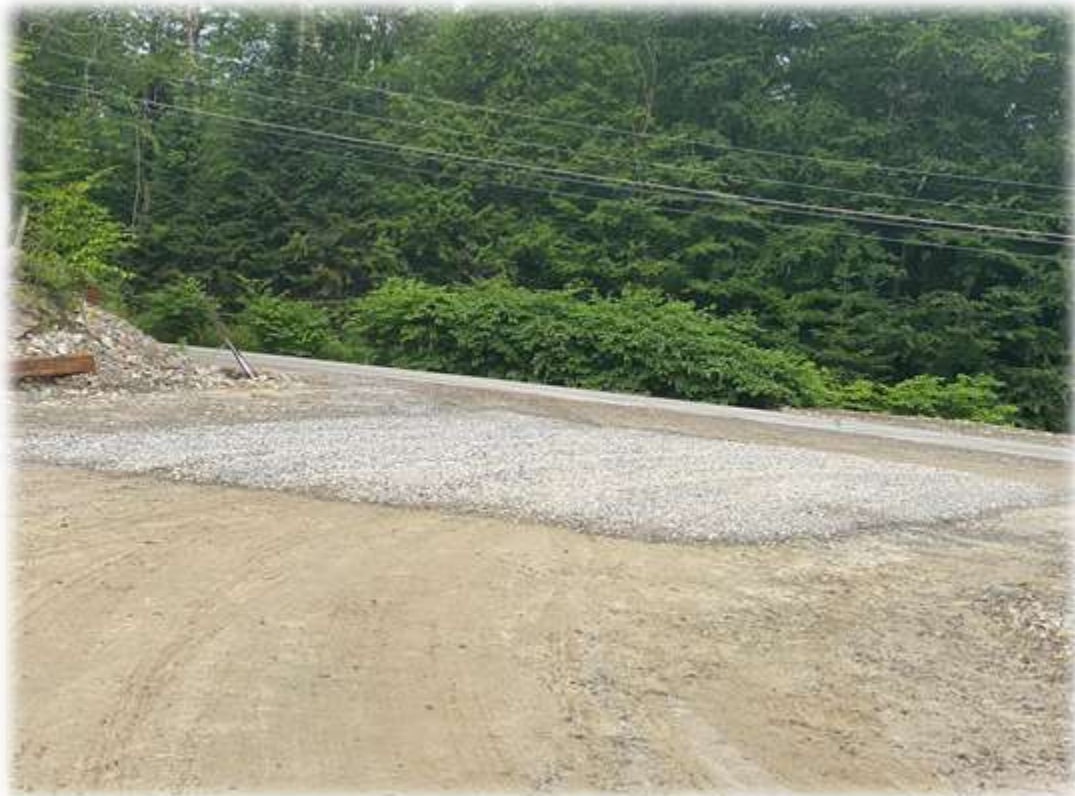
Photo #2: The stabilized construction entrance has new stone installed.

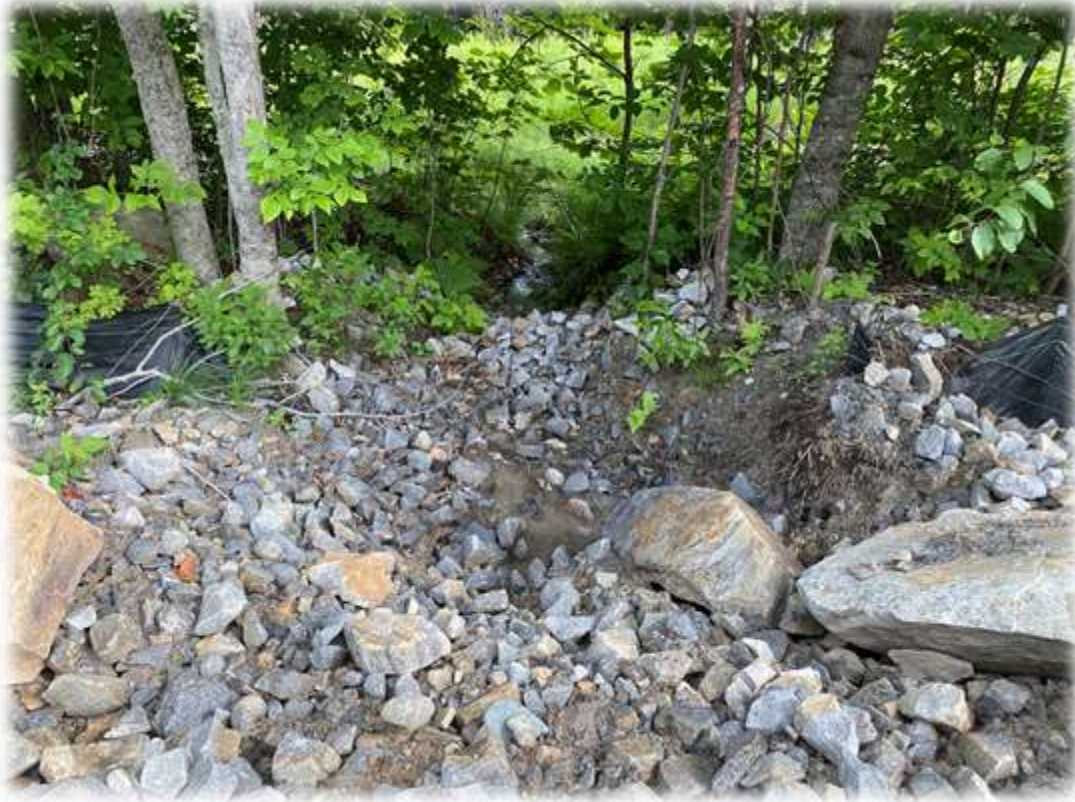
Photo #3: Many of the streams/drainage swales have little water flowing as weekend rain events were not as heavy as forecast.

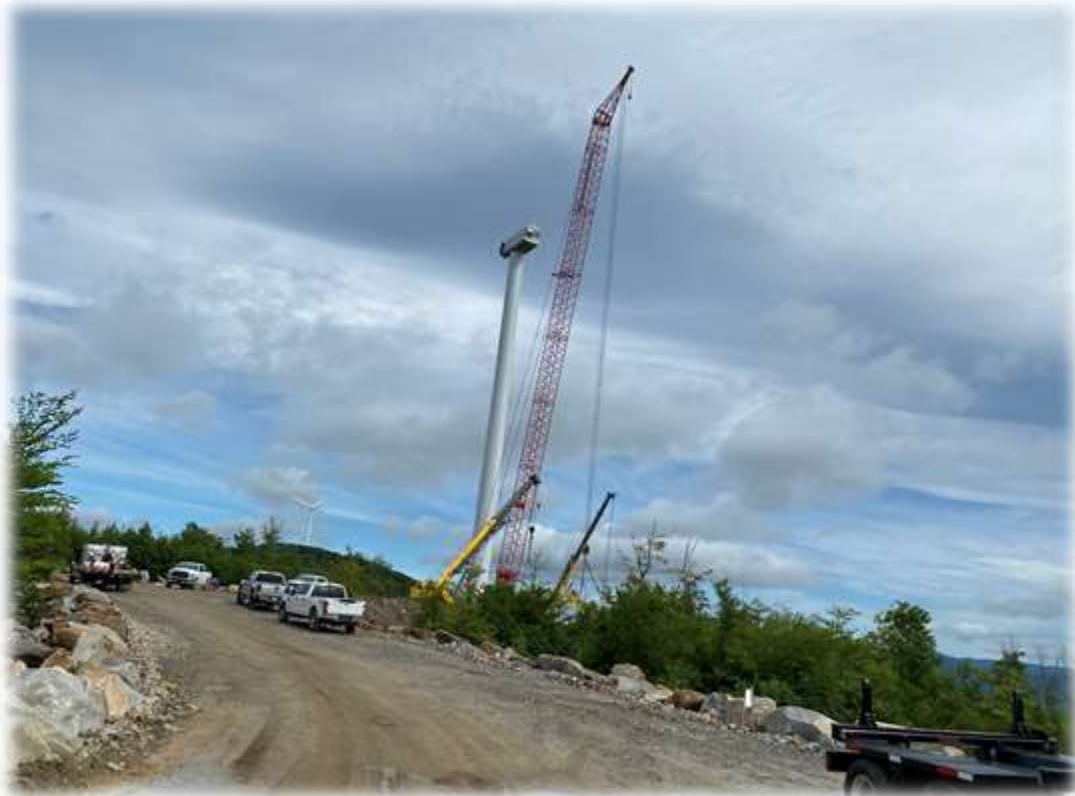
Photo #4: Tower 1 has been set including the Nacelle and blade hub at the top of the tower. Crews were preparing to lift the first blade for attachment to the hub until the wind started blowing.

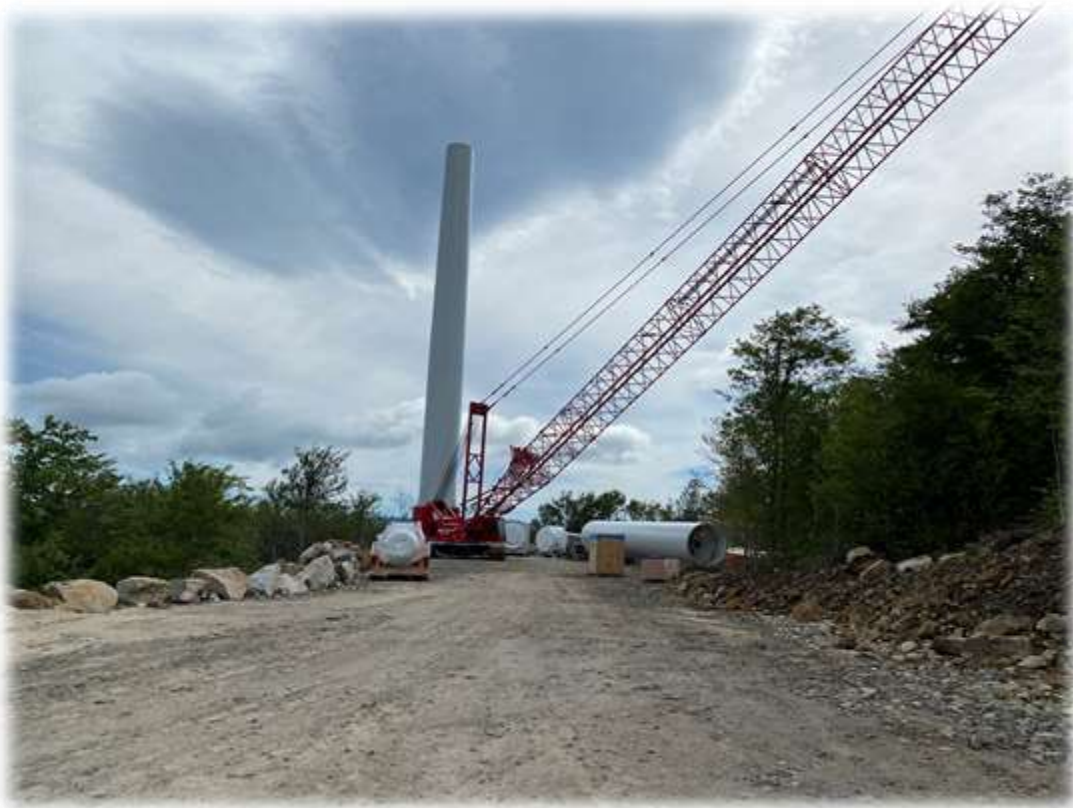
Photo #5: The base and mid-section of Tower 2 has been set.

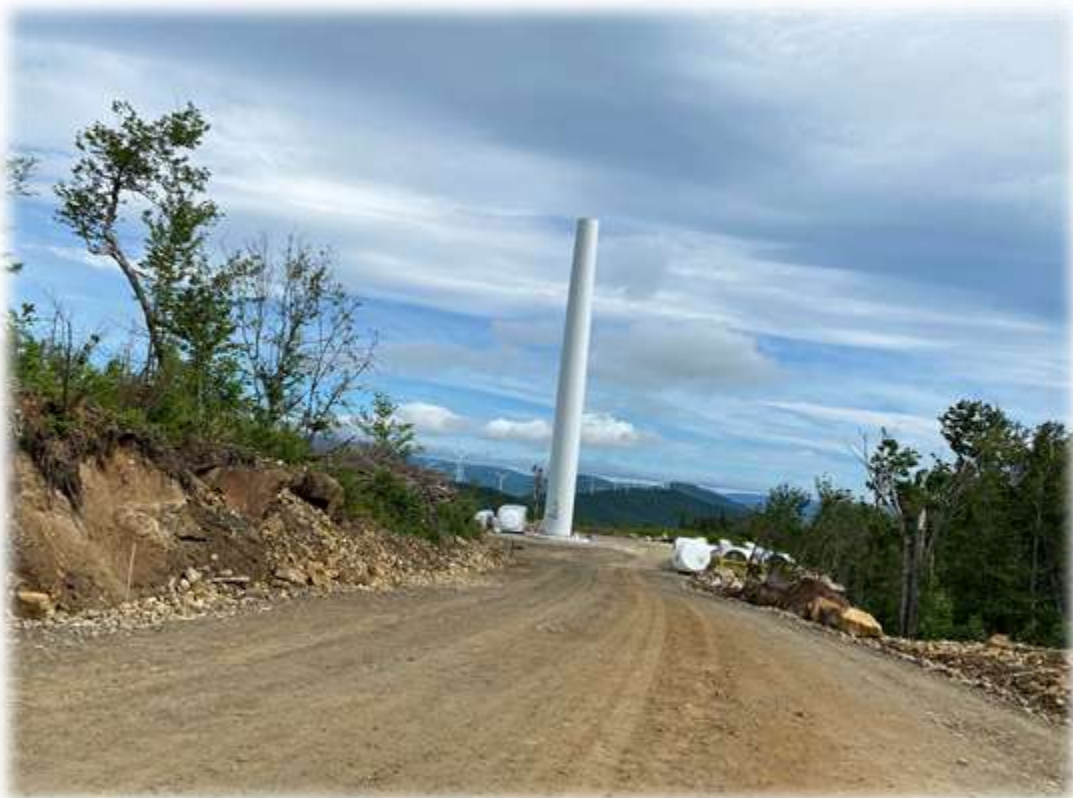
Photo #6: The base and mid-section of Tower 3 has been set.

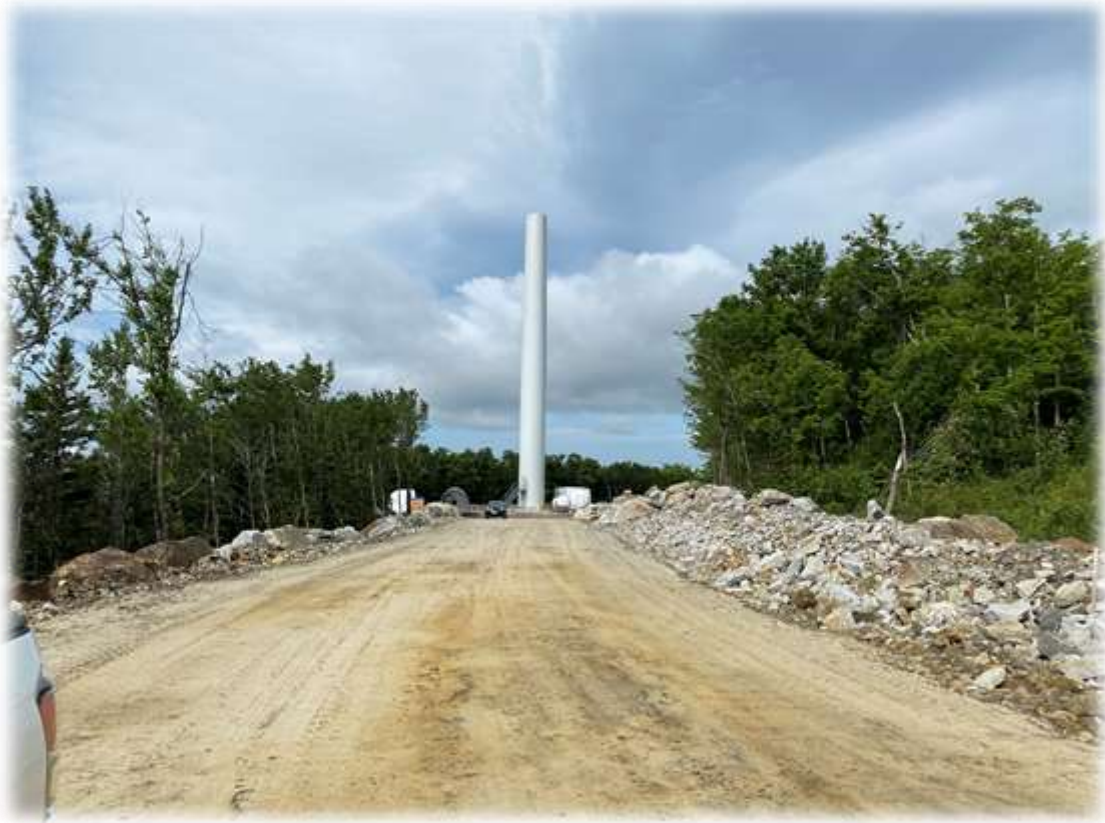
Photo #7: The base and mid-section of Tower 4 has been set.
