# Third Party Inspection Form

# RoxWind LLC

## Horseshoe Valley Road, Roxbury

**Date:** Monday, 07-12-2021      **Time:** 9:00 AM      **Report:** 44  
**Inspected by:** Steve Roberge, PE      **Company/Agency:** SJR Engineering Inc.

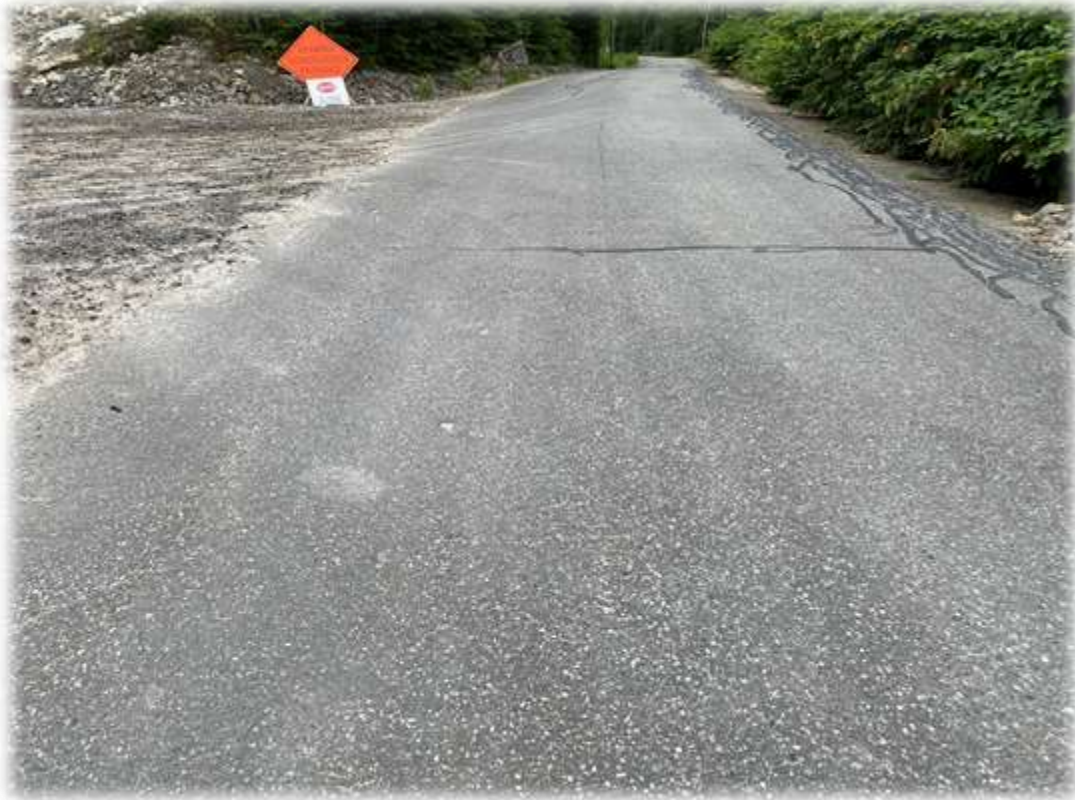
Photo #1: Horseshoe Valley Road is clear of soil debris.

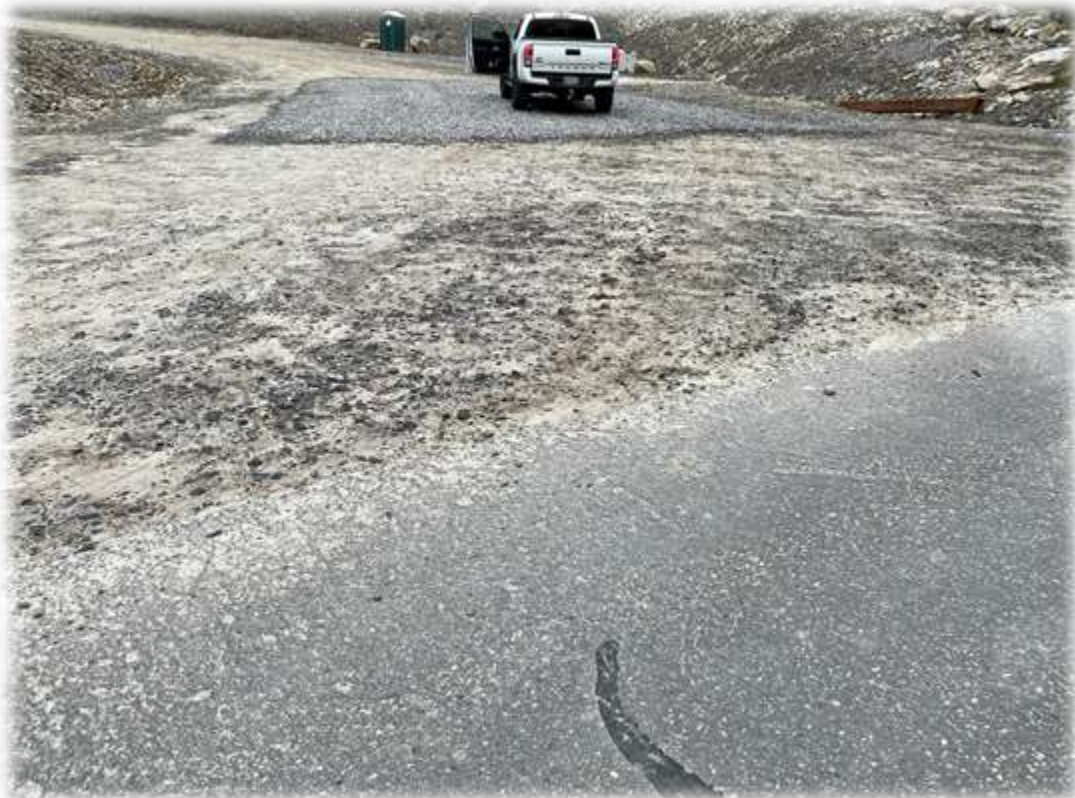
**3. Stabilized Entrance:** Sargent has temporarily removed the stabilized entrance to receive tower parts. All large parts have been delivered. The stabilized entrance has been created again.

Photo #2: The stabilized construction entrance has new stone installed.

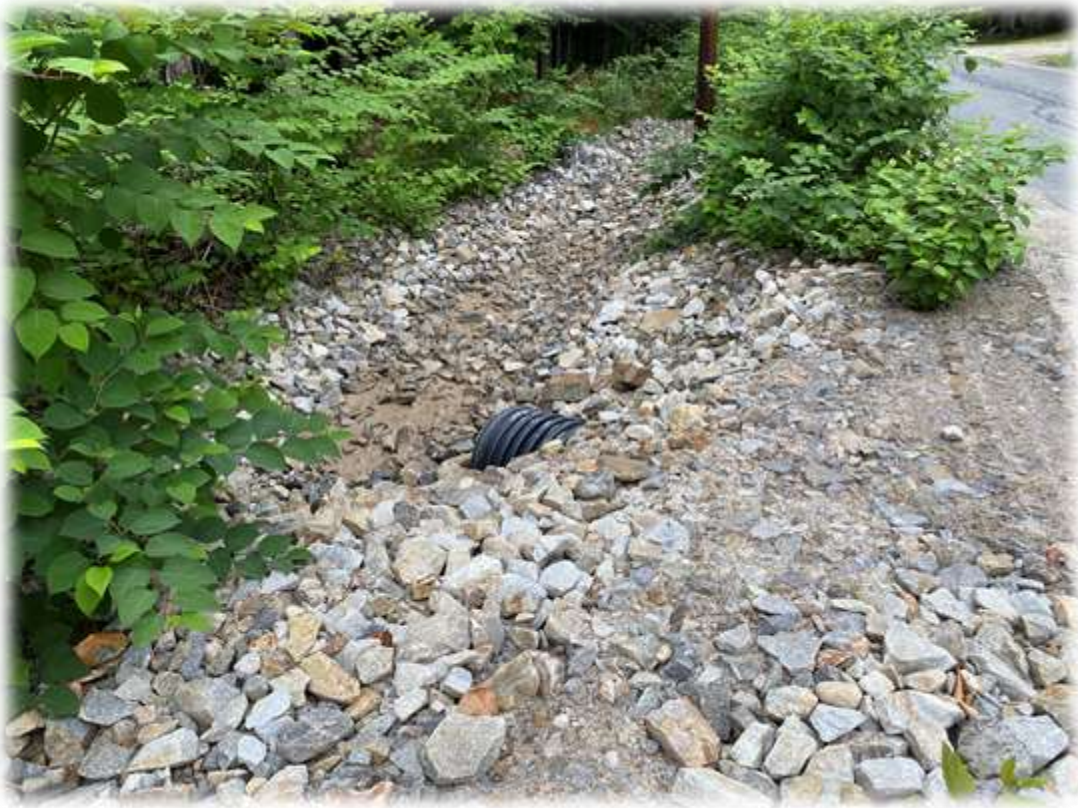
Photo #3: The drainage ditch across Horseshoe Valley Road has no water...

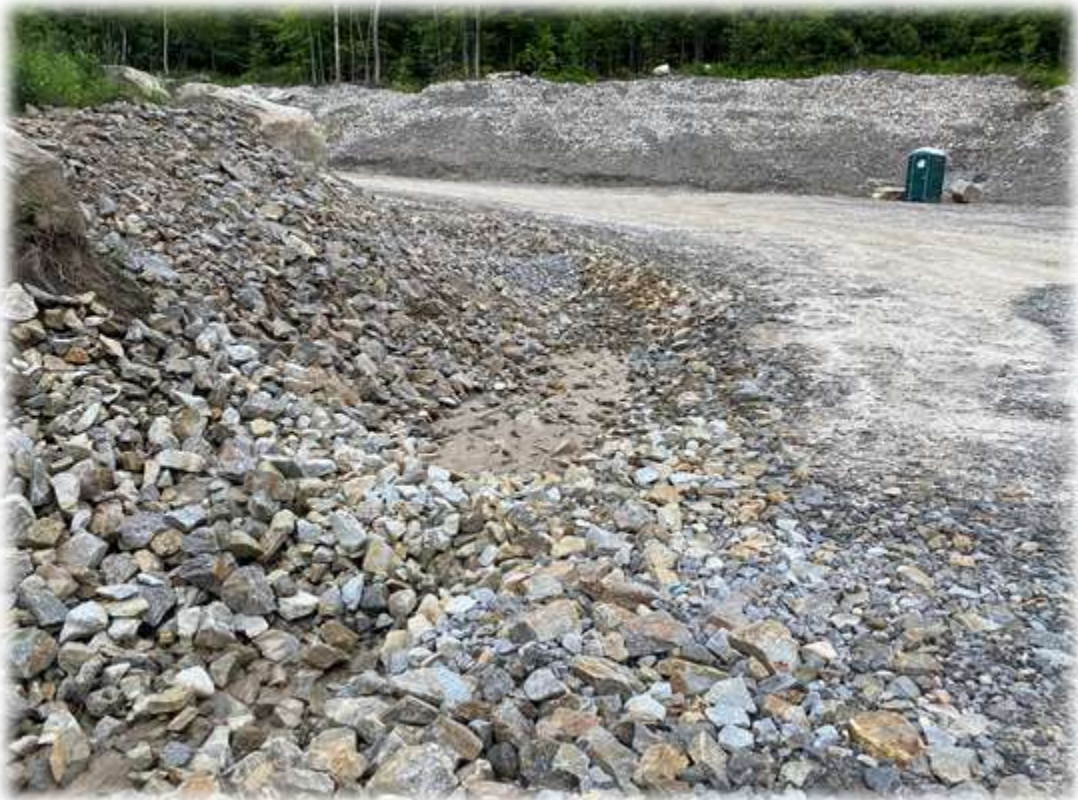
**9. Stone/ECM Check Dam:** In several locations, the Contractor has installed stone check dams in the upslope ditching of the new rocked driveway.

Photo #4: Stone berms within the riprap road ditches have captured some soil material.

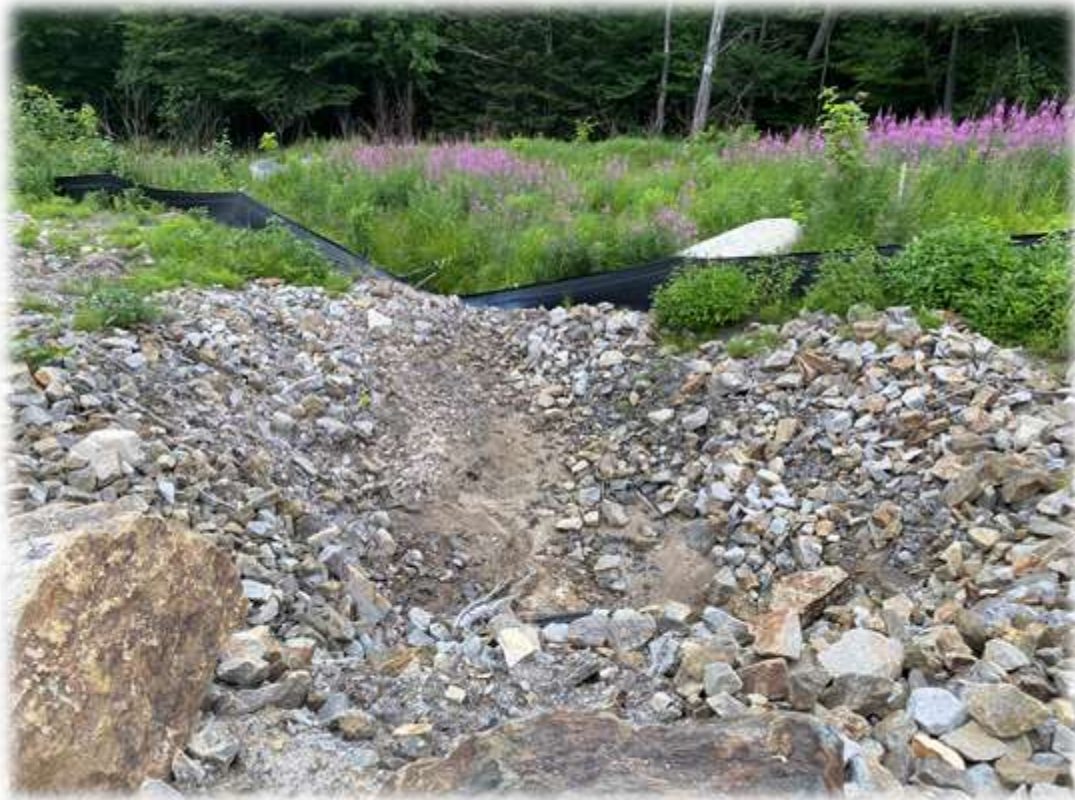
Photo #5: Many of the streams/drainage swales have little water flowing as weekend rain events were not as heavy as forecast. Lupines are in full bloom.

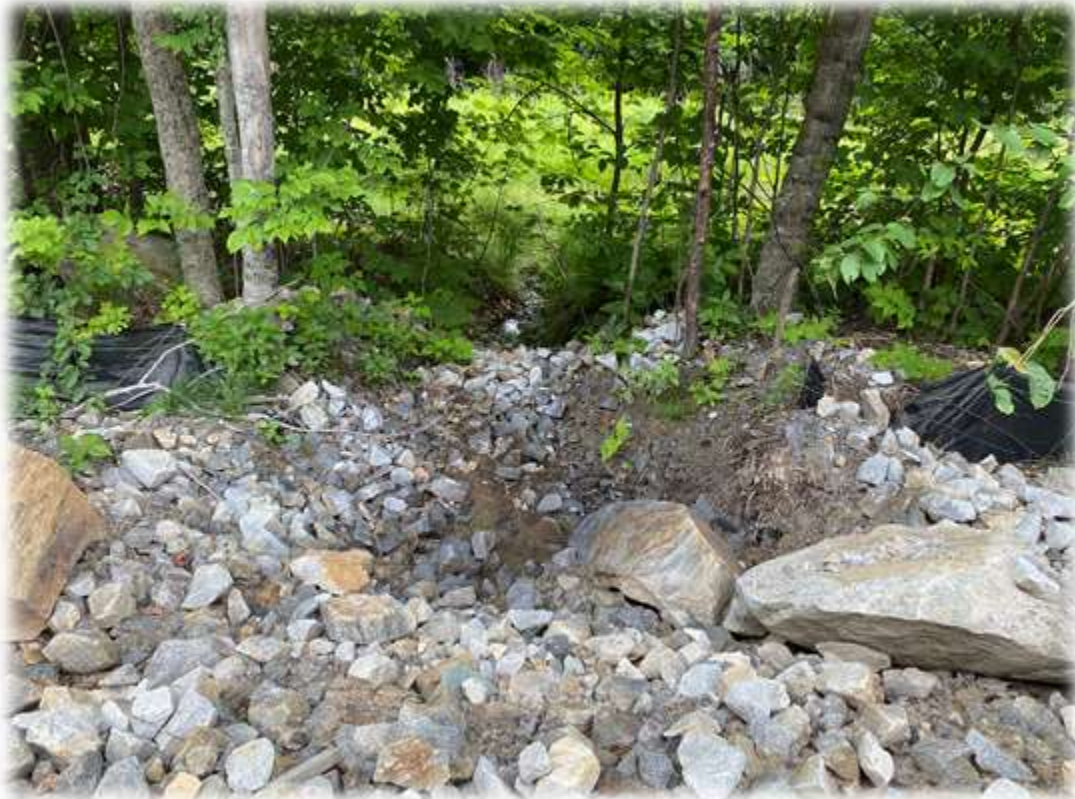
Photo #6: Many of the streams/drainage swales have little water flowing as weekend rain events were not as heavy as forecast in the mountains.

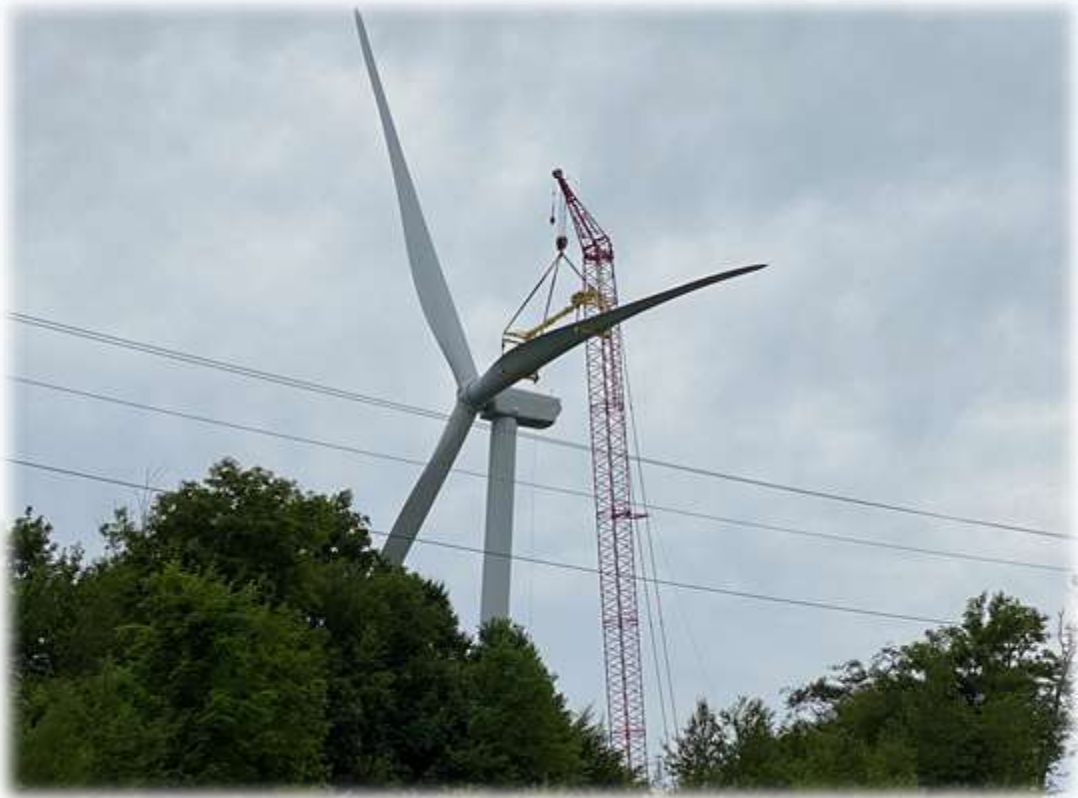
Photo #7: Tower 1 has been set including the Nacelle, blade hub, and 3 blades at the top of the tower.

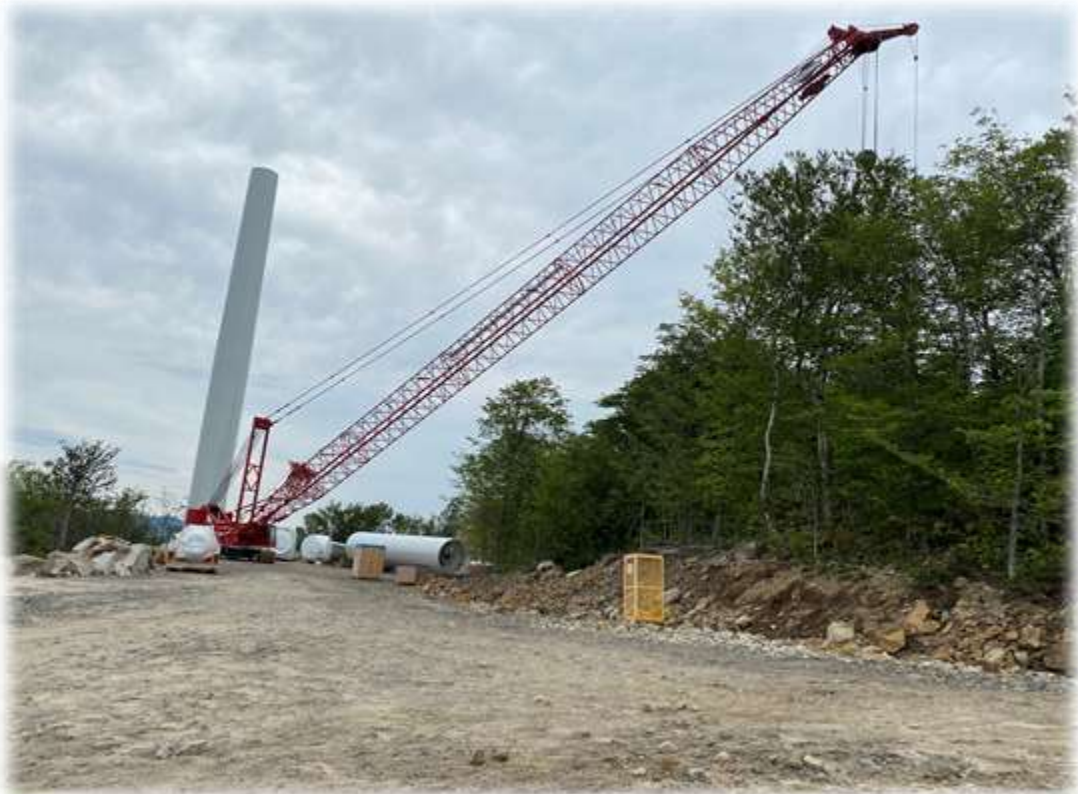
Photo #8: The base and mid-section of Tower 2 has been set. Reed/Reed crane is mobilized for future work in this area.

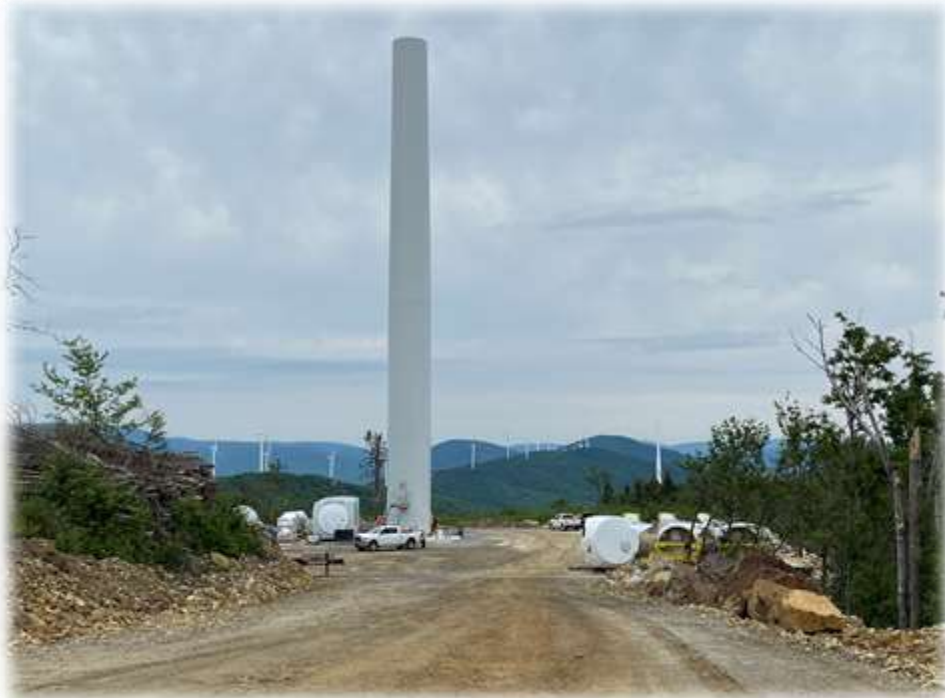
Photo #9: The base and mid-section of Tower 3 has been set. No significant changes since last week.

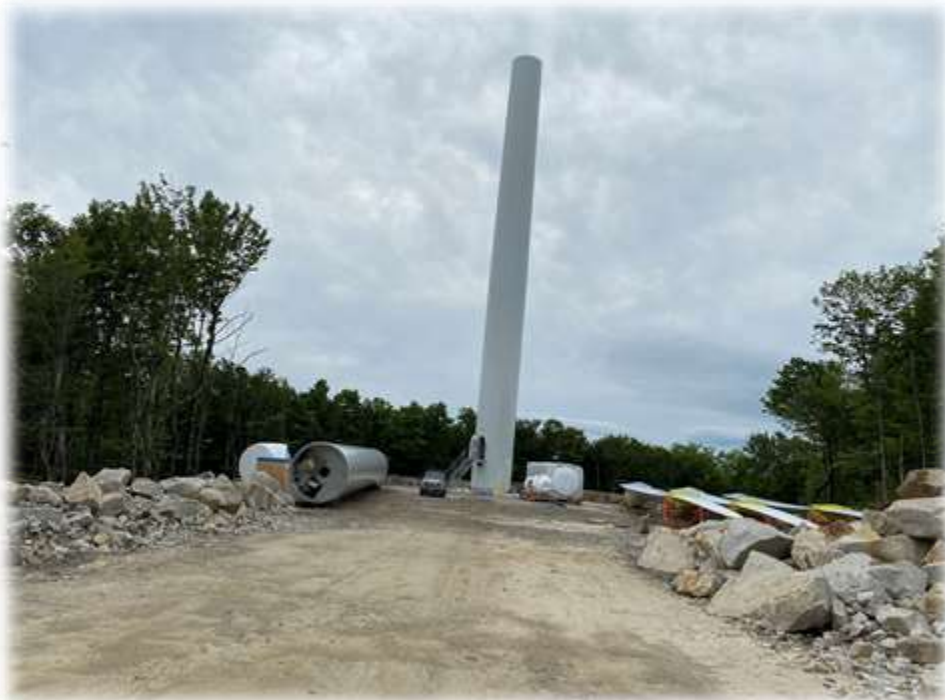
Photo #10: The base and mid-section of Tower 4 has been set. No significant changes since last week.
