# Third Party Inspection Form

# RoxWind LLC

## Horseshoe Valley Road, Roxbury

**Date:** Monday, 07-19-2021      **Time:** 8:00 AM      **Report:** 45  
**Inspected by:** Steve Roberge, PE      **Company/Agency:** SJR Engineering Inc.

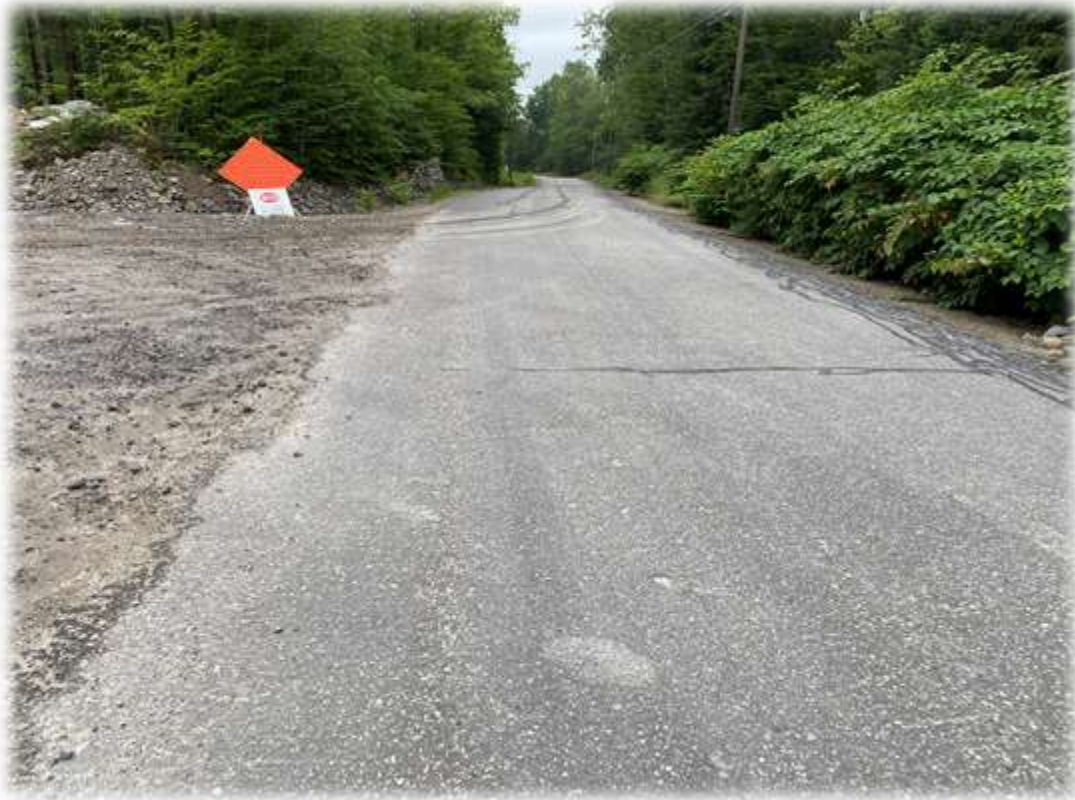
Photo #1: Horseshoe Valley Road is clear of soil debris.

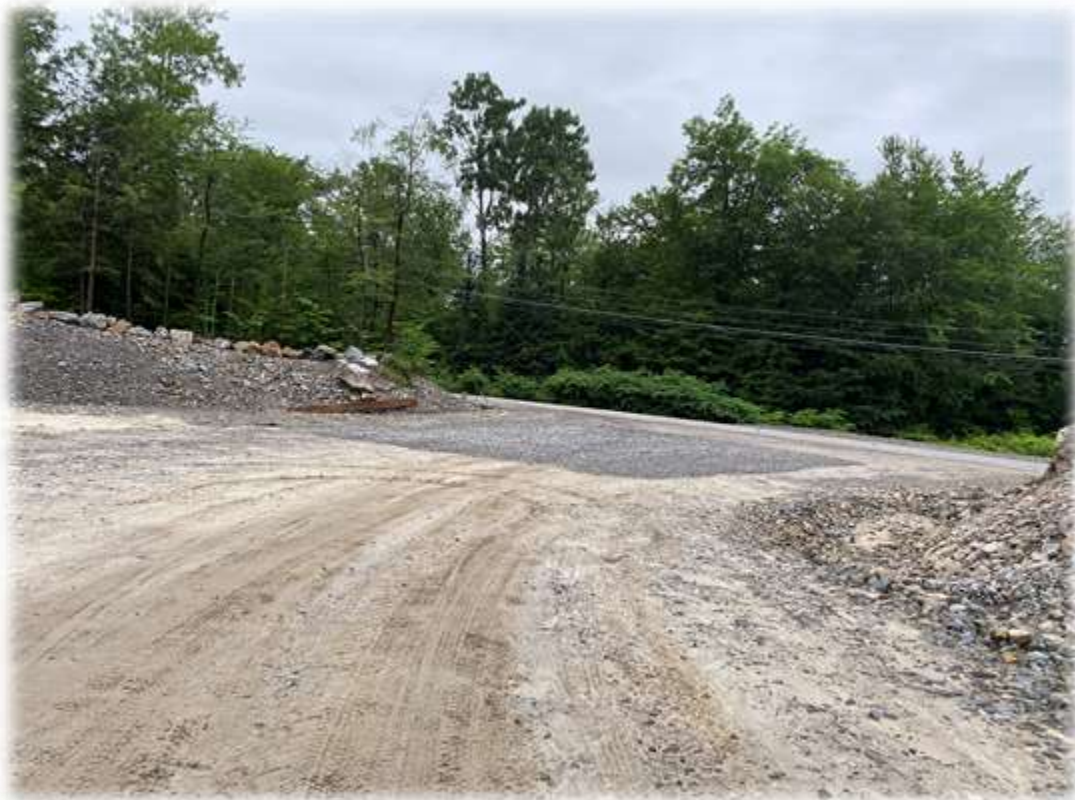
**3. Stabilized Entrance:** Sargent has temporarily removed the stabilized entrance to receive tower parts. All large parts have been delivered. The stabilized entrance has been created again.

Photo #2: The stabilized construction entrance has new stone installed.

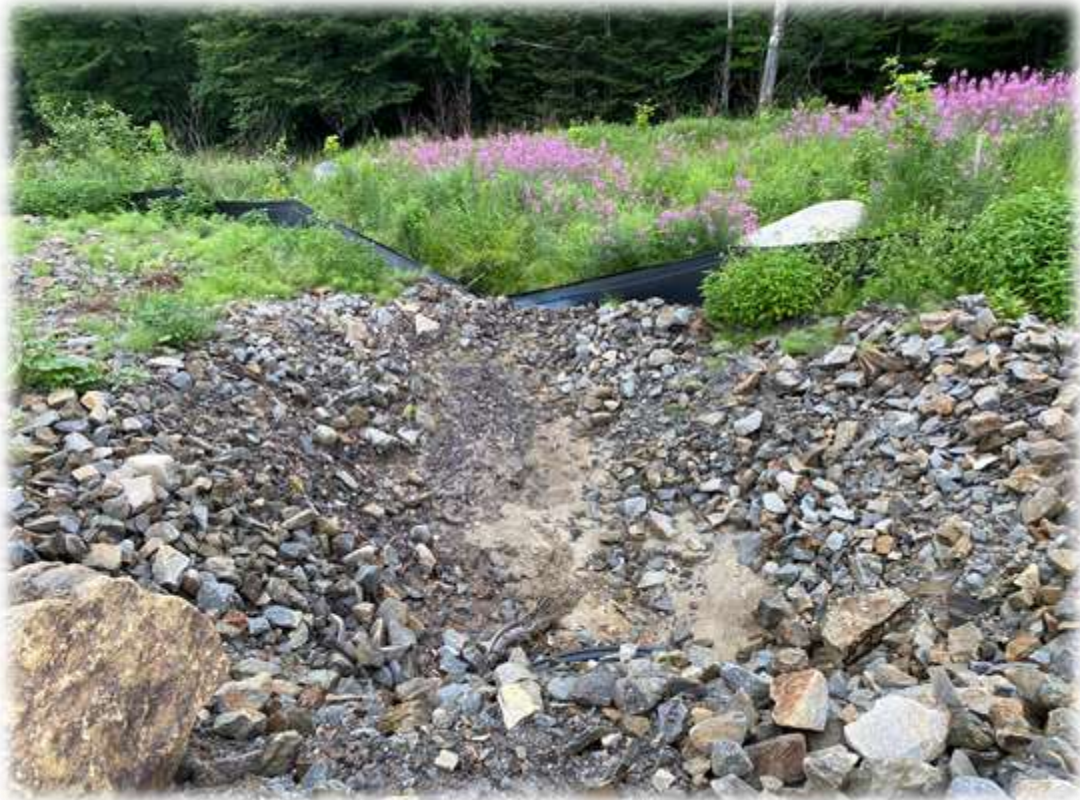
Photo #3: Many of the streams/drainage swales have little water flowing as weekend rain events were not as heavy as forecast. Lupines are in full bloom.

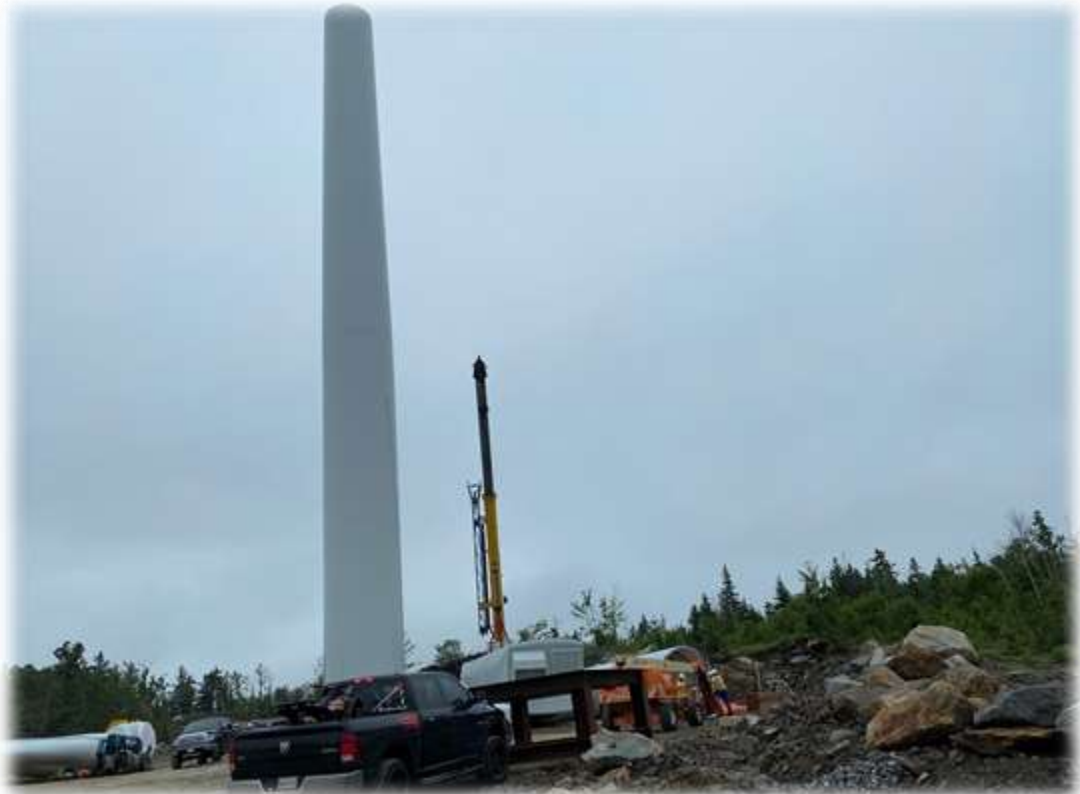
Photo #4: The base and mid-section of Tower 3 has been set. No significant changes since last week. Contractor is prepping site for crane reassembly.

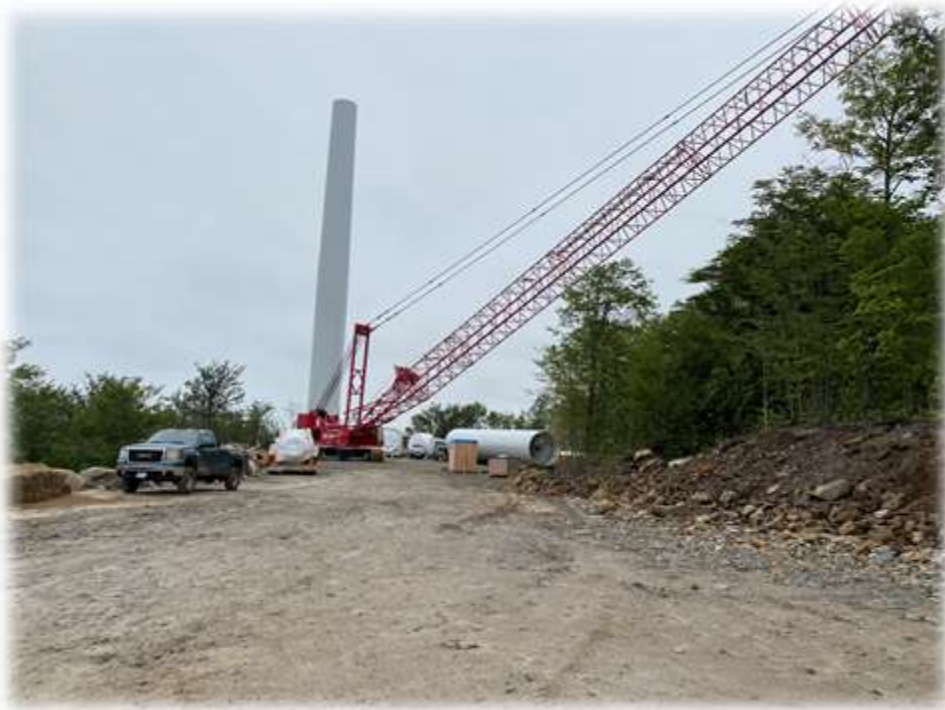
Photo #5: The base and mid-section of Tower 2 has been set. Reed/Reed crane is mobilized for future work in this area.

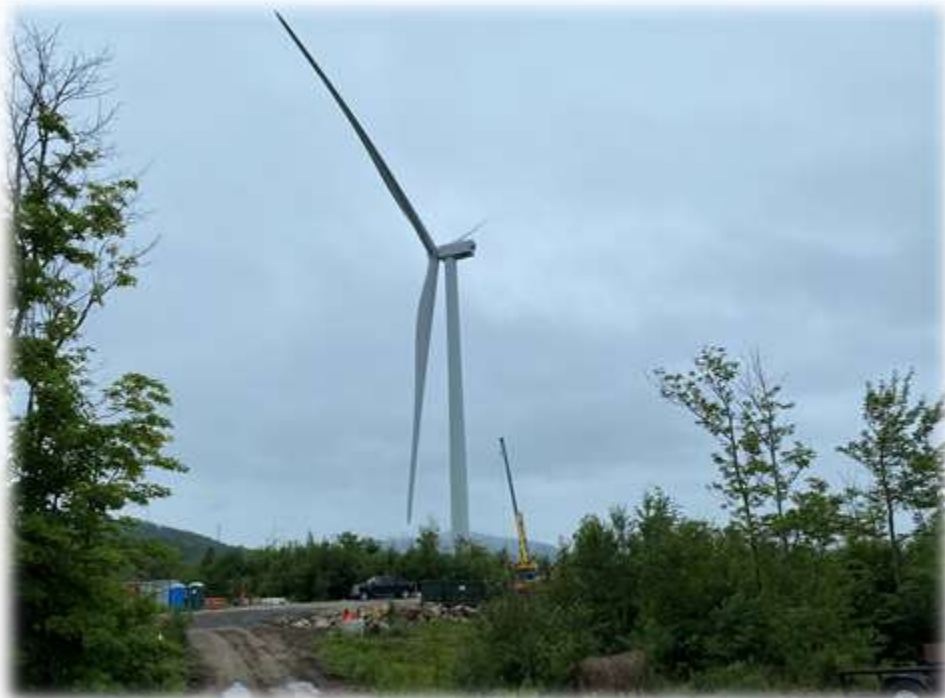
Photo #6: Tower 1 has been set including the Nacelle, blade hub, and 3 blades at the top of the tower. The crane has been taken apart and is being reassembled at tower 4.
