# Third Party Inspection Form

# RoxWind LLC

## Horseshoe Valley Road, Roxbury

**Date:** Monday, 07-26-2021      **Time:** 9:00 AM      **Report:** 46  
**Inspected by:** Steve Roberge, PE      **Company/Agency:** SJR Engineering Inc.

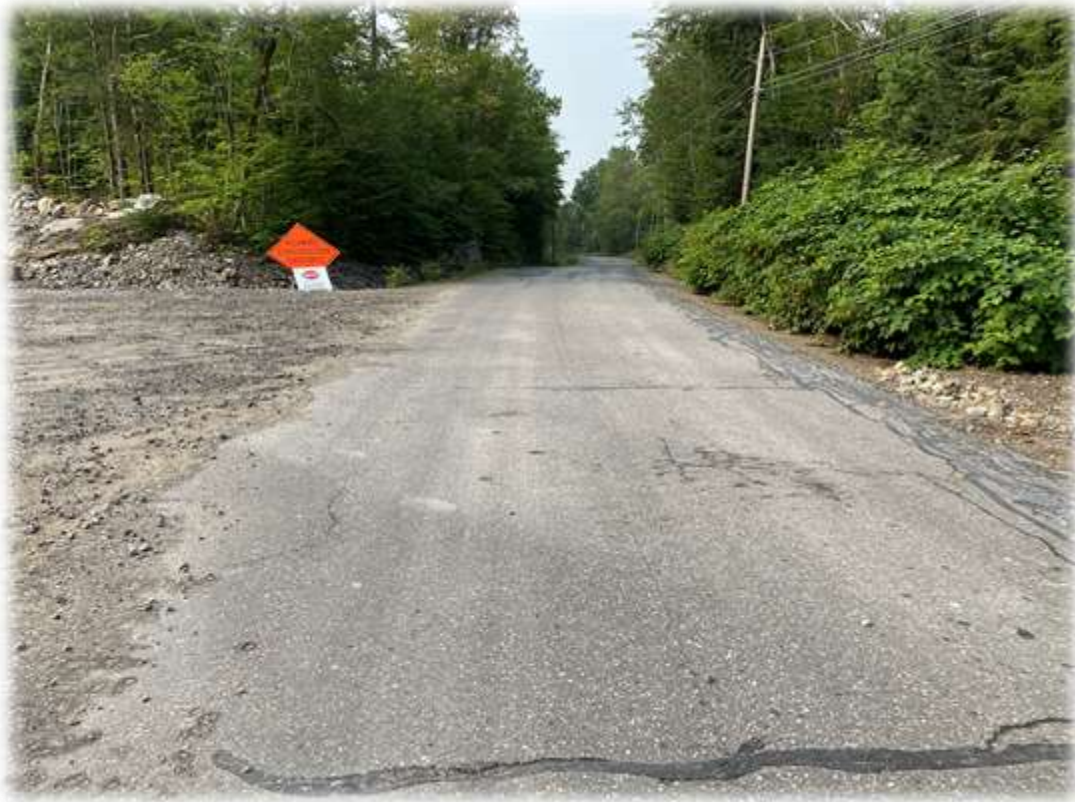
Photo #1: Horseshoe Valley Road is clear of soil debris.

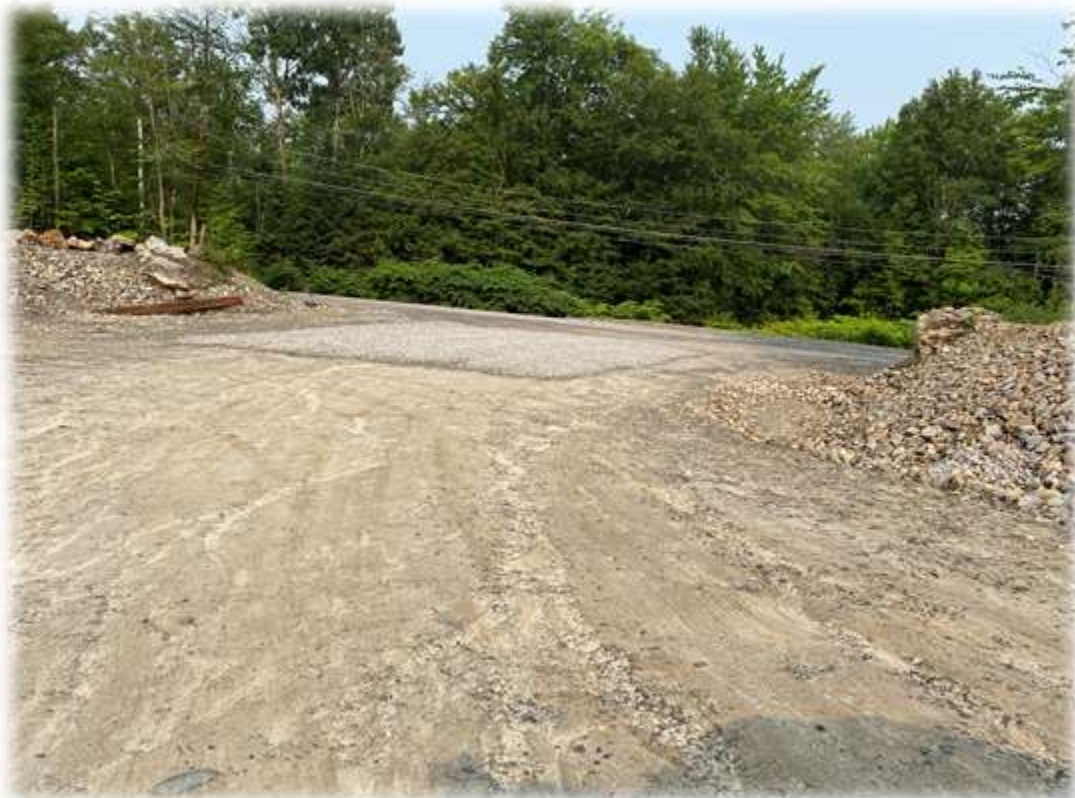
**3. Stabilized Entrance:** Sargent has temporarily removed the stabilized entrance to receive tower parts. All large parts have been delivered. The stabilized entrance has been created again.

Photo #2: The stabilized construction entrance has new stone installed.

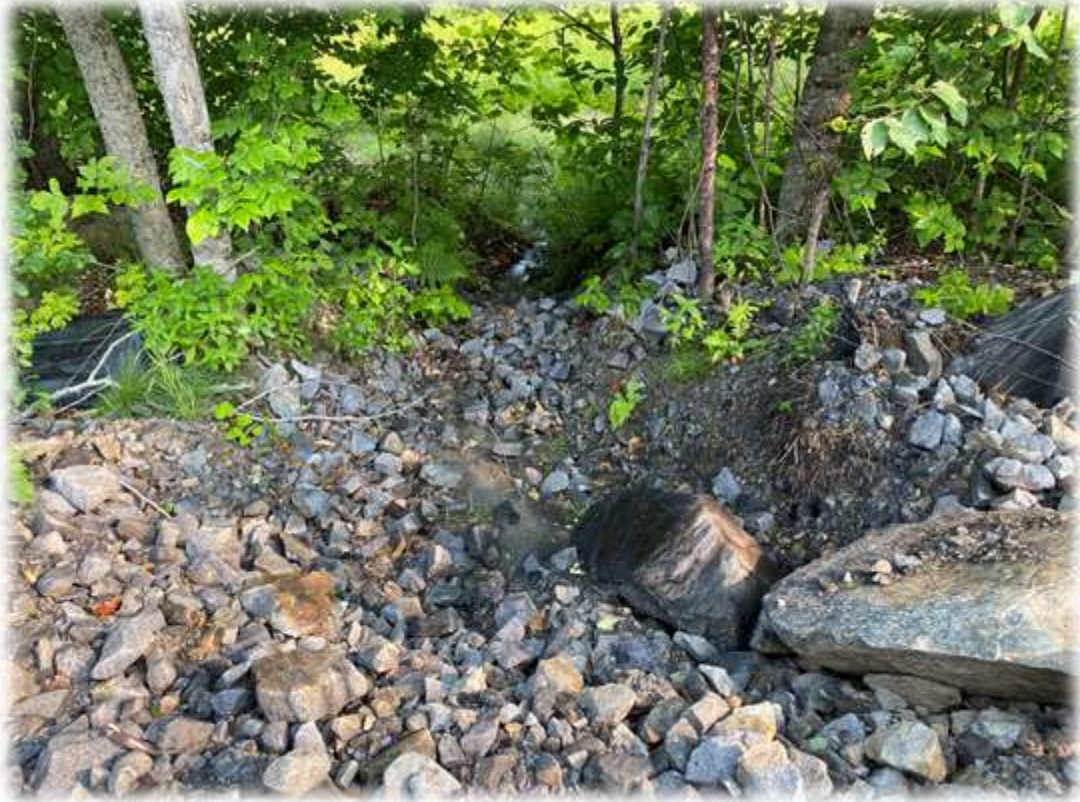
Photo #3: Many of the streams/drainage swales have some water flowing as smaller weekend rain events continue.

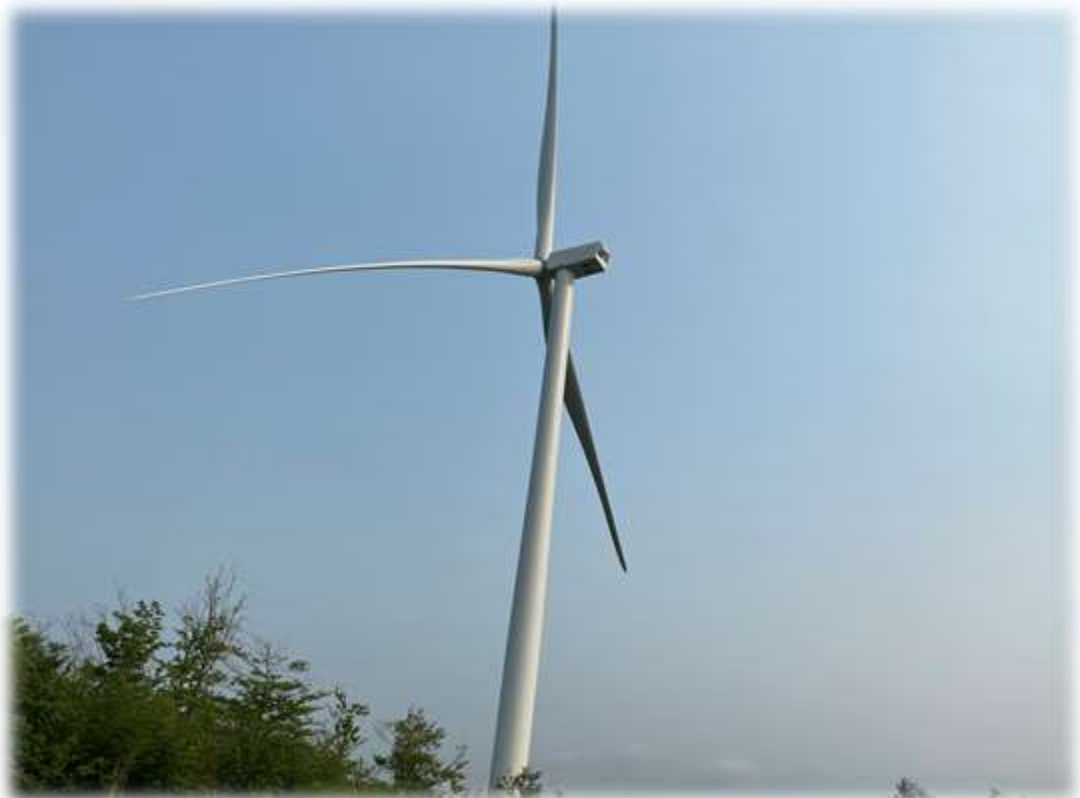
Photo #4: Tower 1 has been set including the Nacelle, blade hub, and 3 blades at the top of the tower.

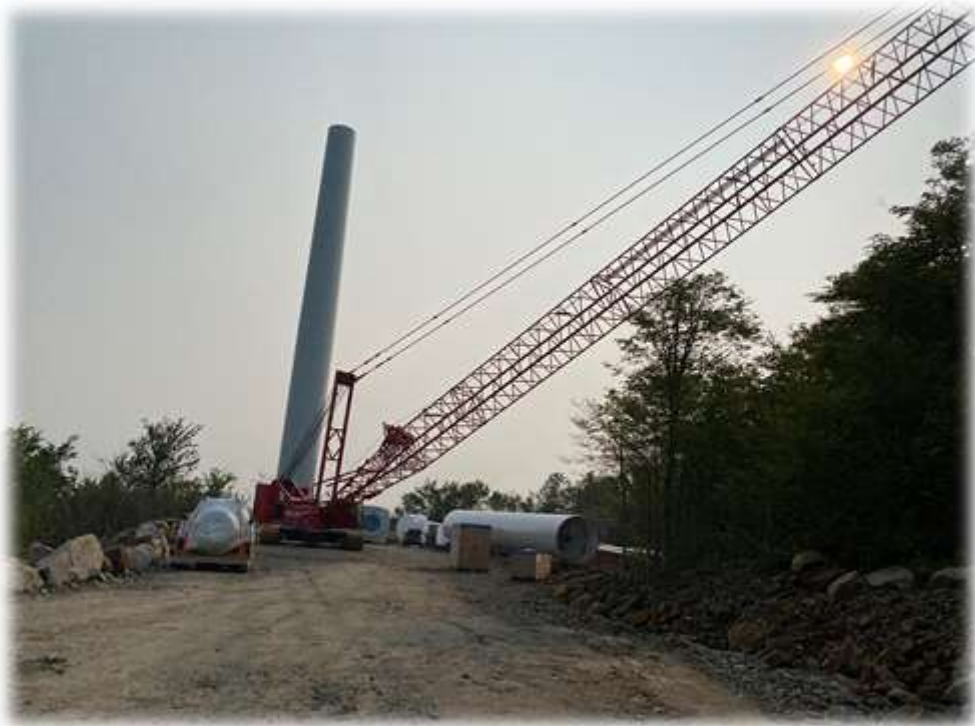
Photo #5: The base and mid-section of Tower 2 has been set. No changes to this padsite have occurred in this area this past week.

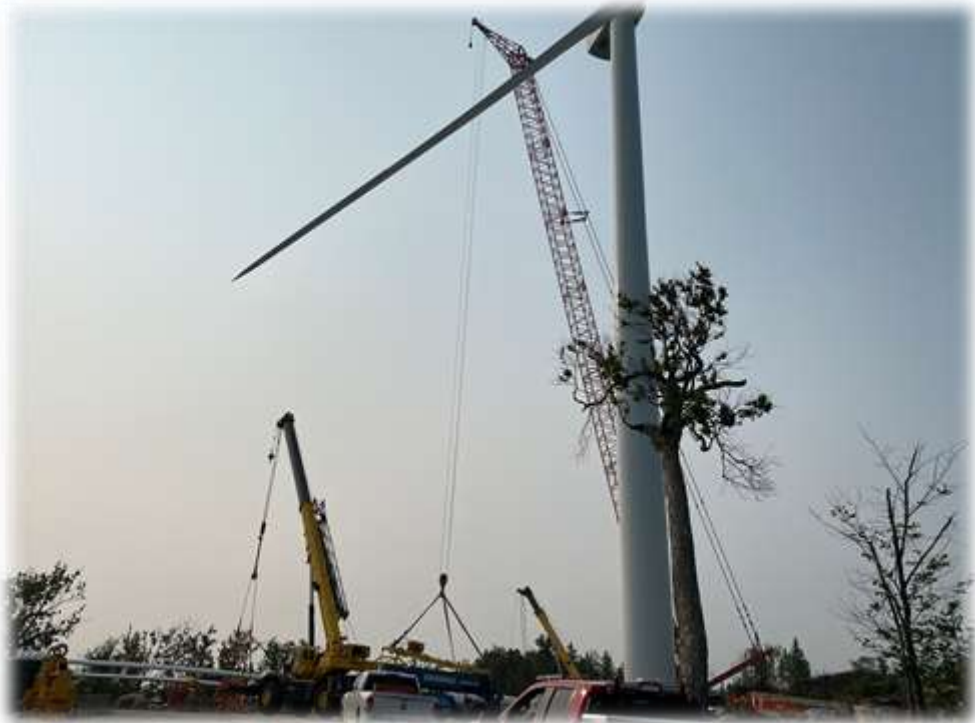
Photo #6: The base, mid-section top section, hub, and 1 blade of Tower 3 have been set.
