Third Party Inspection Form

TO: Erle Townsend, Dawn Hallowell PROJECT NAME/ LOCATION: RoxWind LLC DATE OF INSPECTION: 10-18-2021 WEATHER: Clouds, 45 deg.	FROM: Steve Roberge DEP #: L-27863-ES-A-N, L-27863-NJ-B-N, L-27863-TG-C-N DATE OF REPORT: 10-18-2021 CONDITIONS: Good
--	--

RoxWind LLC

Report: 58

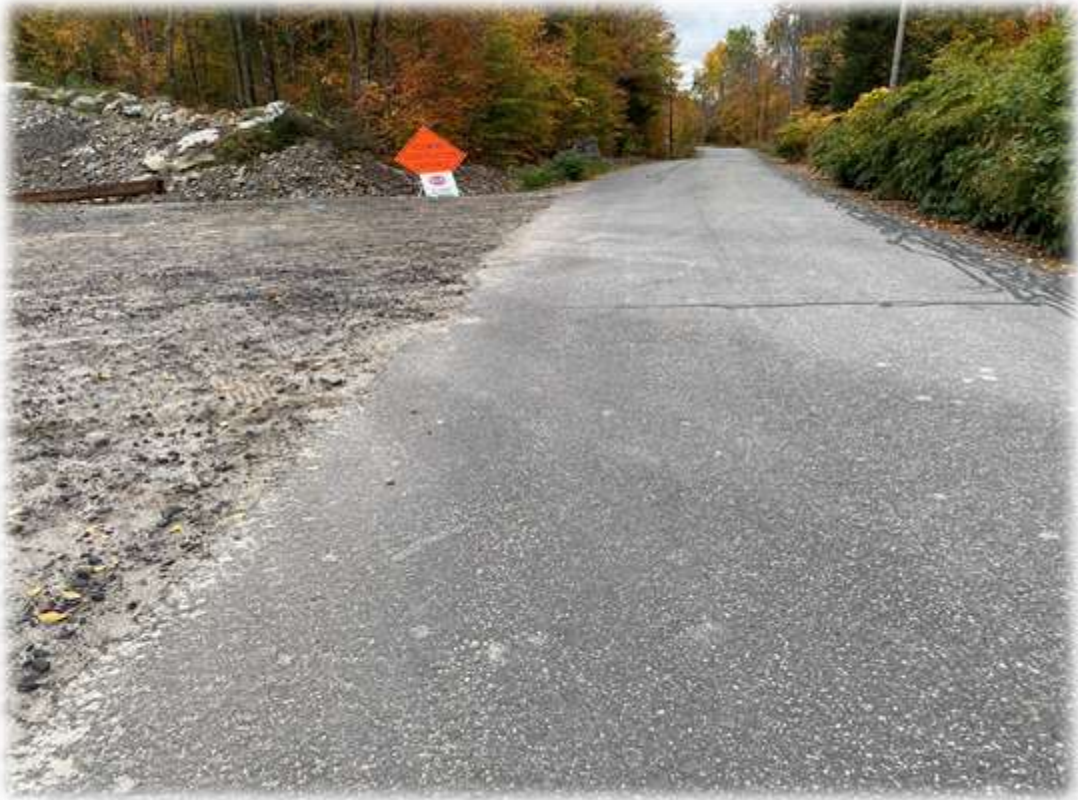
Photo #1: The Contractor has removed crushed stone from the Horseshoe Valley Road intersection with the project driveway.

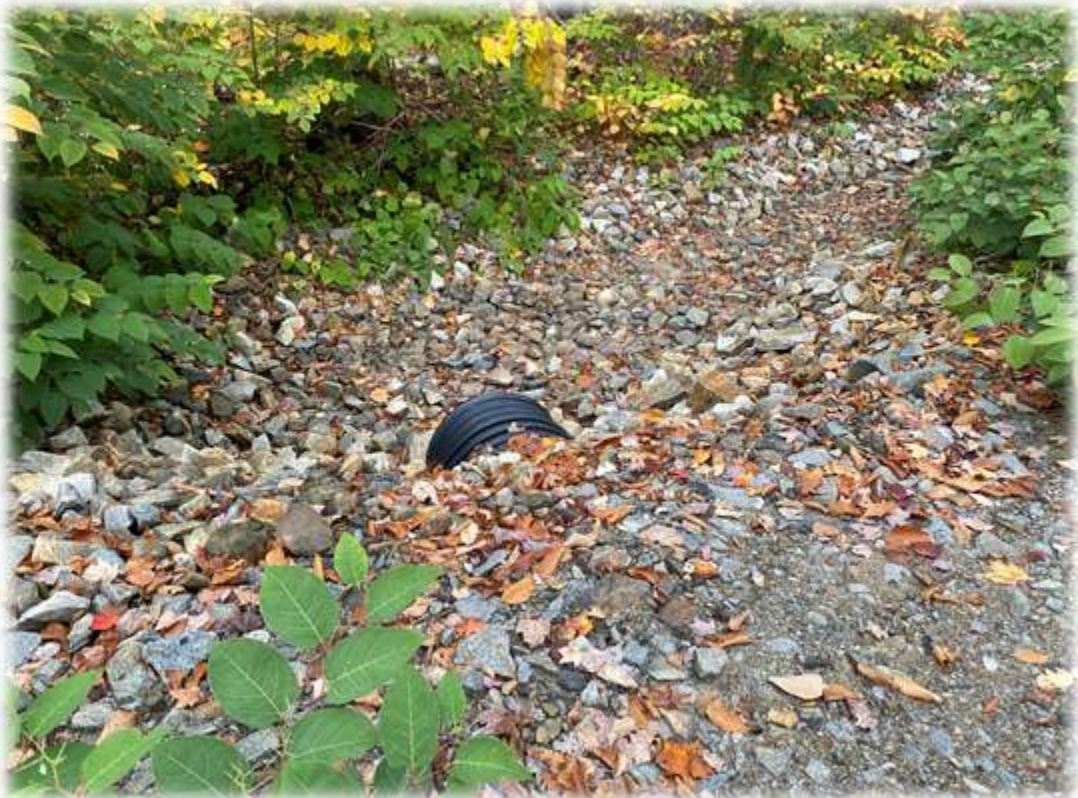
Photo #2: Sediment within the rock-plunge pool area across from the driveway entrance has been removed.

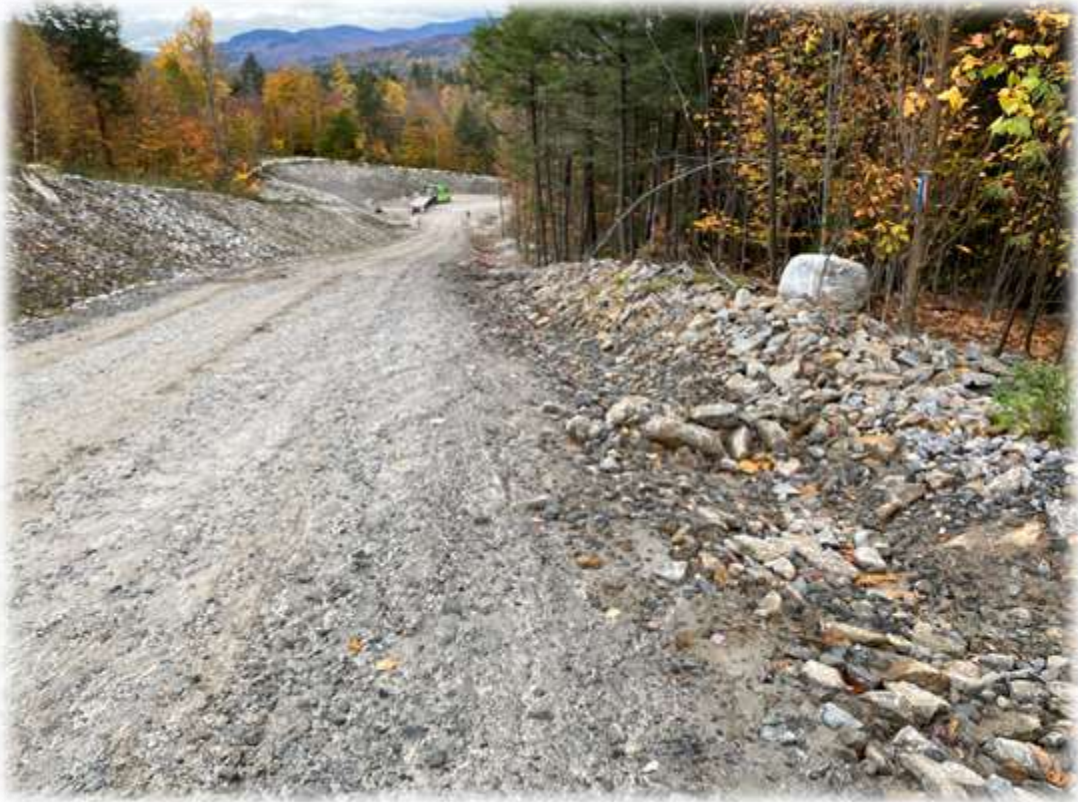
- 9. Stone/ECM Check Dam:** In several locations, the Contractor has installed stone check dams in the upslope ditching of the new rocked driveway. Check dams in the Tower access road have been cleaned of sediment.

Photo #3: Sediment has been removed from the stone check dams along the first hill of the tower access road.

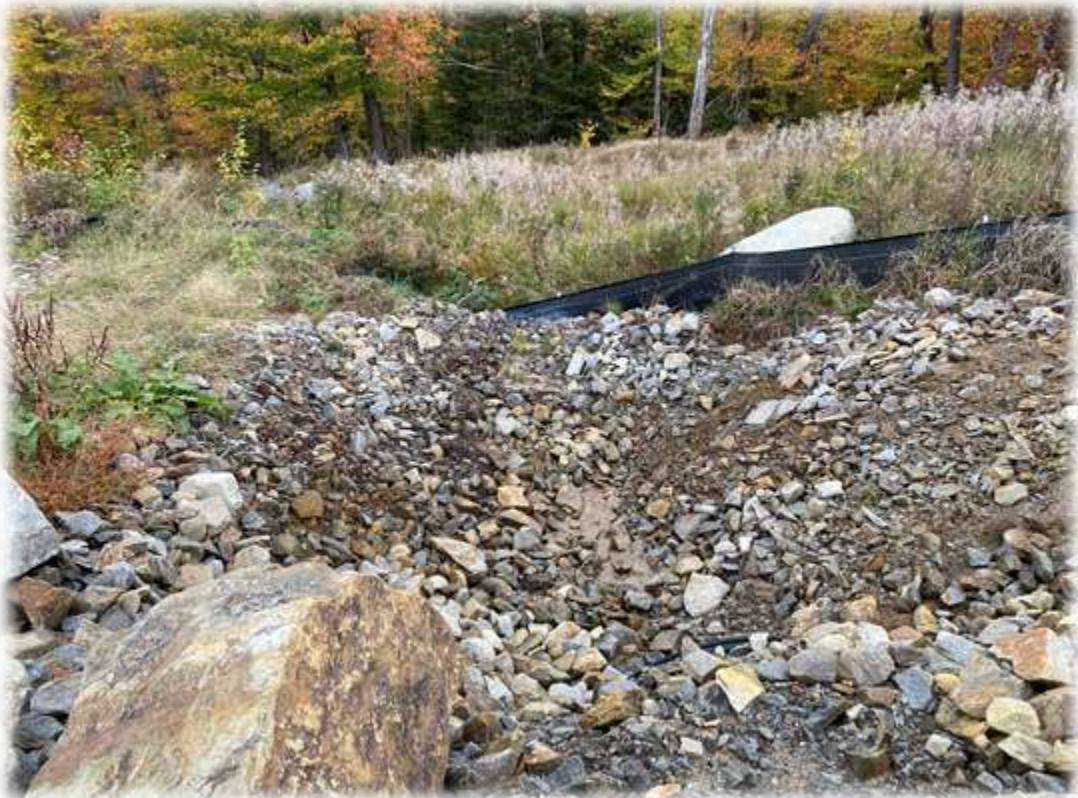
Photo #4: Stream beds do not seem to be passing significant sediment. The plunge pool outlet has been cleared of sandy debris.

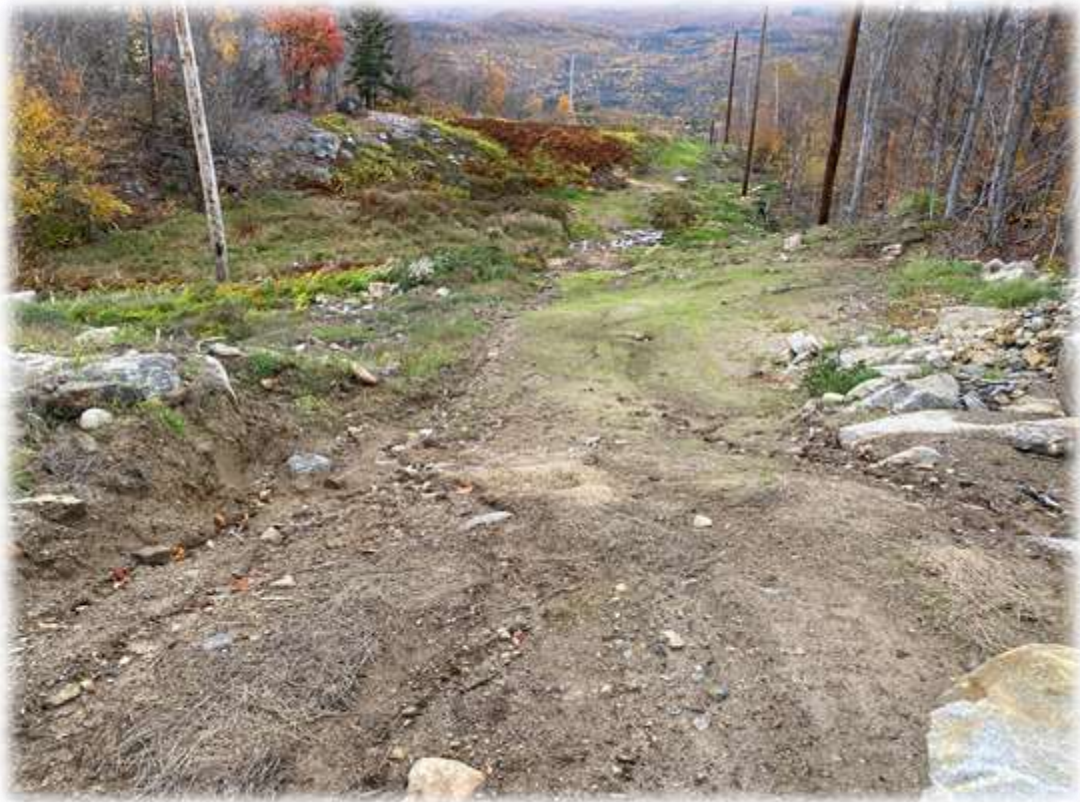
Water bars/stabilized outlets along the restored transmission corridor have been created and seem to be working.

Photo #5: The upper portion of the transmission corridor access road coming into the RoxWind Towers portion of the project has been restored. Water bars have captured and diverted upland areas into stabilized areas. A significant catch of vegetation is becoming established. Some erosion is beginning to occur that should be redirected at the rock barrier along the road.

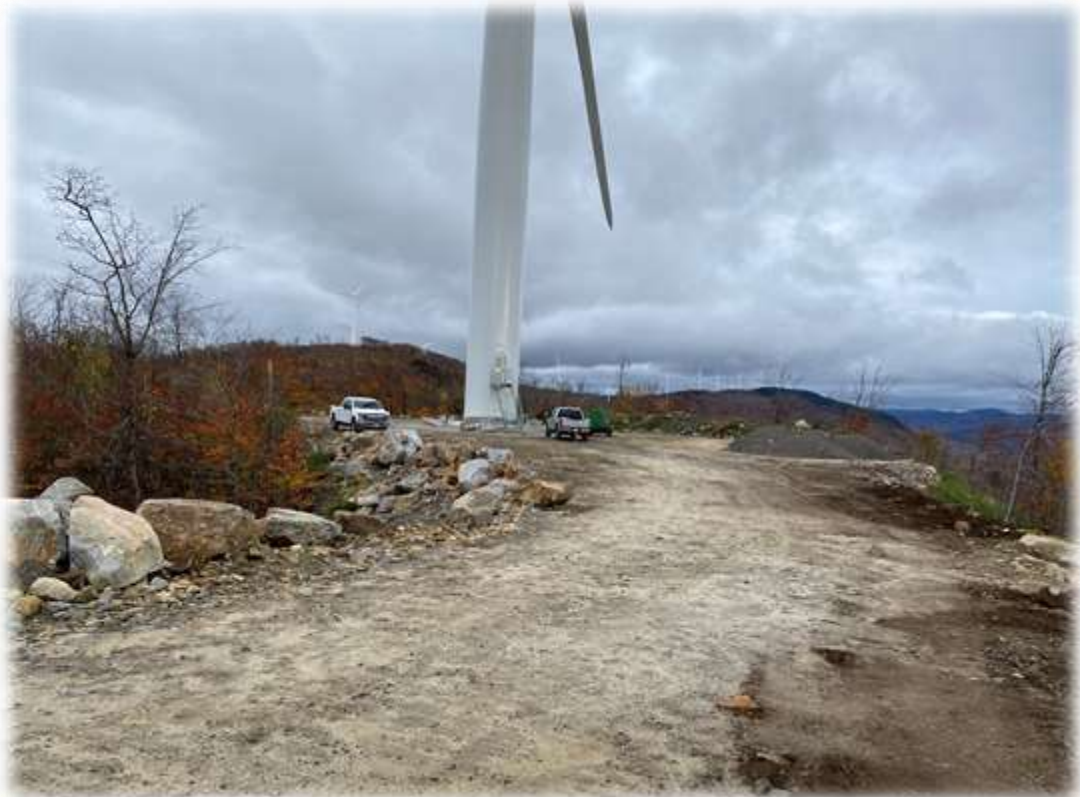
Photo #6: Final gravel is being stockpiled for use in constructing Tower 1 base padsite.

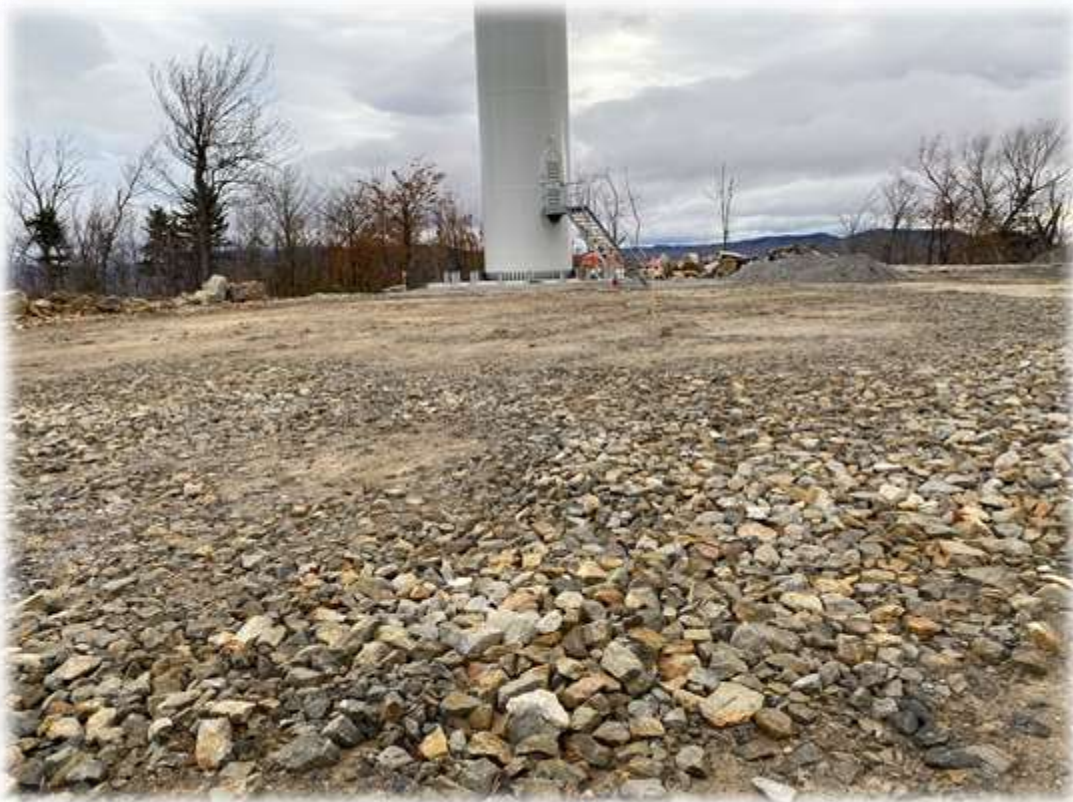
Photo #7: No activities are ongoing at Tower 2 location.

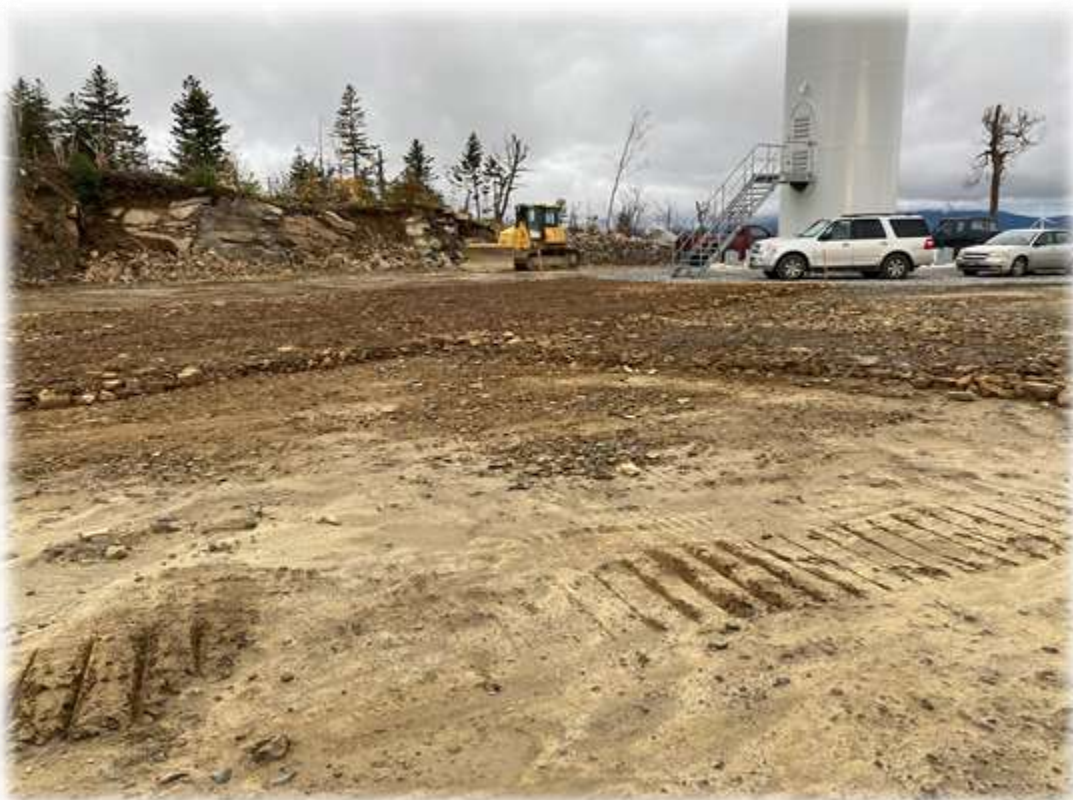
Photo #8: Ongoing testing operations at Tower 2 location. The Contractor is constructing the tower base padsite area.

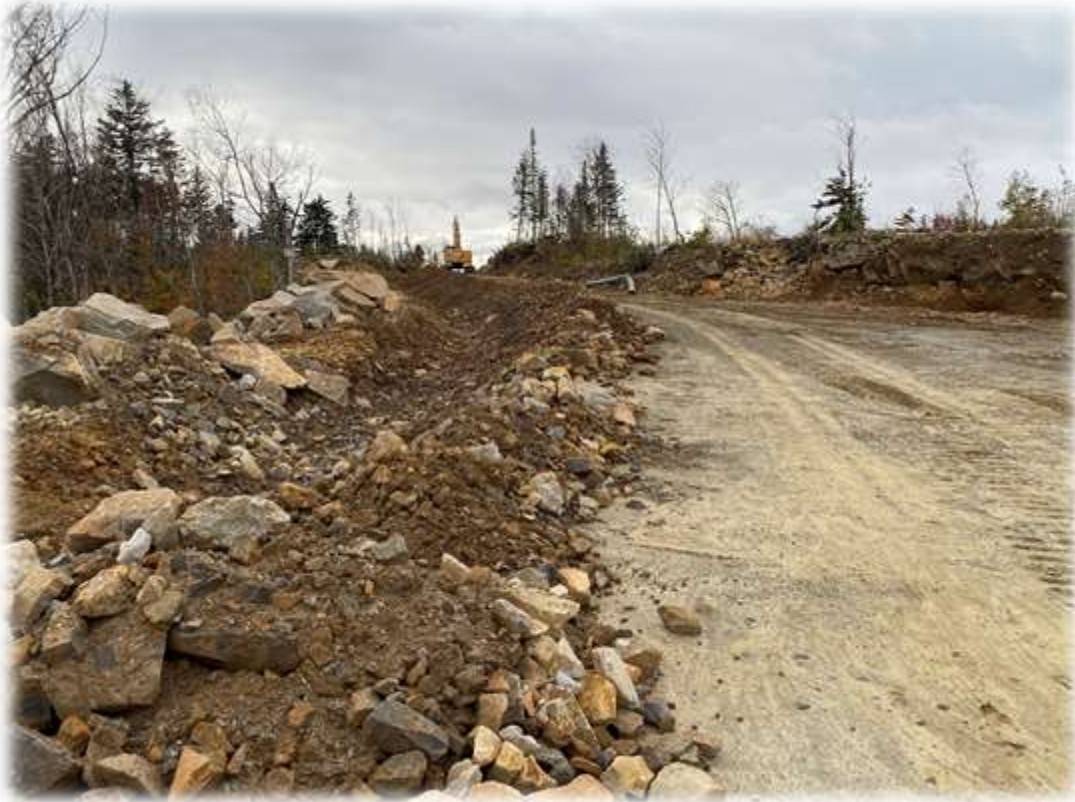
Photo #9: The Contractor is creating new riprap ditches and restoring the access road between Towers 3 and 4.

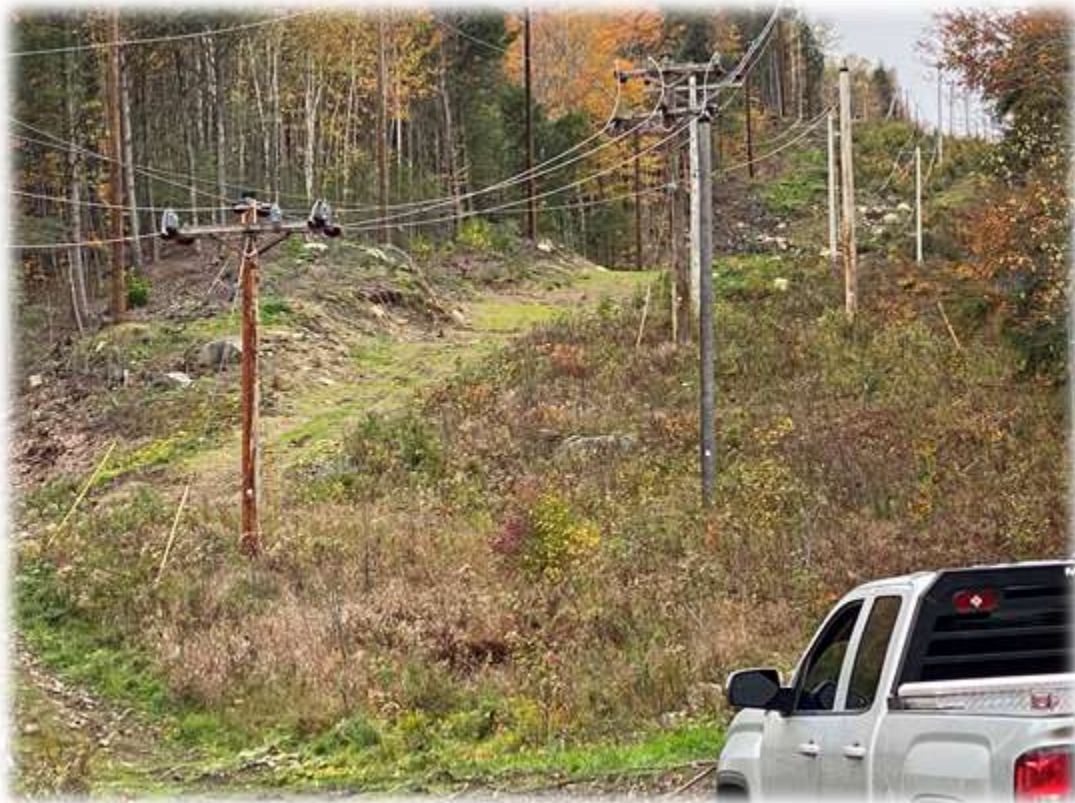
Underwood Electric has completed restoration of the corridor work. The top $\frac{3}{4}$ of the corridor has significant grass becoming established. The lower quarter is struggling to get vegetation established, but more time is needed. The Contractor should consider a second application of seed/mulch on bare areas.

Photo #10: The bottom $\frac{1}{4}$ of the corridor has some vegetative growth. More growth is needed in bare areas.

1. Bottom quarter of corridor experiencing slow vegetative growth. Perhaps consider a second seeding/mulching over bare areas?
2. Now that all the tower parts have been delivered, water bars should be re-installed along the access road (work in progress).

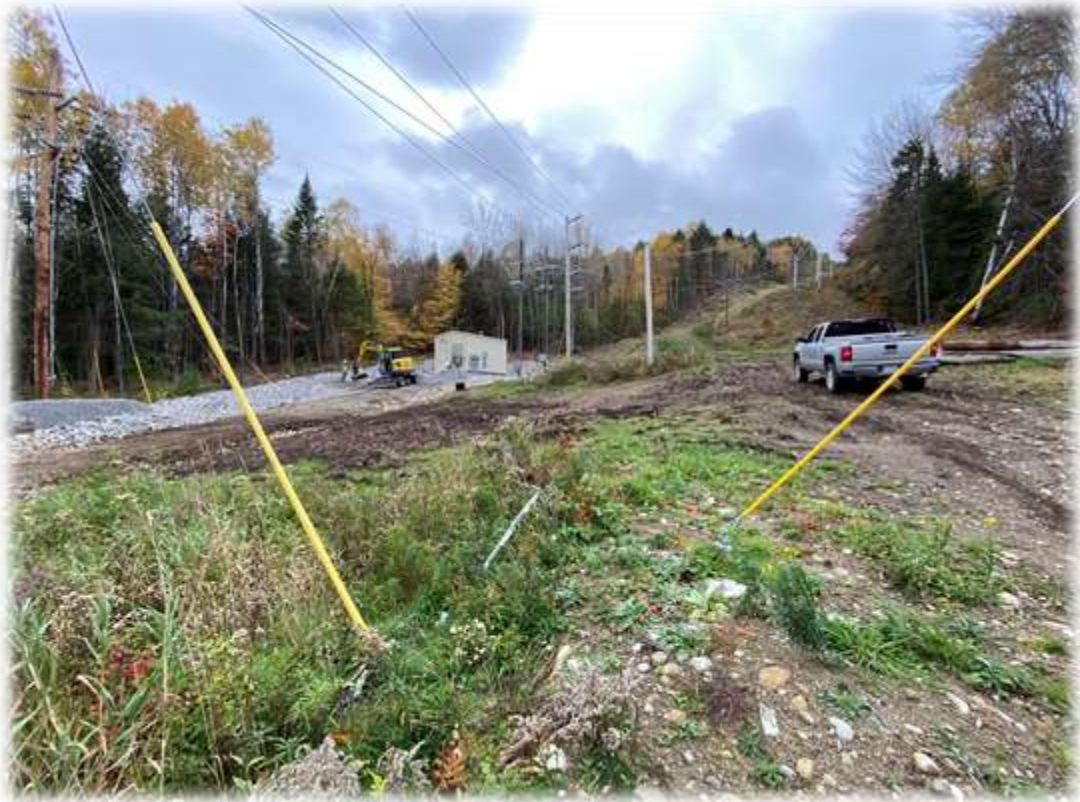
14. Ditches/Swales: New ditches have been created during the construction of the new rocked driveway leading up the hill. Much of the previous ditch erosion has been eliminated. Both sides of the driveway ditch to the SCADA building needs to be cleaned of debris (work in progress).

Photo #11: The laydown area at the bottom of the corridor needs additional seed/mulch for a better vegetative catch. The mats have been removed from the SCADA building driveway, however, the drainage ditch needs debris removed from both sides of the driveway ditching. Contractor is performing final touches to SCADA building area and driveway.
