Third Party Inspection Form

TO: Erle Townsend, Dawn Hallowell PROJECT NAME/ LOCATION: RoxWind LLC DATE OF INSPECTION: 11-01-2021 WEATHER: Sun, 50 deg.	FROM: Steve Roberge DEP #: L-27863-ES-A-N, L-27863-NJ-B-N, L-27863-TG-C-N DATE OF REPORT: 11-01-2021 CONDITIONS: Good
---	--

RoxWind LLC

Horseshoe Valley Road, Roxbury

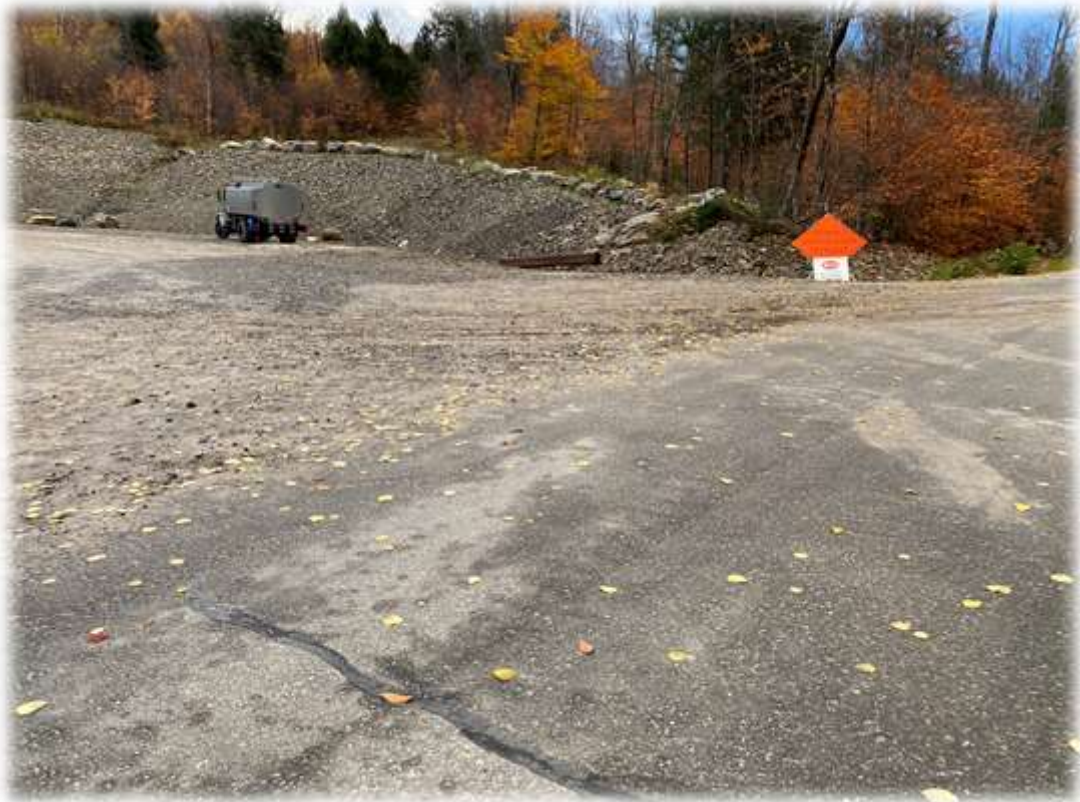
Photo #1: The Contractor has removed crushed stone from the Horseshoe Valley Road intersection with the project driveway. A slight covering of sand material is being tracked onto the paved surface that should be removed daily at this time of year.

3. Stabilized Entrance: All large parts have been delivered. The stabilized entrance has been created again. Horseshoe Valley Road has some light sand tracking onto road, but generally remains clear of soil debris. The soil debris needs to be cleaned, particularly this time of year, as the debris may become slippery during the colder weather.

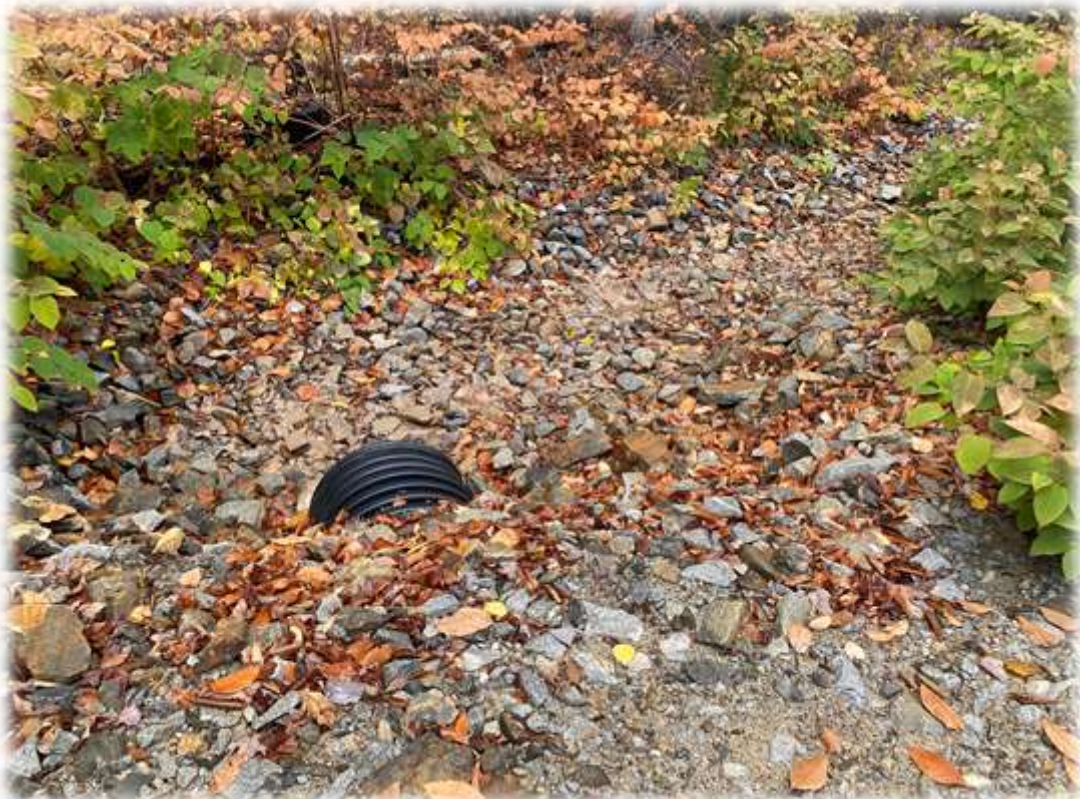
Photo #2: Sediment within the rocky plunge pool area across from the driveway entrance has been removed. No new sediment buildup noted.

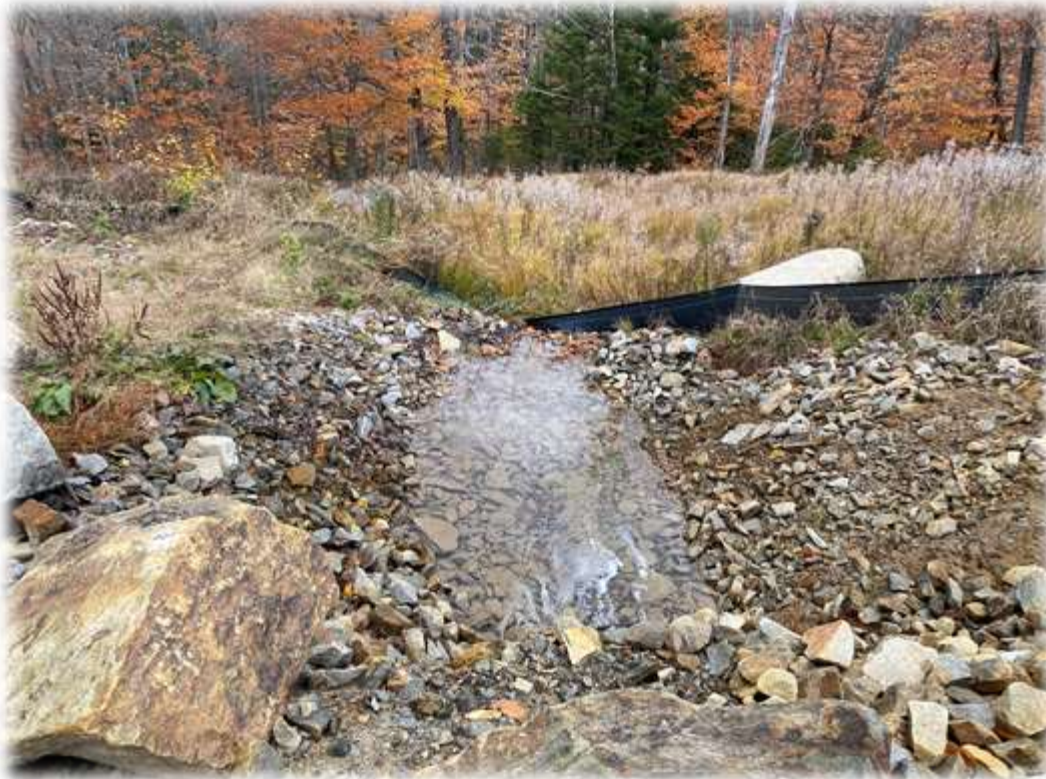
Photo #3: Stream beds do not seem to be passing significant sediment. The plunge pool outlet has been cleared of sandy debris.

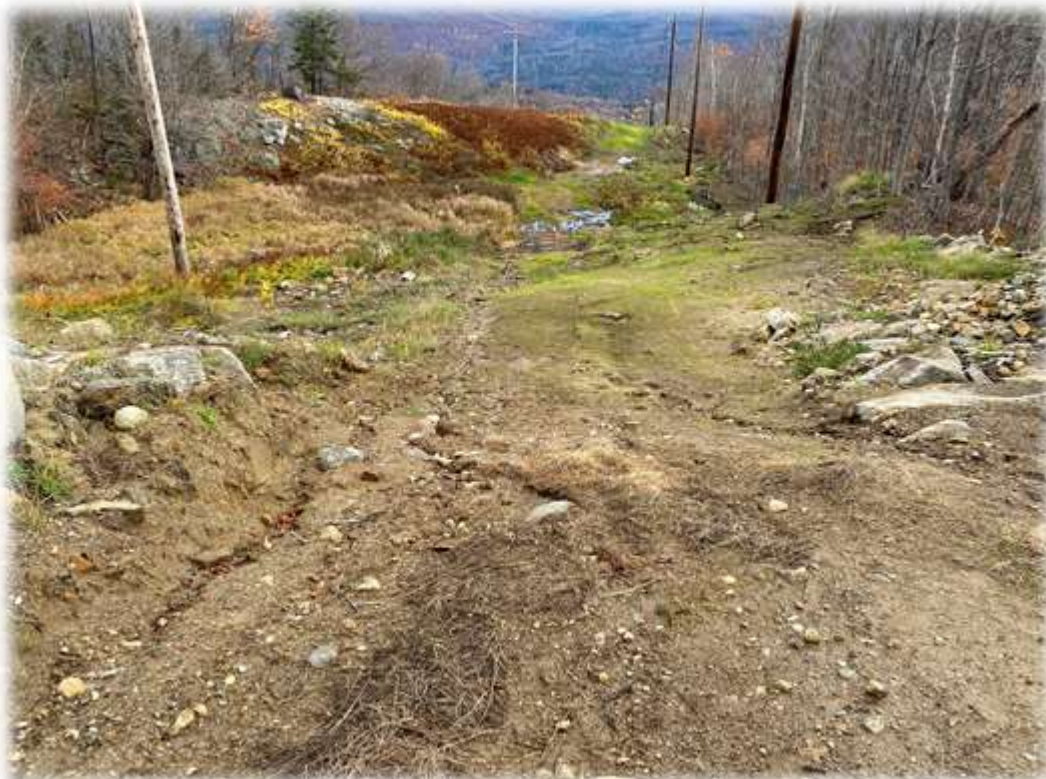
Photo #4: The upper portion of the transmission corridor access road coming into the RoxWind Towers portion of the project has been restored. Water bars have captured and diverted upland areas into stabilized areas. A significant catch of vegetation is becoming established. Some erosion is beginning to occur that should be redirected at the rock barrier along the road.

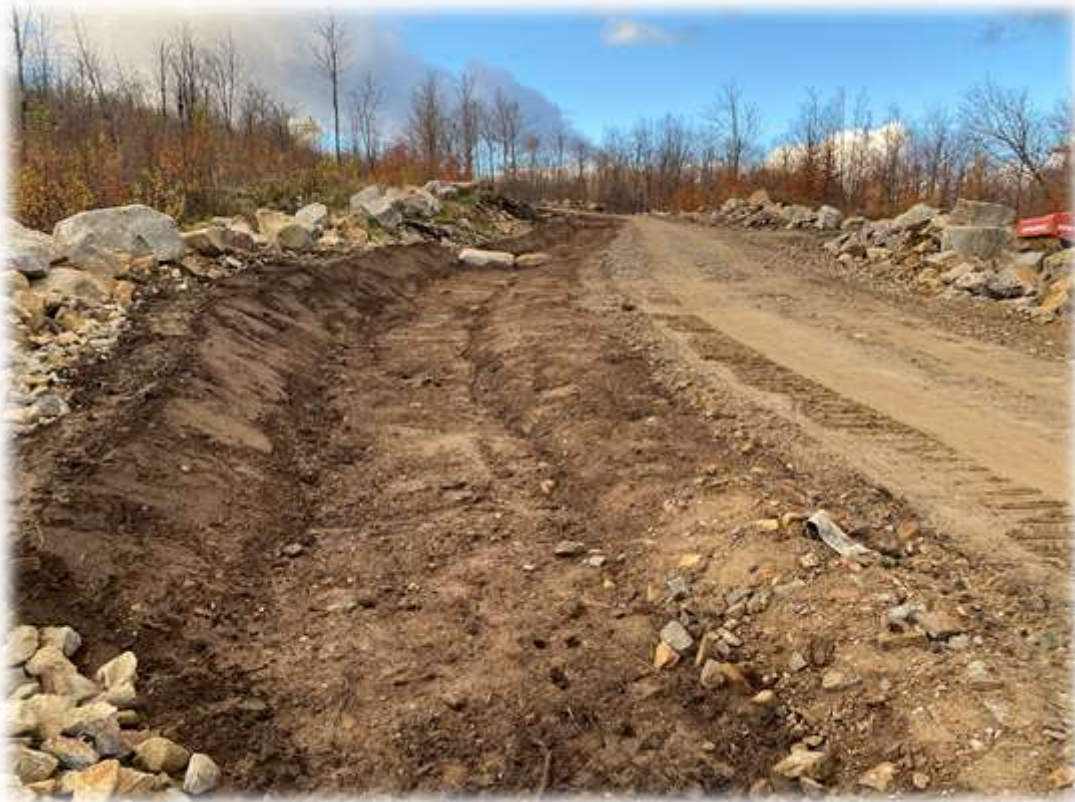
Photo #5: The Contractor continues restoring the narrower access road and has constructed the filter media ditch along the left side of access road. They have constructed to the 180 degree road curve near tower 1 to tower 4. No erosion or ponding of water was noted in the filter media ditch.

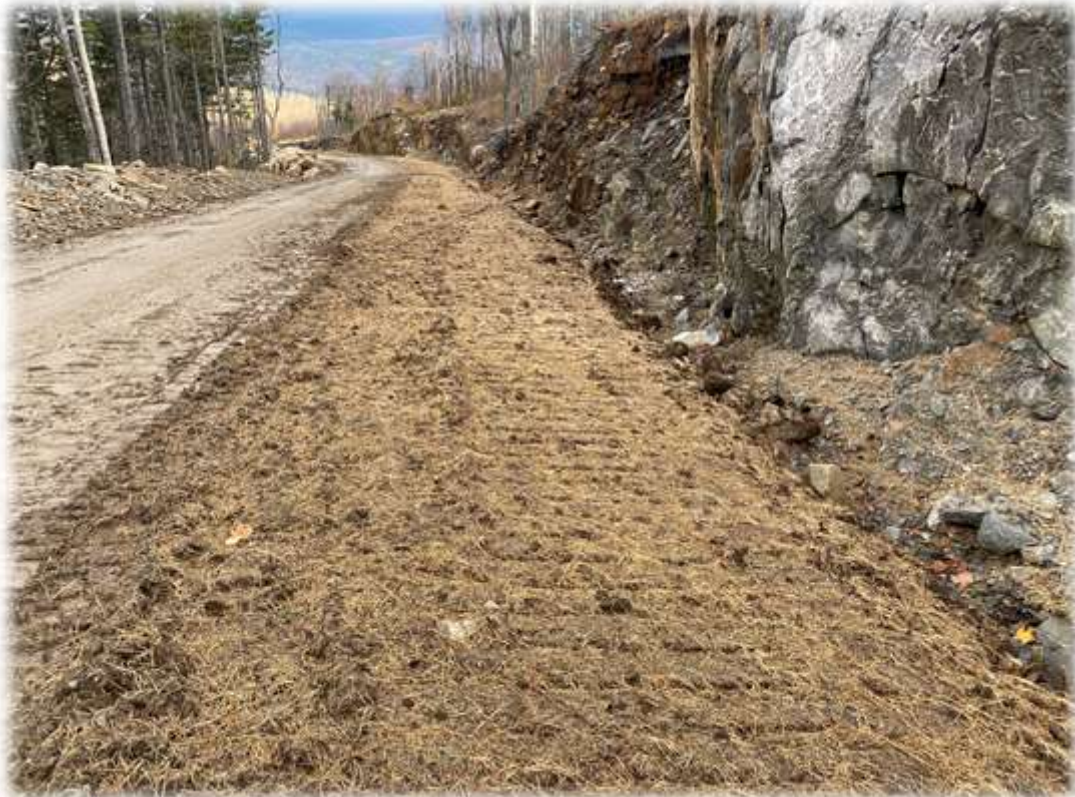
Photo #6: The loam/seed/mulch material has been applied to the restored access road between Towers 2/3. No erosion issues have been noted.

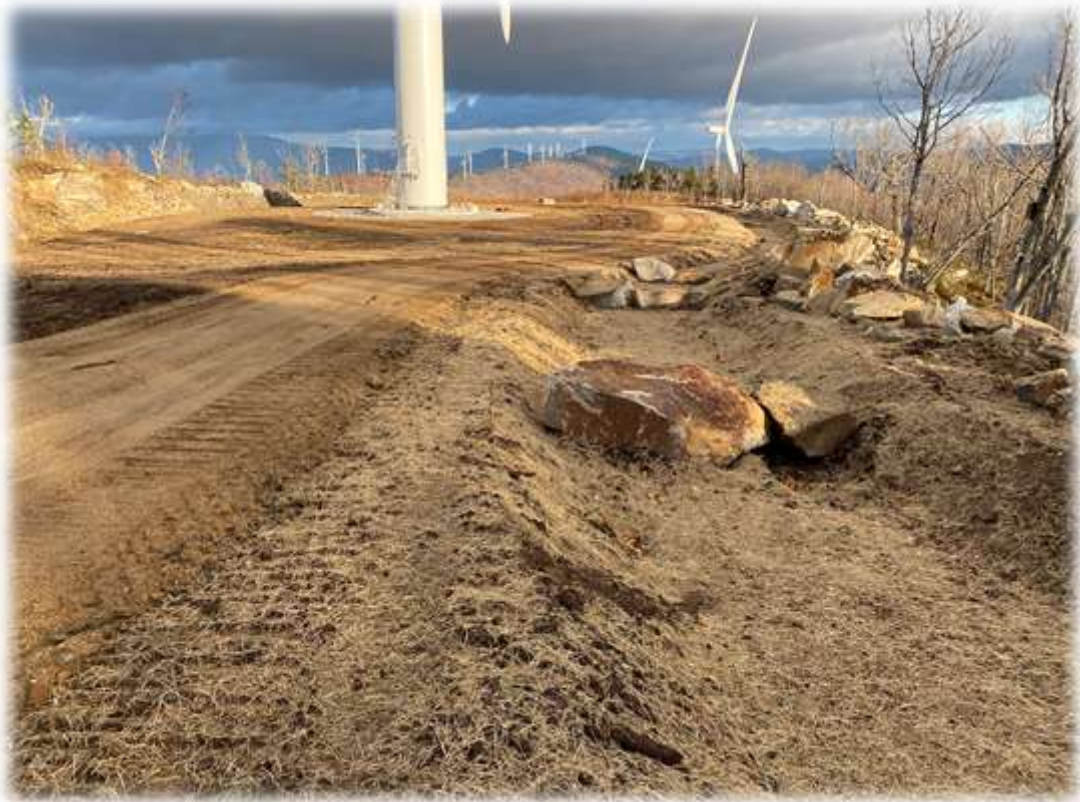
Photo #7: The access road has been made narrower (12' wide) and the remaining area loamed and tracked in near tower 3. The Tower 3 area is partially hydroseeded.

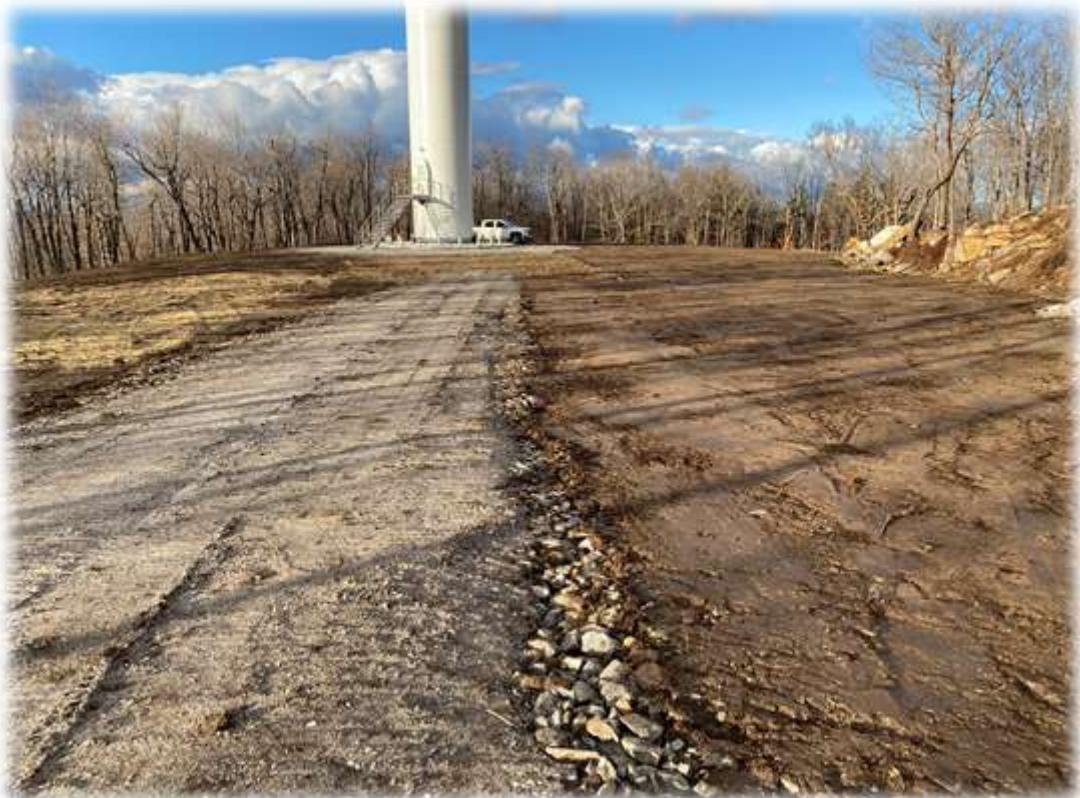
Photo #8: The access road has been made narrower (12' wide) and the remaining area loamed and tracked in near tower 4. The Tower 4 area is partially hydroseeded.

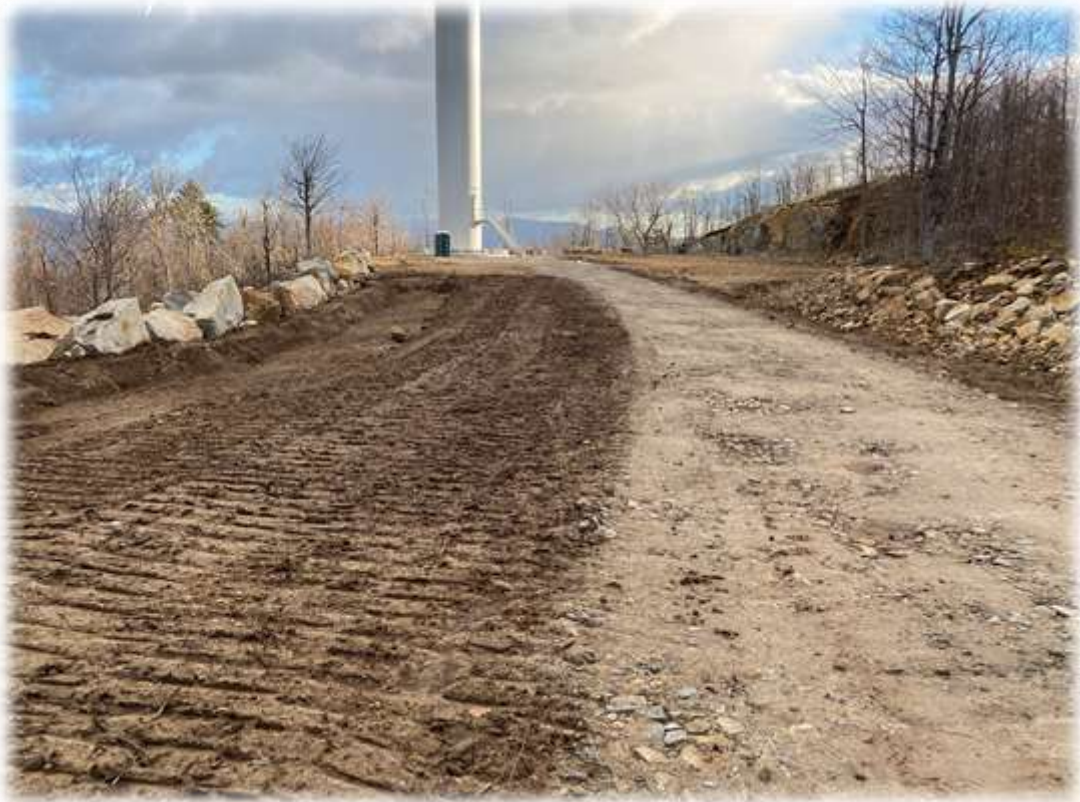
Photo #9: The Contractor has restored and loamed Tower 2 area and has created a filter media ditch along the downslope side of access road. The site is partially hydroseeded and mulched. No erosion has been noted.

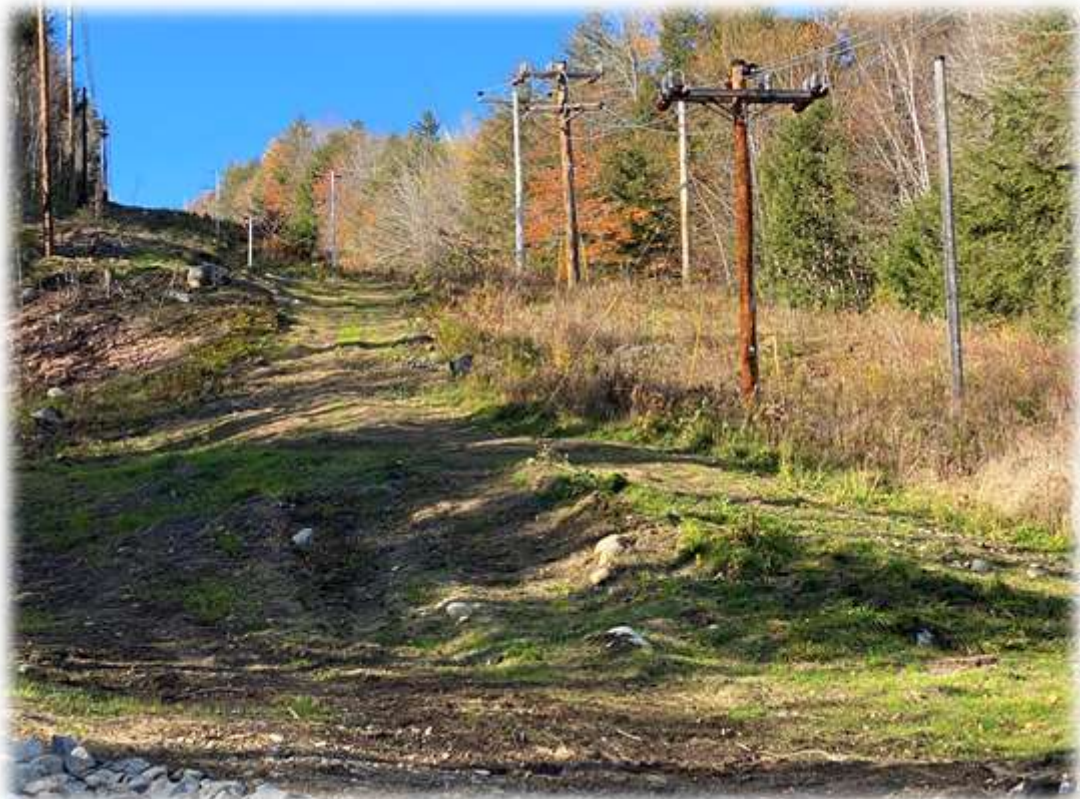
Photo #10: The lower end of the transmission corridor has some vegetative growth. More growth is needed in bare areas. A heavy application of hay mulch is needed in bare soil areas.

Underwood Electric has completed restoration of the corridor work. The top $\frac{3}{4}$ of the corridor has significant grass established. The lower quarter is struggling to get vegetation established, but more time is needed (no changes). The Contractor should consider a second application of seed/winter mulch on bare areas.

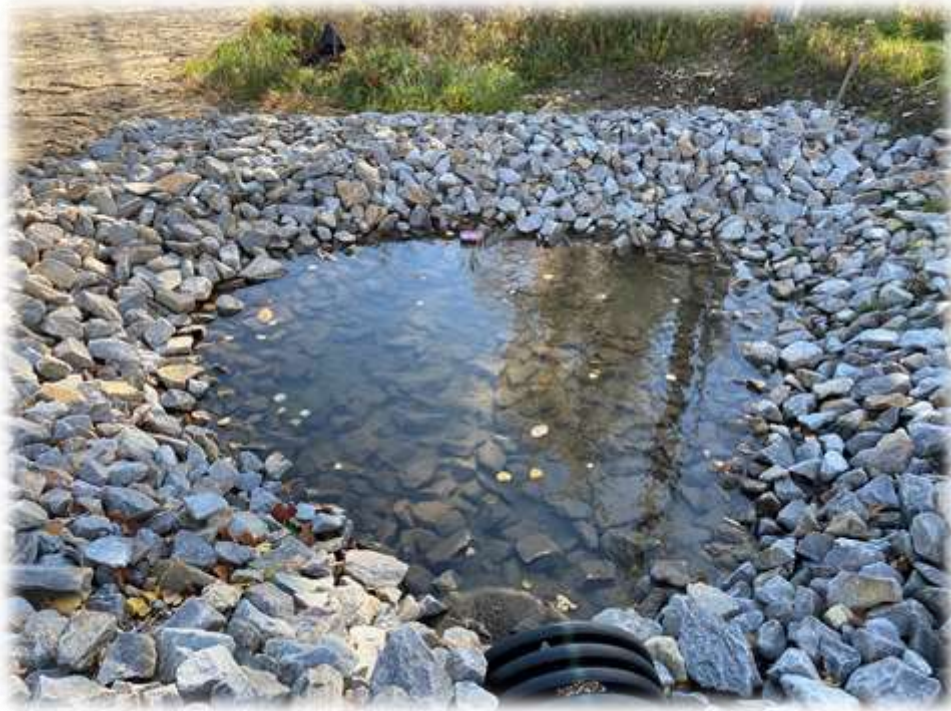
Photo #11: The culvert plunge pool along the SCADA building driveway has clear water within the pool.

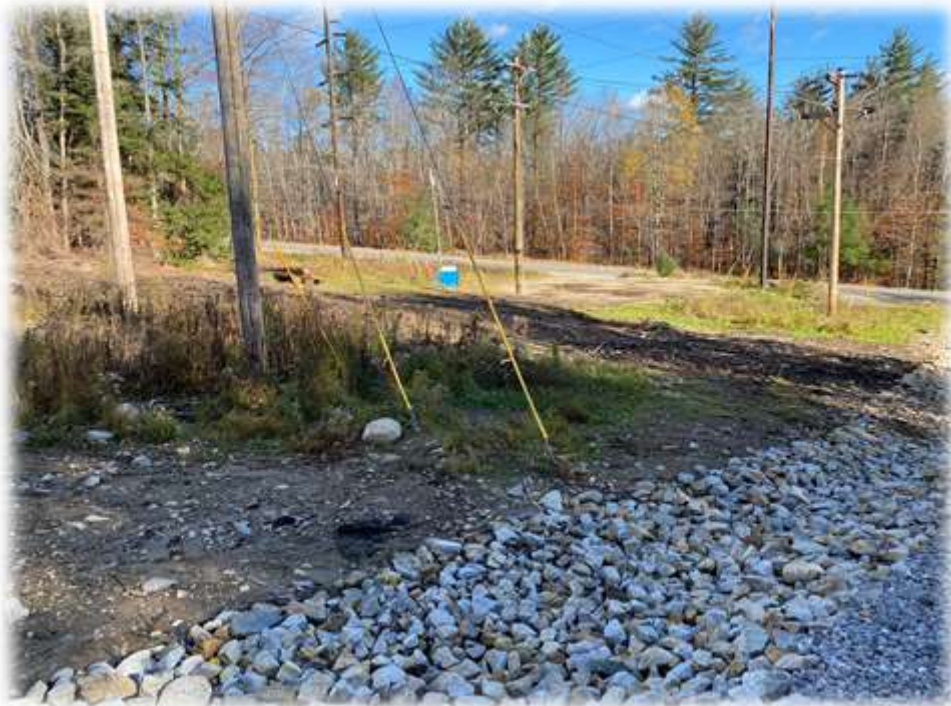
Photo #12: The laydown area at the bottom of the corridor needs additional seed/mulch for a better vegetative catch.
