Third Party Inspection Form

RoxWind LLC

Horseshoe Valley Road, Roxbury

Date: Monday, 11-15-2021 **Time:** 8:00 AM **Report:** 62
Inspected by: Steve Roberge, PE **Company/Agency:** SJR Engineering Inc.
Weather Conditions: 30 degrees, Clouds
Owner Rep: Palmer Management Corp (Sumul Shah)
Construction Site/Project Manager: Reed-Reed (Kate Doughty, Jake Hall)
Engineer: Sewall (Jody Dube-Oneal)
Site Earthwork Contractor: Sargent Construction (Tim LePage, Pete Broberg, Mark Wright)
Clearing Contractor: Comprehensive Land Technologies (CLT)
Onsite Environmental Inspections: Stephan (Reed/Reed)
Contact onsite today: **Owner Rep:** NA, **Reed/Reed:** Kate (phone), **Sargent:** Aaron (phone), **MD+B:** NA, **CMP:** NA
Date of Last Inspection: 11-08-2021
Estimated # of days since last rainfall over $\frac{1}{2}$ ": 1.18" rainfall 11/12/2021
Photographs taken: 11 photos included in report

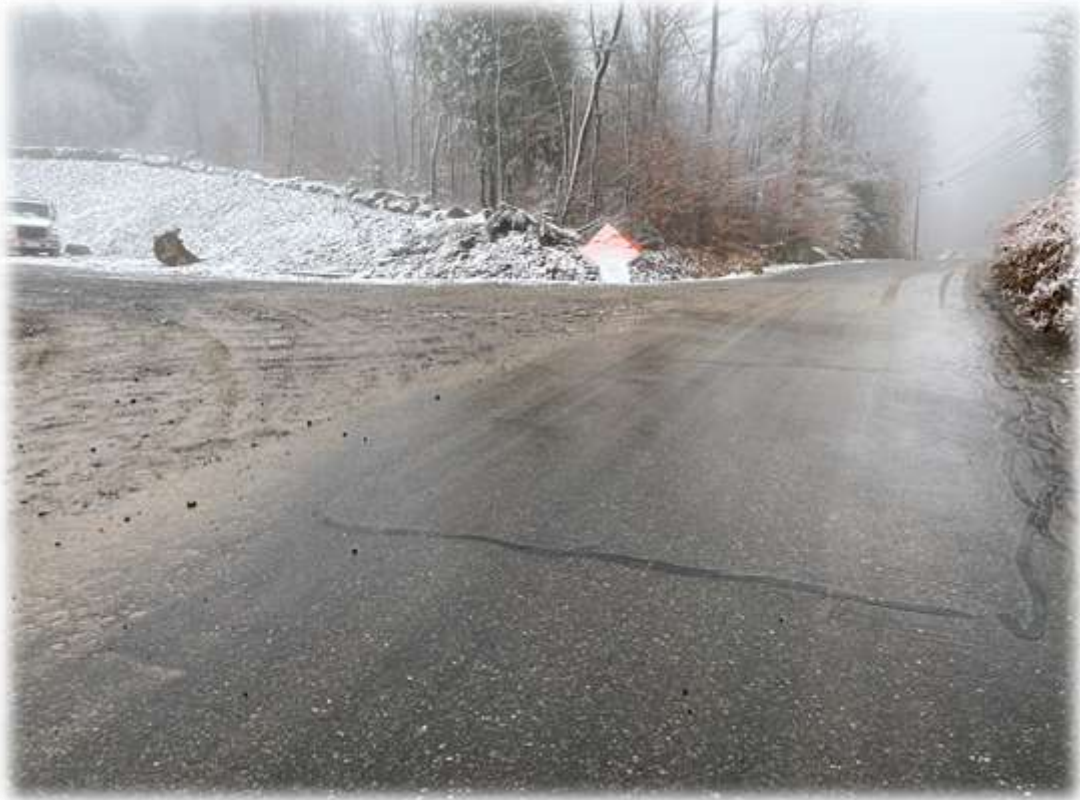
Photo #1: The Contractor has removed crushed stone from the Horseshoe Valley Road intersection with the project driveway. A slight covering of silt material is being tracked onto the paved surface that should be removed periodically throughout the day at this time of year.

3. Stabilized Entrance: The stabilized entrance has been established. Horseshoe Valley Road has some silt soils tracking onto the road. These need to be cleaned periodically throughout the day as they will freeze to road.

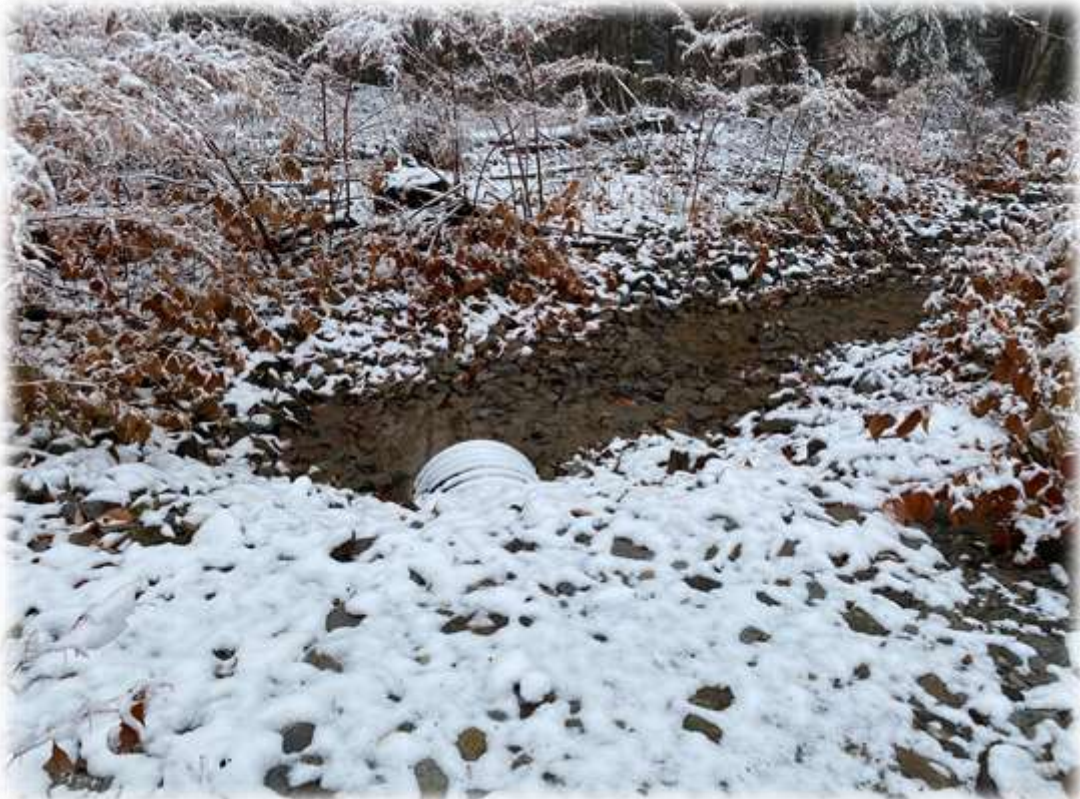
Photo #2: Sediment within the rocky plunge pool area across from the driveway entrance has been removed. No significant new sediment buildup noted. Water in pool is slightly turbid.

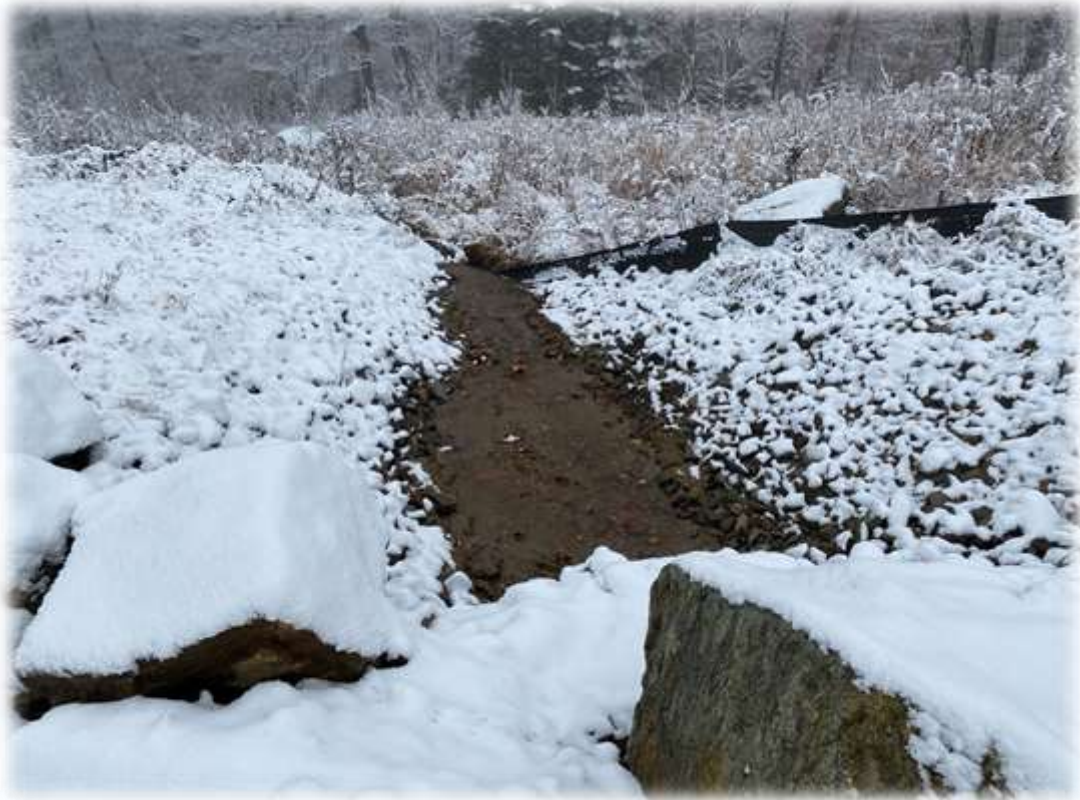
Photo #3: Some soil material within the $\frac{1}{2}$ filled stream culvert has washed and has been captured by the silt fence.

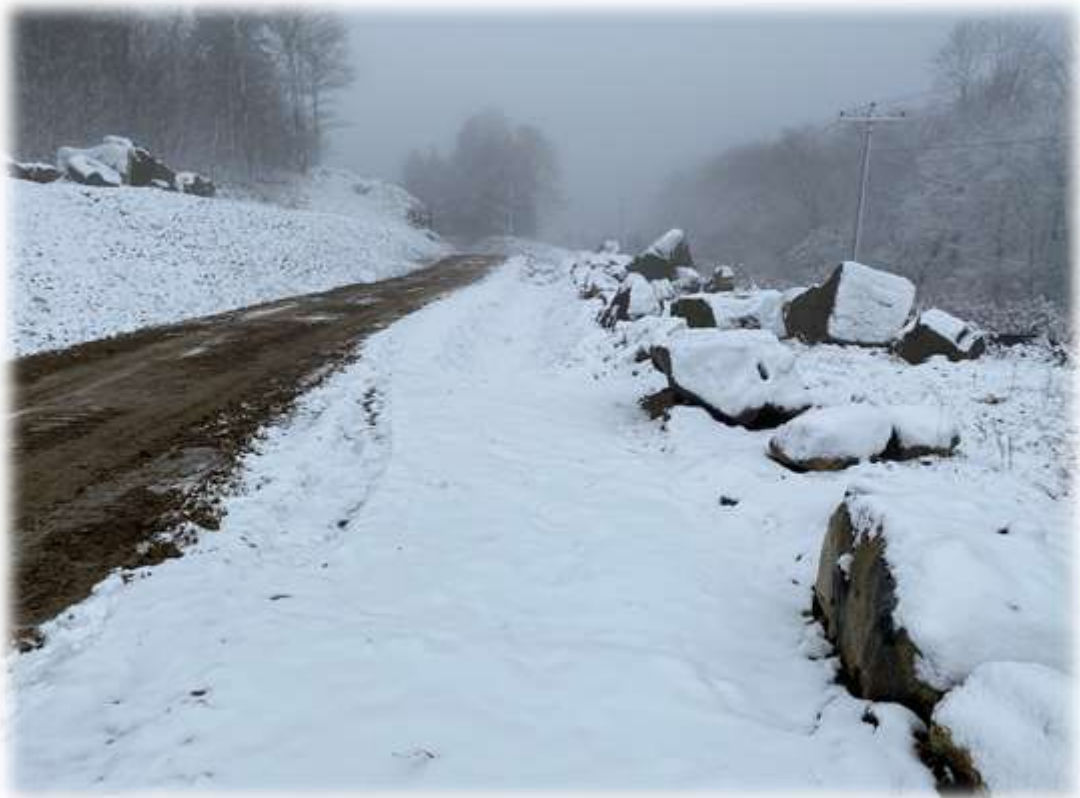
Photo #4: Snow cover in the filter media ditch construction along the main access road depicts some areas that the filter media has eroded. Sargent is repairing these locations along the bottom $\frac{1}{2}$ mile of main access road.

1. The steeper sections of the soil filter media ditch have eroded. Sargent is reshaping the ditches to pre-rain conditions and adding additional check dams to the ditching. Existing check dams are being cleaned ready for the next rain event. "Work in progress"
2. Silt sediment is being tracked onto Horseshoe Valley Road and needs to be cleaned periodically throughout the day. (freezing/slippery)
3. Bottom quarter of corridor experiencing slow vegetative growth (now covered in snow).

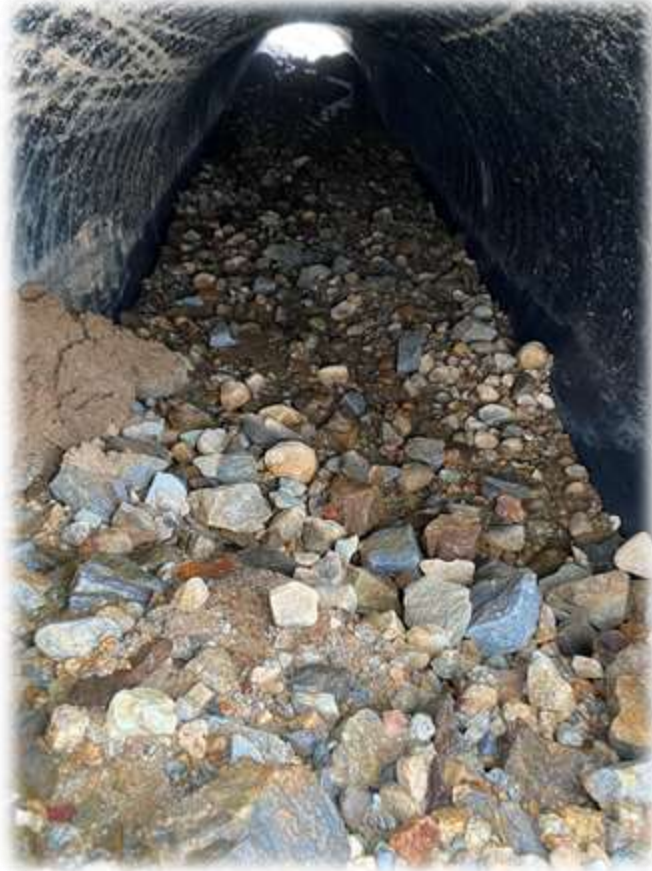
Photo #5: The new gravel fill inside the stream culverts has washed fines from the soil by this weekend's significant rain event.

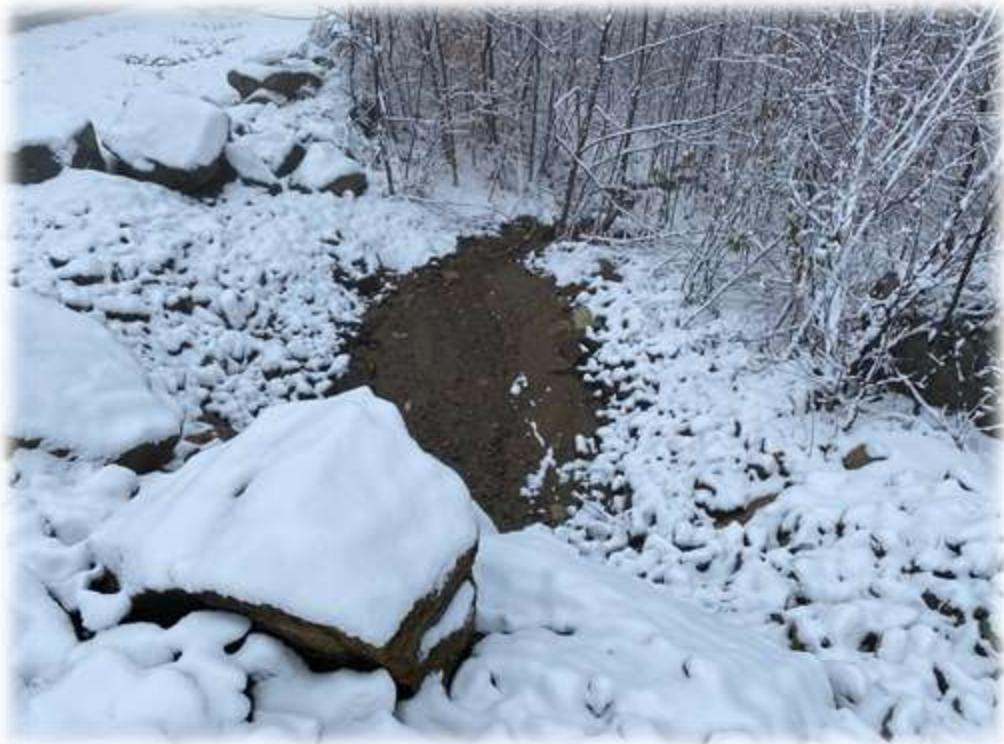
Photo #6: Outside view of same culvert (sta 124+50) showing washed gravel flowing in stream.

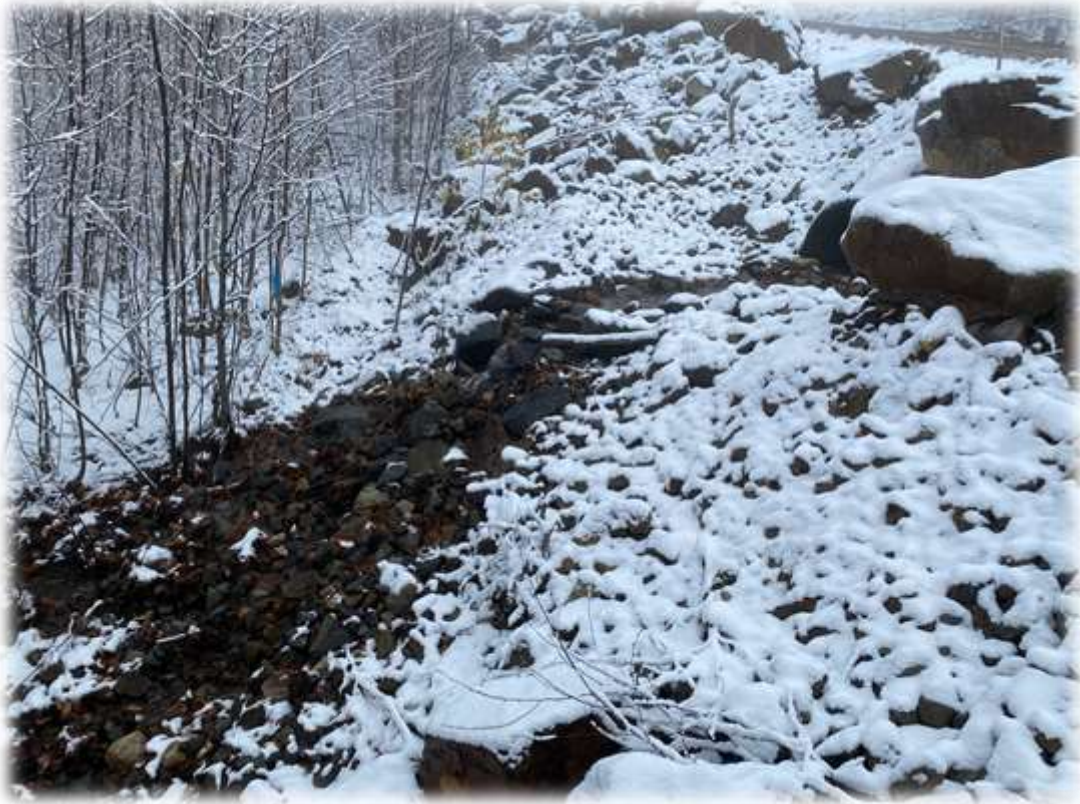
Photo #7: While the picture does not reflect the vertical elevation very well (8' drop), the discharge end of culvert at sta 125+50 has significant riprap on fabric protection that distributes the concentrated pipe flow over the whole rock.

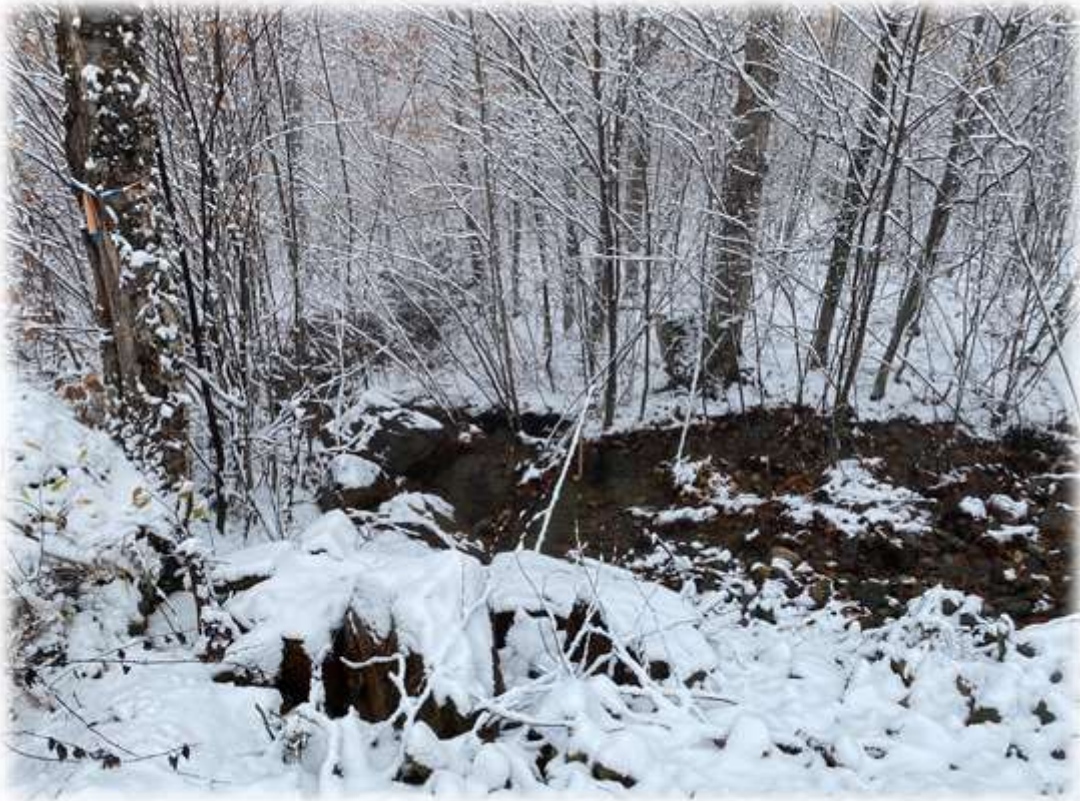
Photo #8: The stream along the downslope side of culvert 125+50 is relatively clear water.

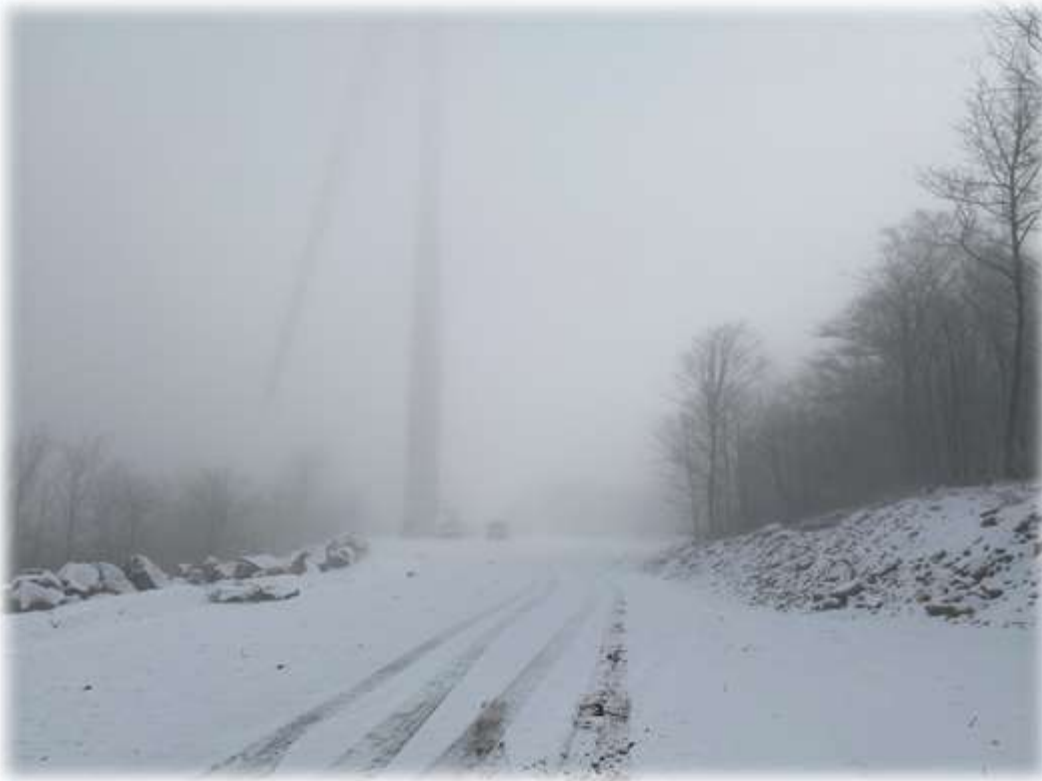
Photo #9: Tower 2 is barely visible in the fog/snow, with 2" of snow covering the entire project area.

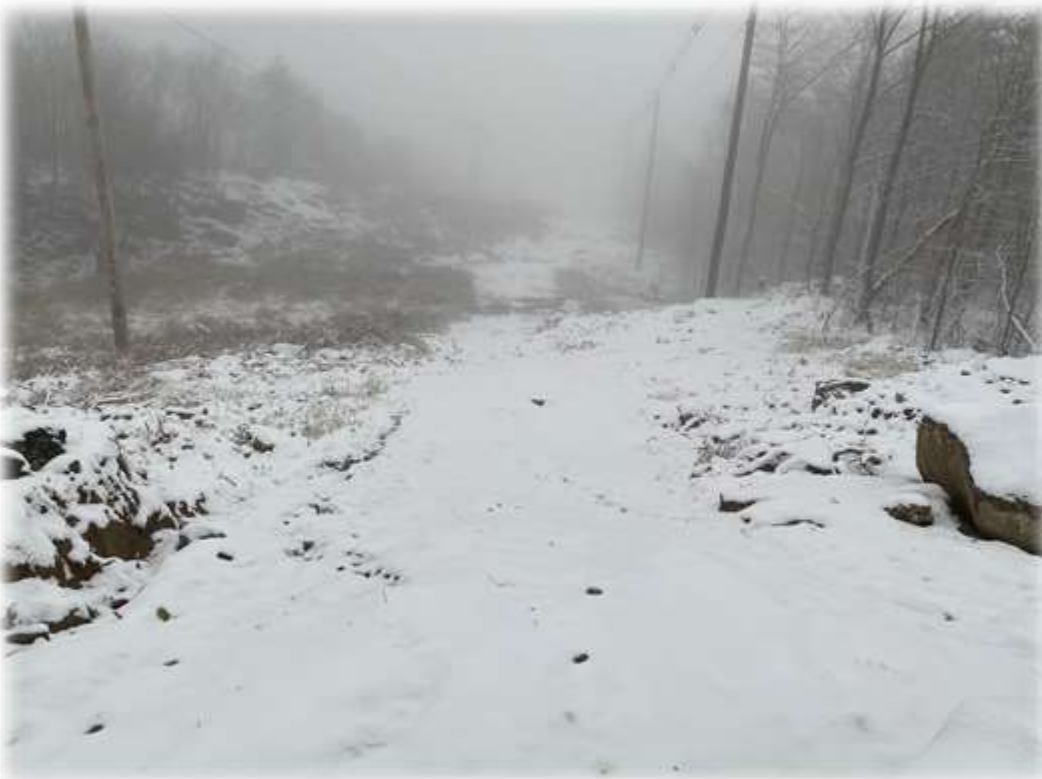
Photo #10: The upper portion of the transmission corridor access road coming into the RoxWind Towers portion of the project has been restored. Water bars have captured and diverted upland areas into stabilized areas. A significant catch of vegetation is becoming established. Some erosion is beginning to occur that should be redirected at the rock barrier along the road.

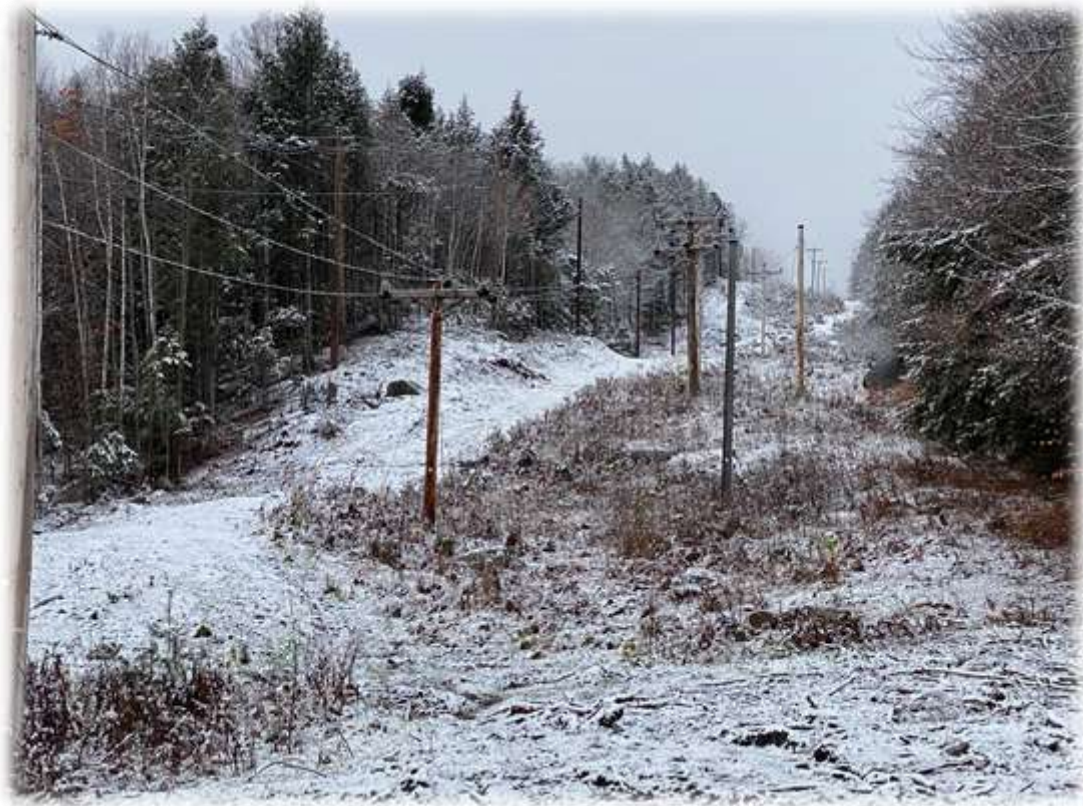
Photo #11: The corridor is snow covered ending any potential growing season for established vegetation.

Underwood Electric has completed restoration of the corridor work. The top $\frac{3}{4}$ of the corridor has significant grass established. The lower quarter is struggling to get vegetation established, but more time is needed (no changes). The Contractor should consider a second application of seed/winter mulch on bare areas.
