# Third Party Inspection Form

| PROJECT NAME/ LOCATION:<br><b>RoxWind Transmission Corridor</b> | DEP #: <b>L-27863-ES-A-N, L-27863-NJ-B-N,<br/>L-27863-TG-C-N</b> |

## Transmission Corridor SCADA building to towers

**Report:** 10

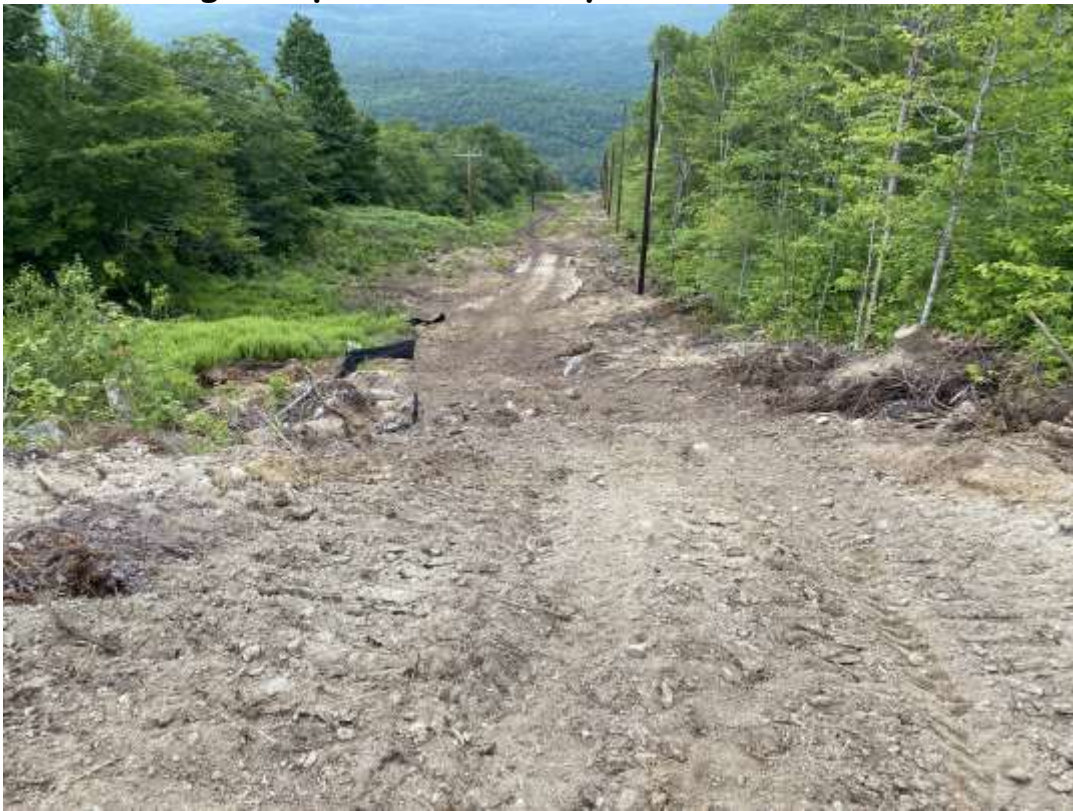
Photo #1: The upper portion of the transmission corridor access road coming into the RoxWind Towers portion of the project has been constructed and structures set. CLT has removed the "danger" trees from the corridor using hand labor and a forwarder. They have re-constructed most of the water bars.

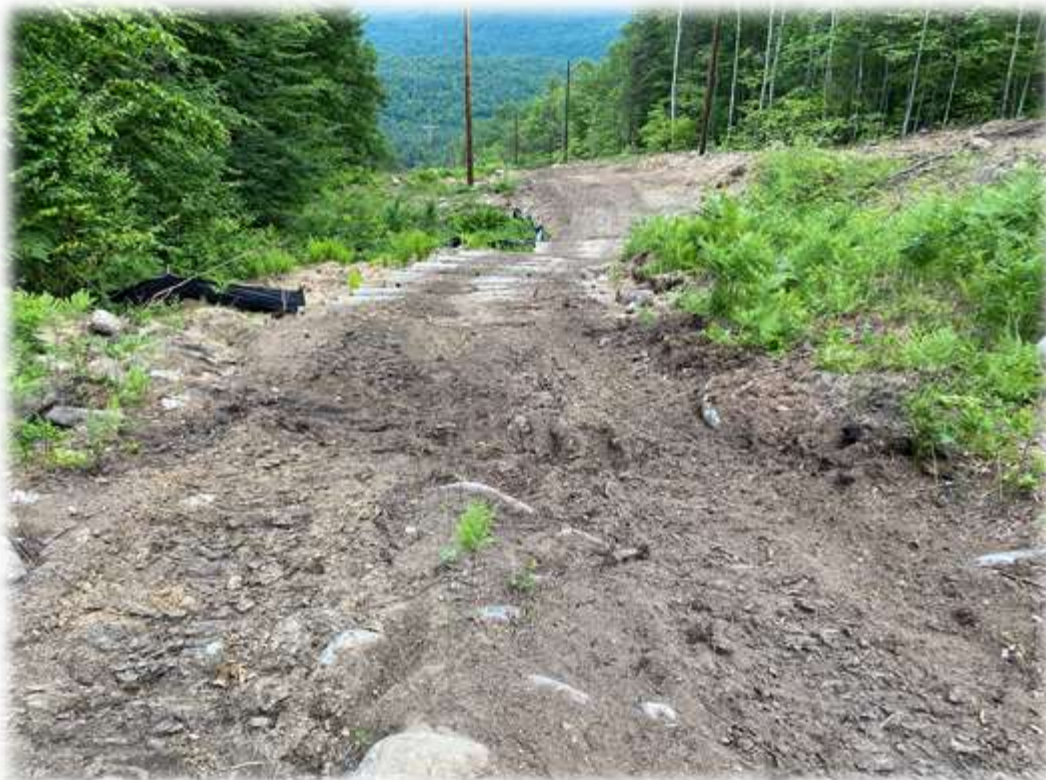
Photo #2: Water bars have been created along the corridor access road. The bars flow to a stabilized area with silt fence barrier to collect potential sediment wash.

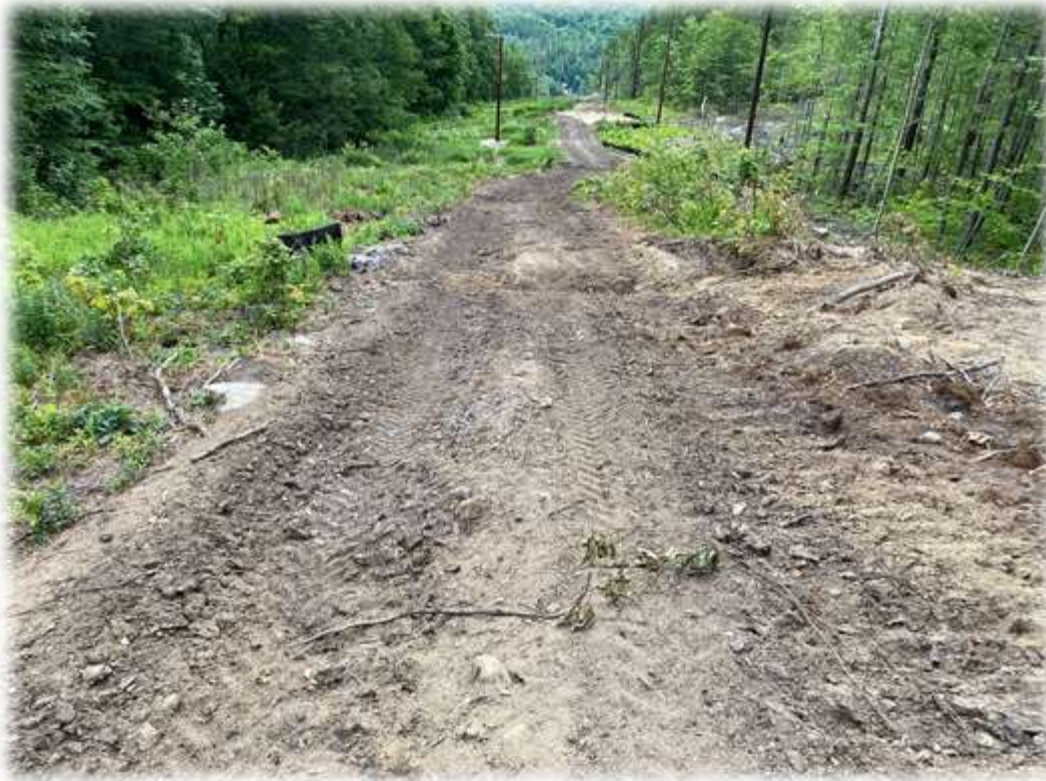
Photo #3: Water bars have been created along the corridor access road. The bars flow to a stabilized area with silt fence barrier to collect potential sediment wash

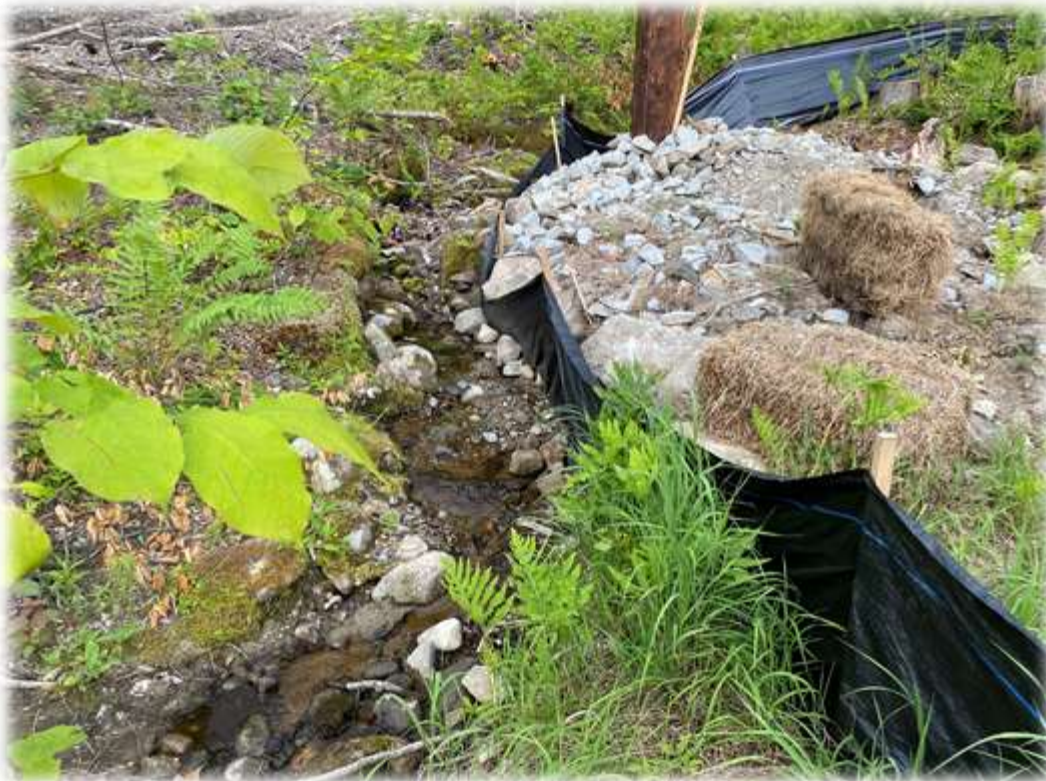
CLT has removed the bridge over the stream as they placed cut trees on abutting property Owner parcel. No impacts to the stream have been noted. No action has been taken on the riprap/rock foundation along Pole 23 (adjacent to the stream bank)

Photo #4: Structure P-23 has been placed along the side of a stream. Silt fence and rock have been placed to minimize impact to the stream. Some of the rock that has fallen into the stream has been removed. No action has been taken regarding removing the silt fence and resulting rock fall into the stream.

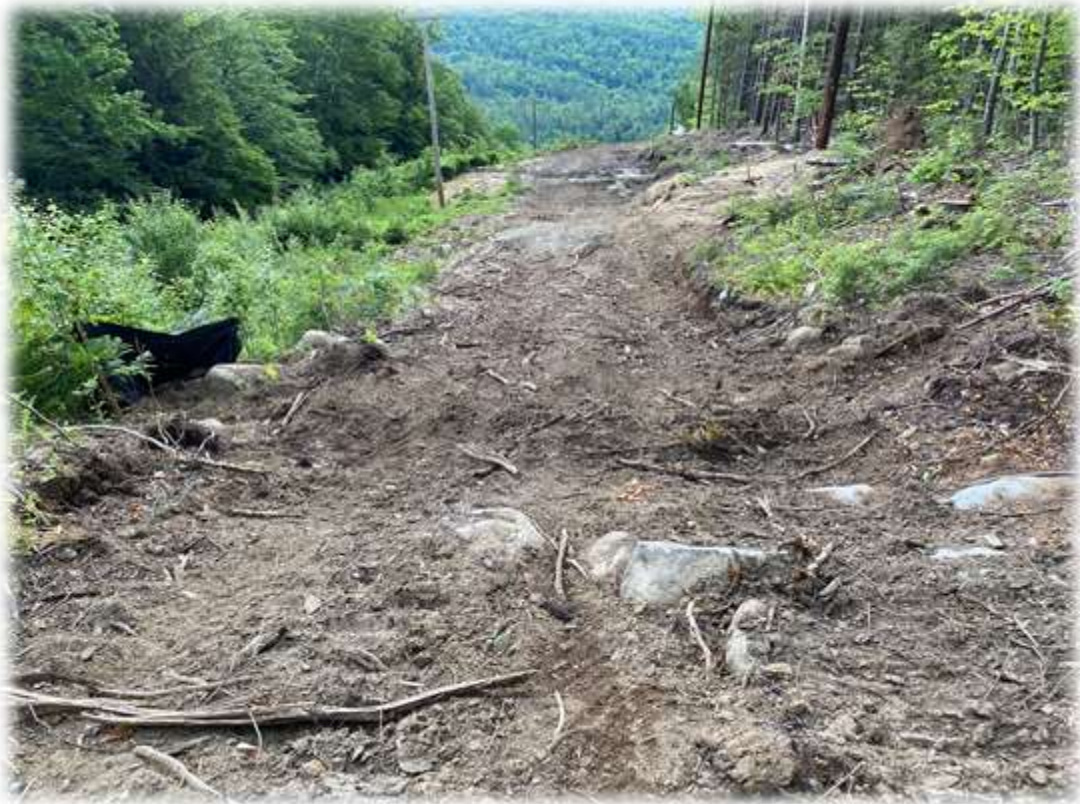
Photo #5: Water bars have been reconstructed and have adequate stabilized outlets.

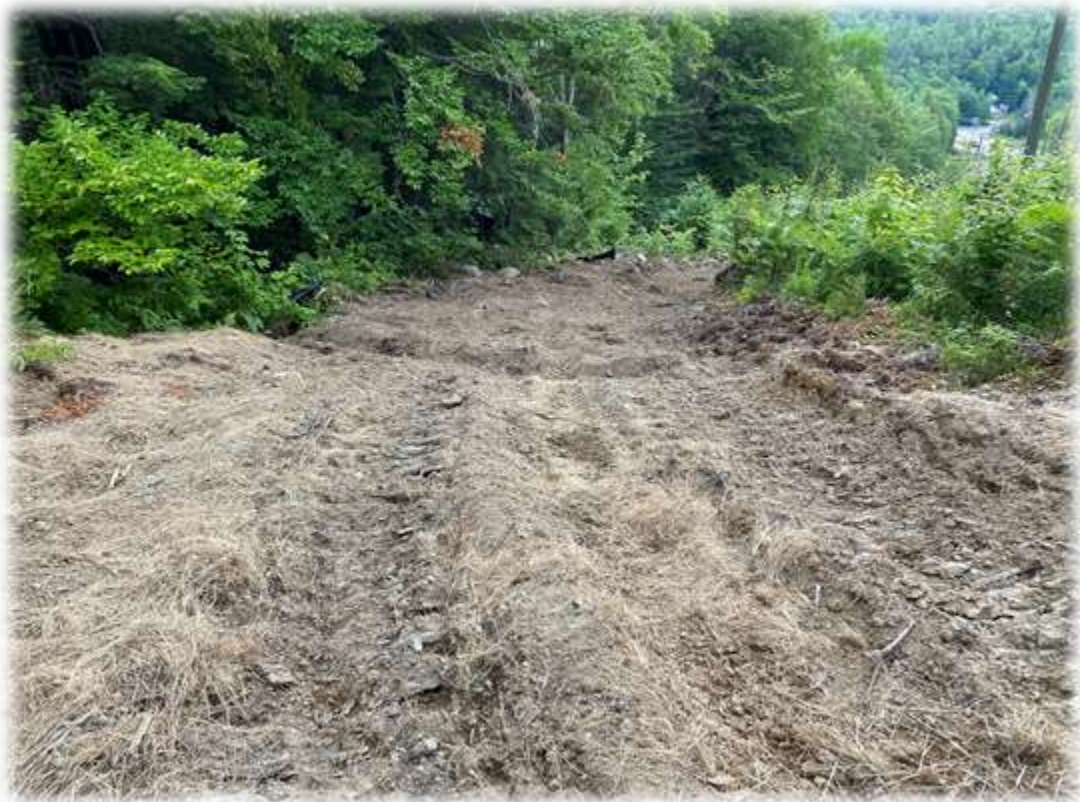
Photo #6: Water bars have been reconstructed and have adequate stabilized outlets.

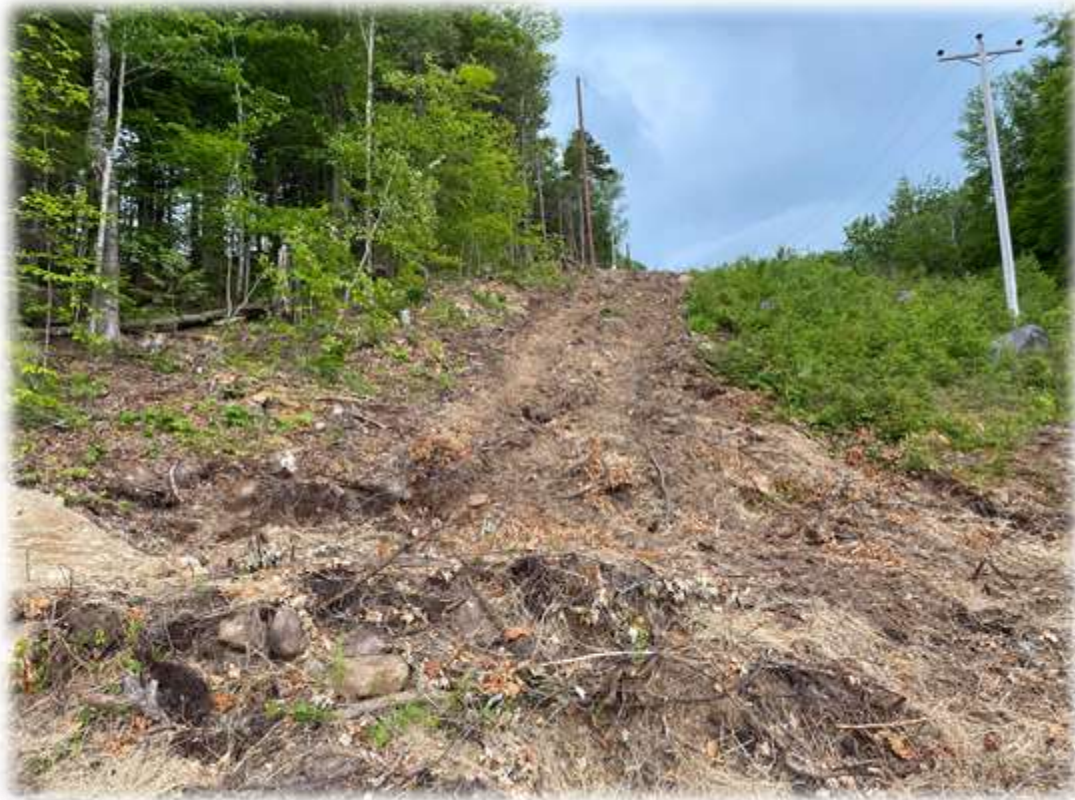
CLT has cut numerous safety "danger" trees along the corridor. They used hand labor for cutting and a forwarder to move material off the corridor. They have regraded most of the water bars as they work themselves out. Disturbed soils have hay mulch placed as necessary, but a section near pole 18 was missed.

Photo #7: CLT has disturbed a new area adjacent to the woods line (near pole 18) that needs hay mulch (work in progress).

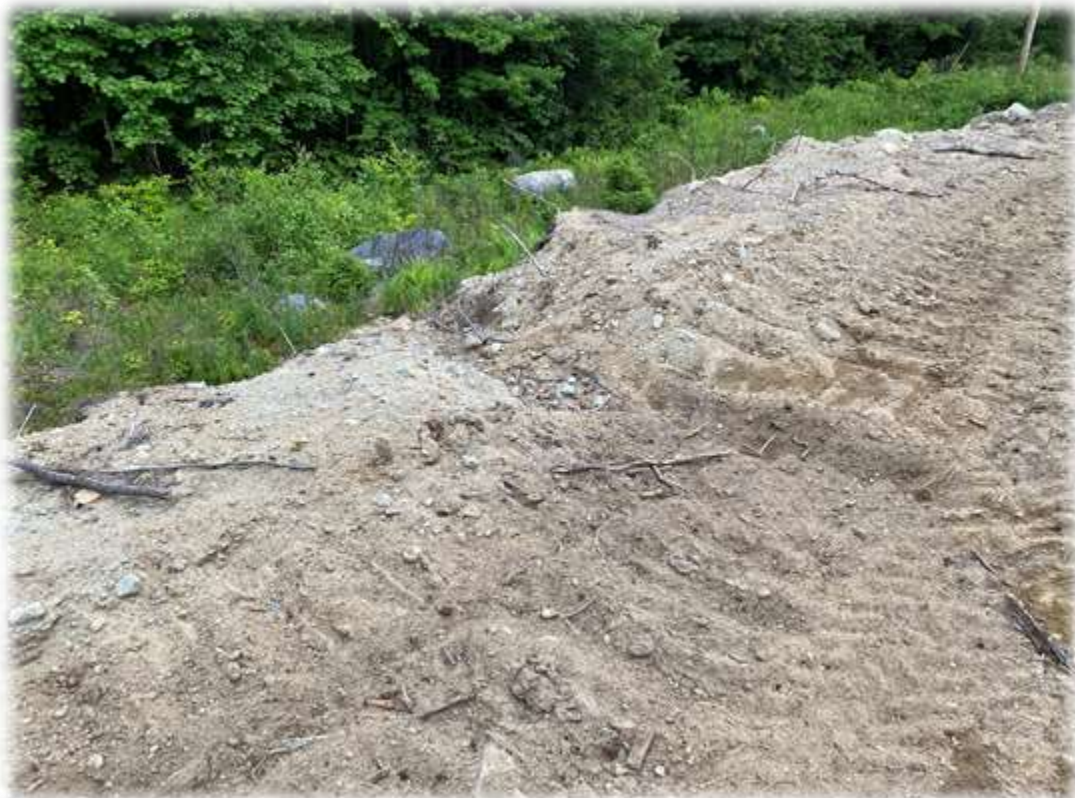
**12. Water Bars:** Water bars have been installed in locations along the corridor access road. These need to be maintained (ongoing work in progress) as equipment traveling cross the bars crush the berms allowing water to continue flowing down the travel path. The distance between the water bars is based on the steepness of the slope. This will help to control washouts of the road during significant rain events. The water bar discharge area has a "capture area" established to collect sediment and filter turbid water. A couple of water bars along the bottom of the corridor do not have a stabilized outlet (capture area).

Photo #8: This area remains stable, but the water bars installed do not have any stabilized outlets. Sediments that are diverted by the bar will flow into vegetated areas and need to be removed.

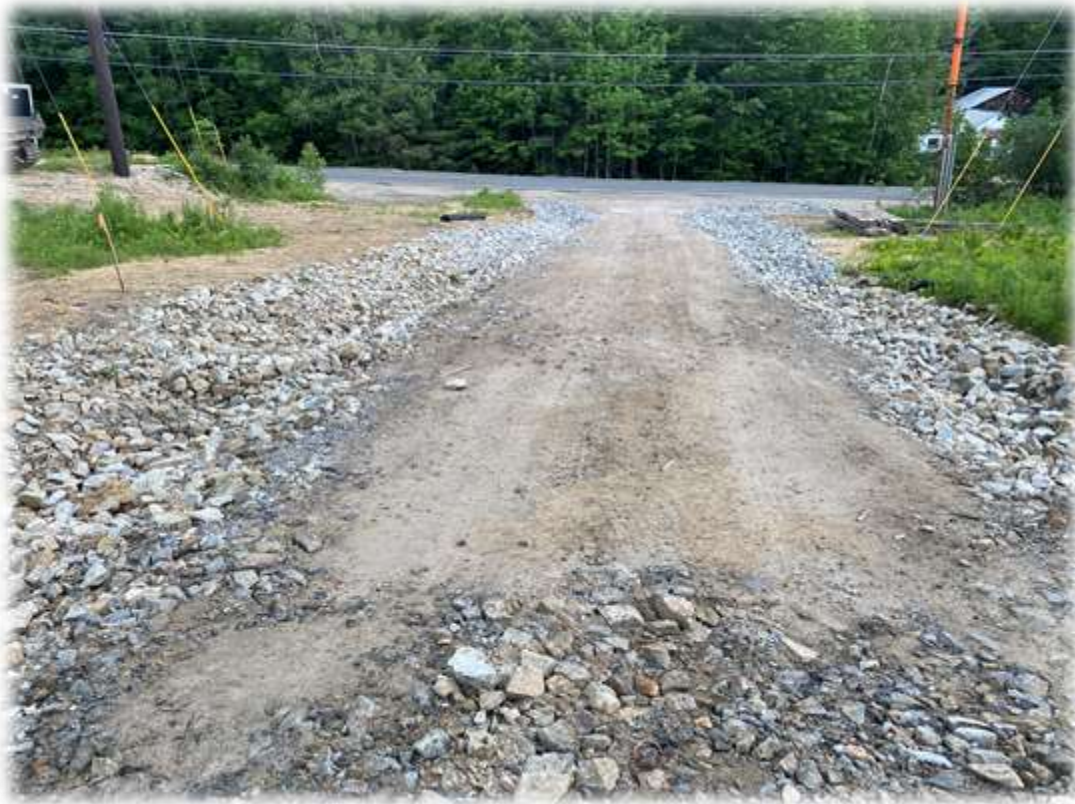
Photo 9: The SCADA driveway has been completed.

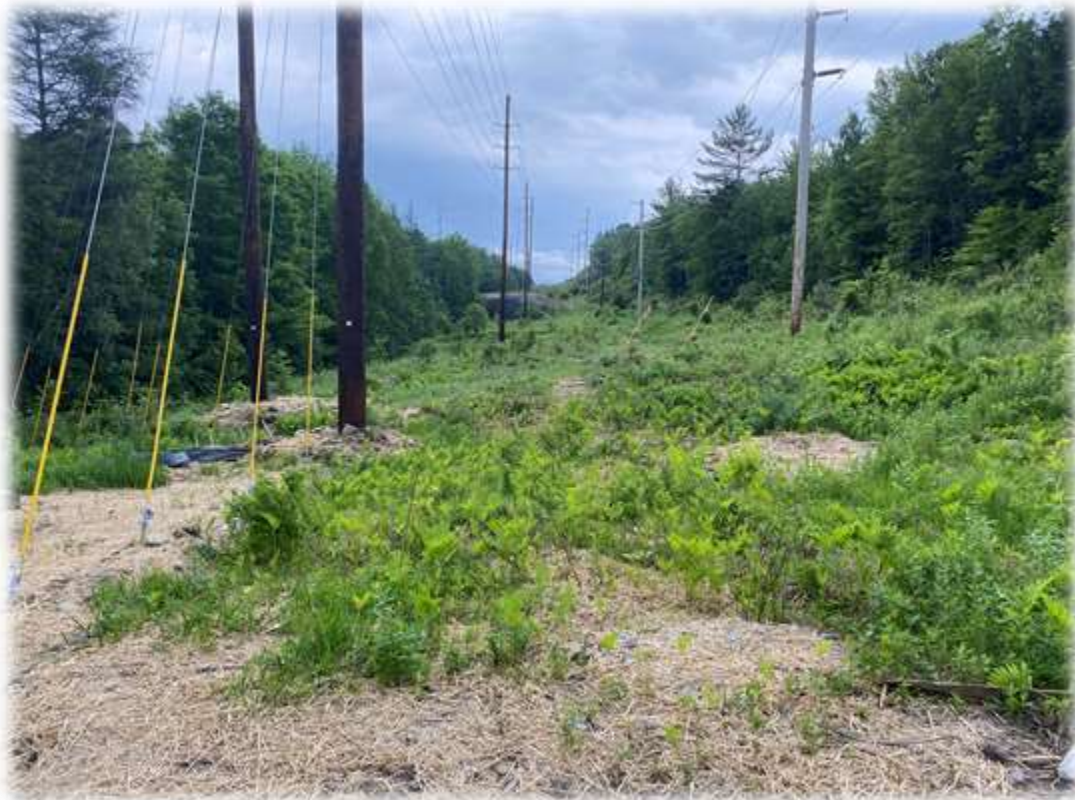
Photo #10: Vegetation is quickly re-establishing itself in the matted section of the corridor towards the substation.

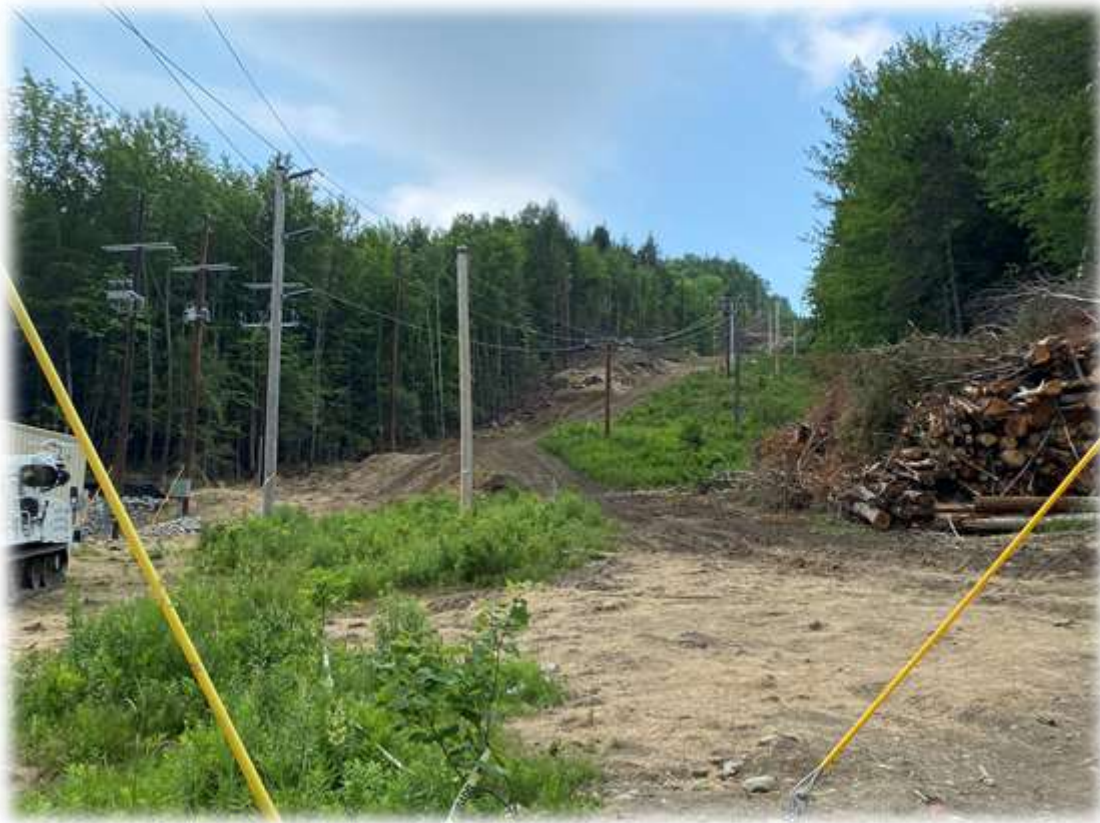
Photo #11: an overview of the lower end of the corridor.
