# Third Party Inspection Form

TO: <b>Erle Townsend, Dawn Hallowell</b>	FROM: <b>Steve Roberge</b>
PROJECT NAME/ LOCATION: <b>RoxWind Transmission Corridor</b>	DEP #: <b>L-27863-ES-A-N, L-27863-NJ-B-N, L-27863-TG-C-N</b>
DATE OF INSPECTION: <b>06-28-2021</b>	DATE OF REPORT: <b>06-28-2021</b>
WEATHER: <b>Cloudy, Lightning 70 deg</b>	CONDITIONS: <b>Good</b>

# RoxWind LLC

## Transmission Corridor SCADA building to towers

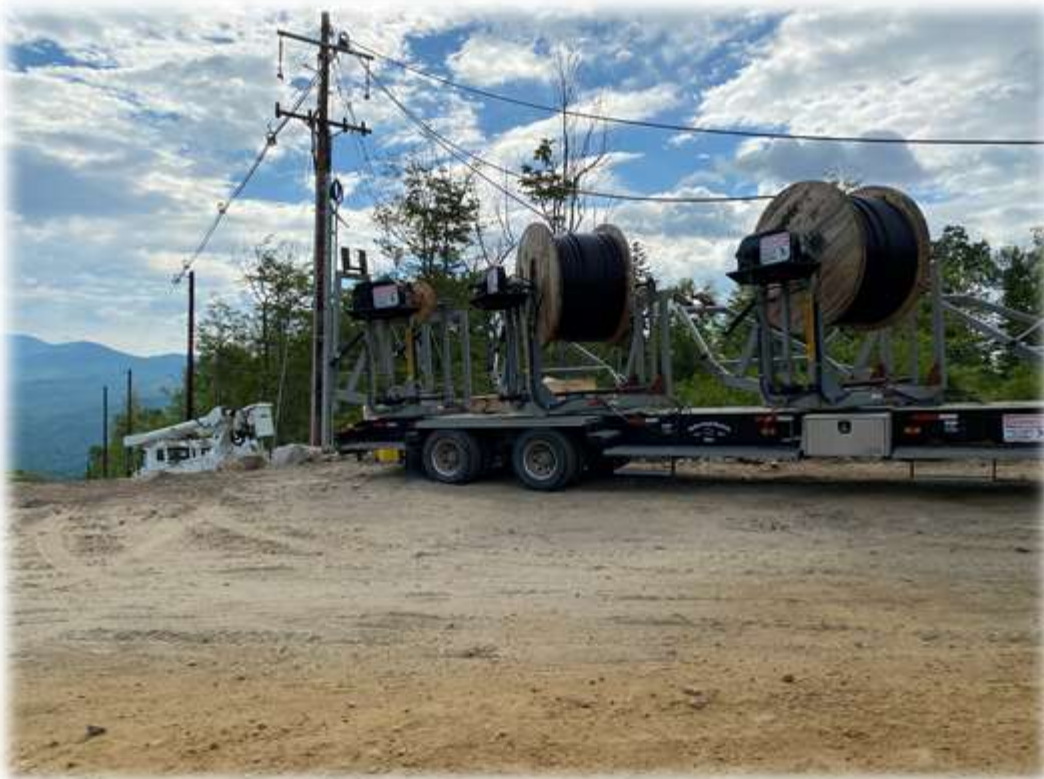
Photo #1: The upper portion of the transmission corridor access road coming into the RoxWind Towers portion of the project has been constructed and structures set. CLT has removed the "danger" trees from the corridor using hand labor and a forwarder. Underwood Electric has pulled ropes from top to bottom of the corridor.

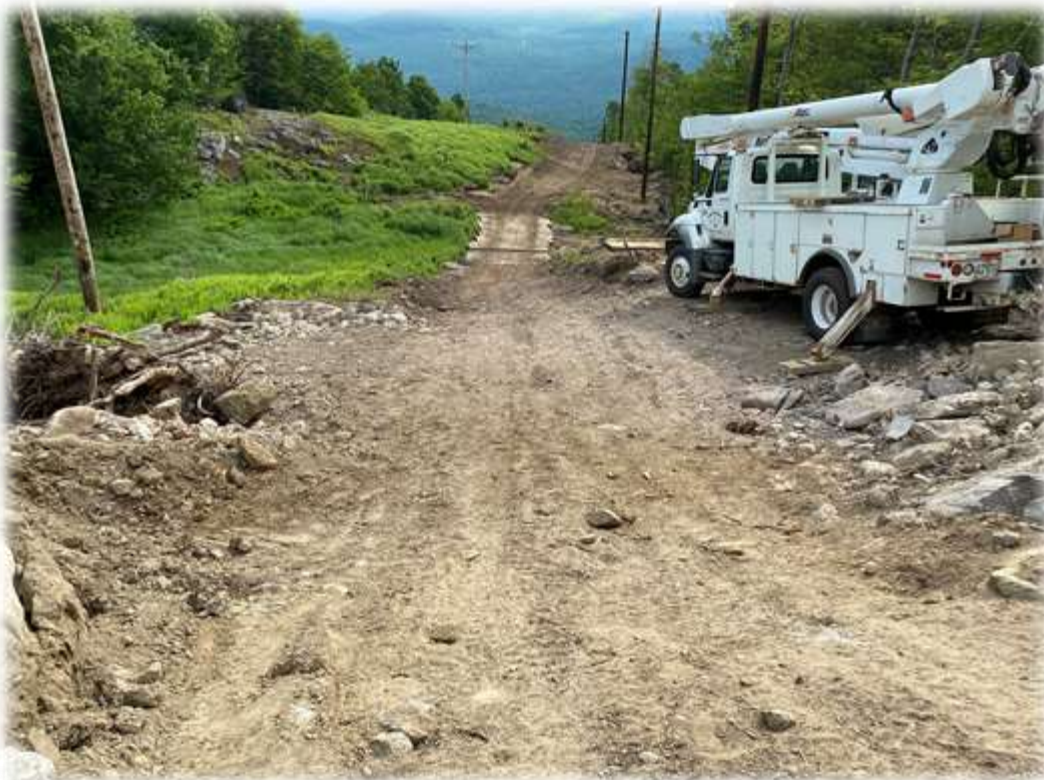
Photo #2: The corridor remains dry, mats have been placed in wetland areas, and disturbed areas mulched.

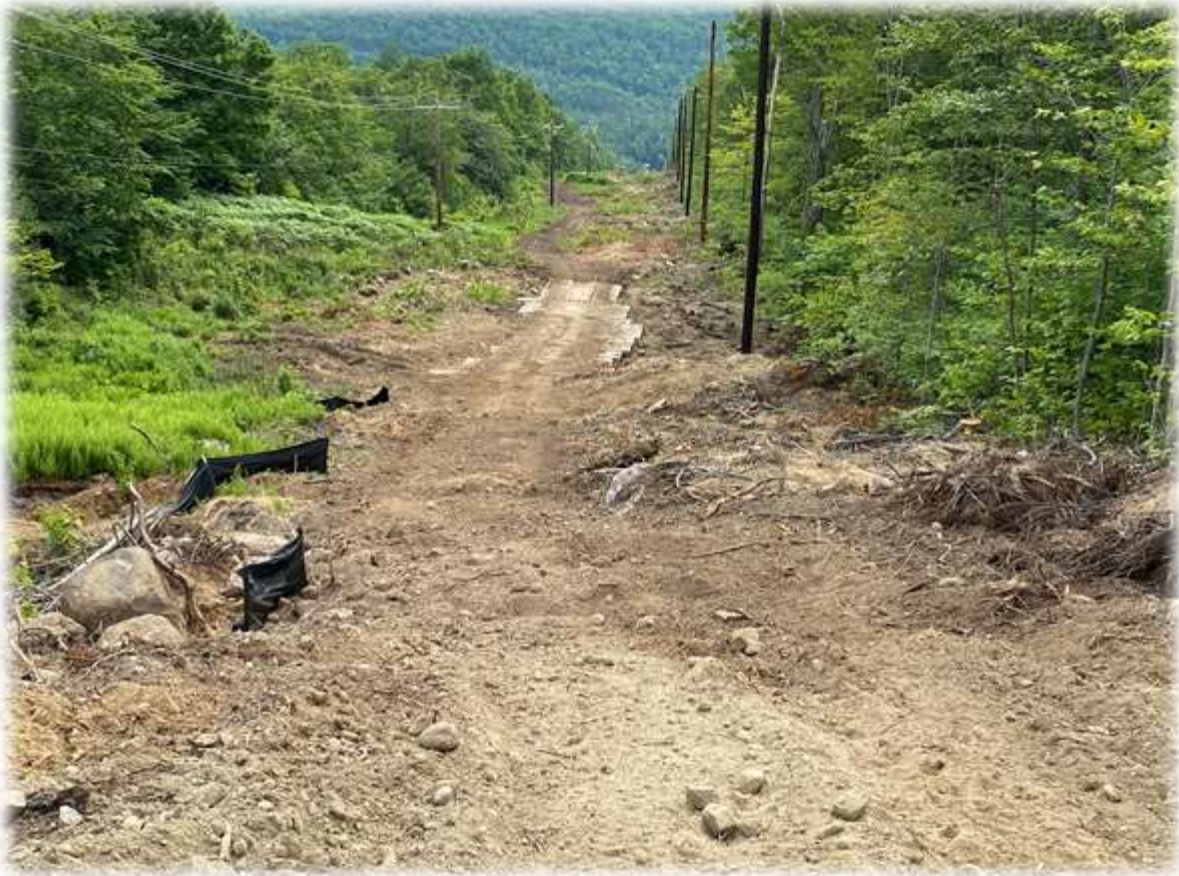
Photo #3: Water bars have been created along the corridor access road. The bars flow to a stabilized area with silt fence barrier to collect potential sediment wash

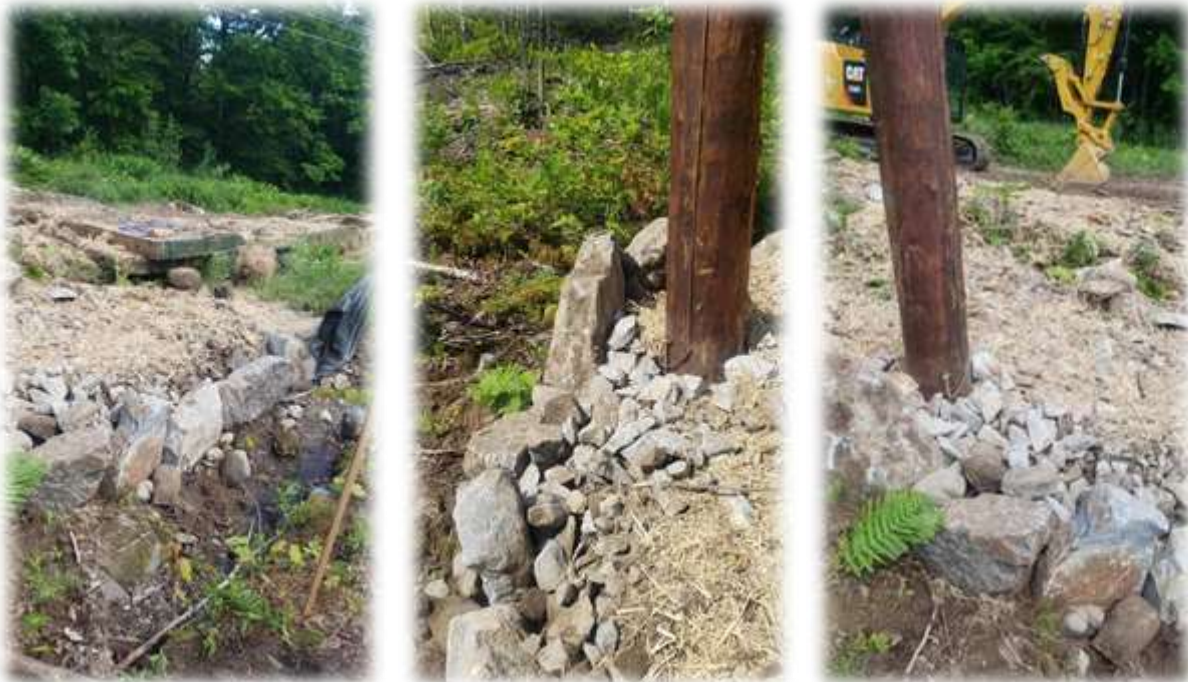
CLT has removed the bridge over the stream as they placed cut trees on abutting property Owner parcel. No impacts to the stream have been noted. Pole 23 (adjacent to the stream bank) has a large rock retaining wall adjacent to the pole and side of stream. It appears as though it will do the job of protecting the structure and allowing water flows to remain in the stream bed.

Photo #4: Structure P-23 has been placed along the side of a stream. Large rock has been placed in retaining wall formation with smaller stone inside the containment area. (Project generated photo from last week)

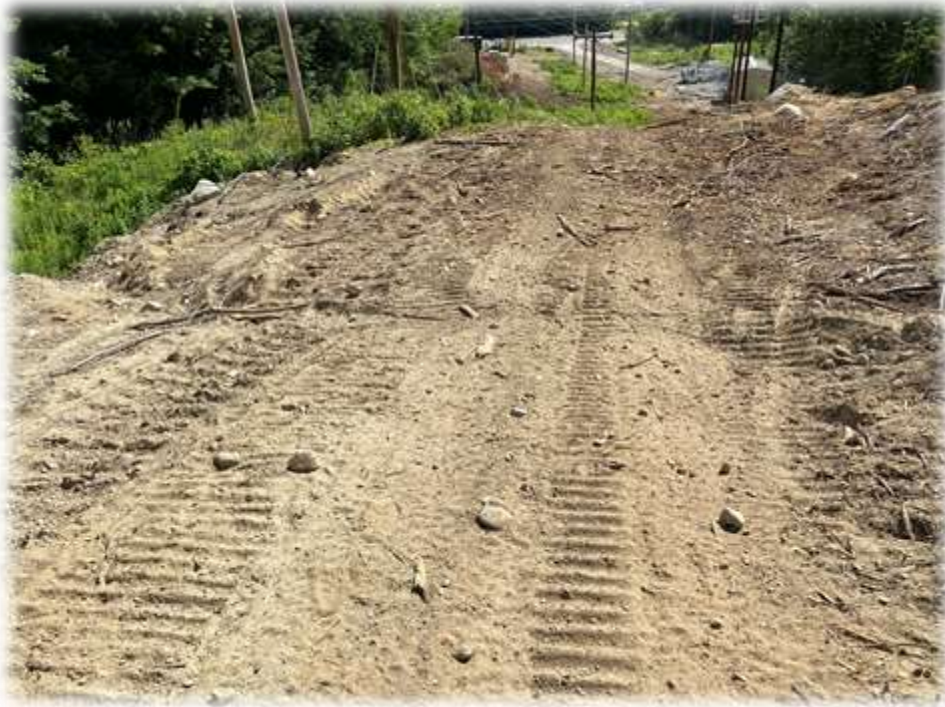
**12. Water Bars:** Water bars have been installed in locations along the corridor access road. These need to be maintained (ongoing work in progress) as equipment traveling cross the bars crush the berms allowing water to continue flowing down the travel path. The distance between the water bars is based on the steepness of the slope. This will help to control washouts of the road during significant rain events. The water bar discharge area has a "capture area" established to collect sediment and filter turbid water. Several of the water bars along the bottom of the corridor do not have a stabilized outlet (capture area).

Photo #5: This area remains stable, but the water bars installed do not have any stabilized outlets. Sediments that are diverted by the bar will flow into vegetated areas and need to be removed.

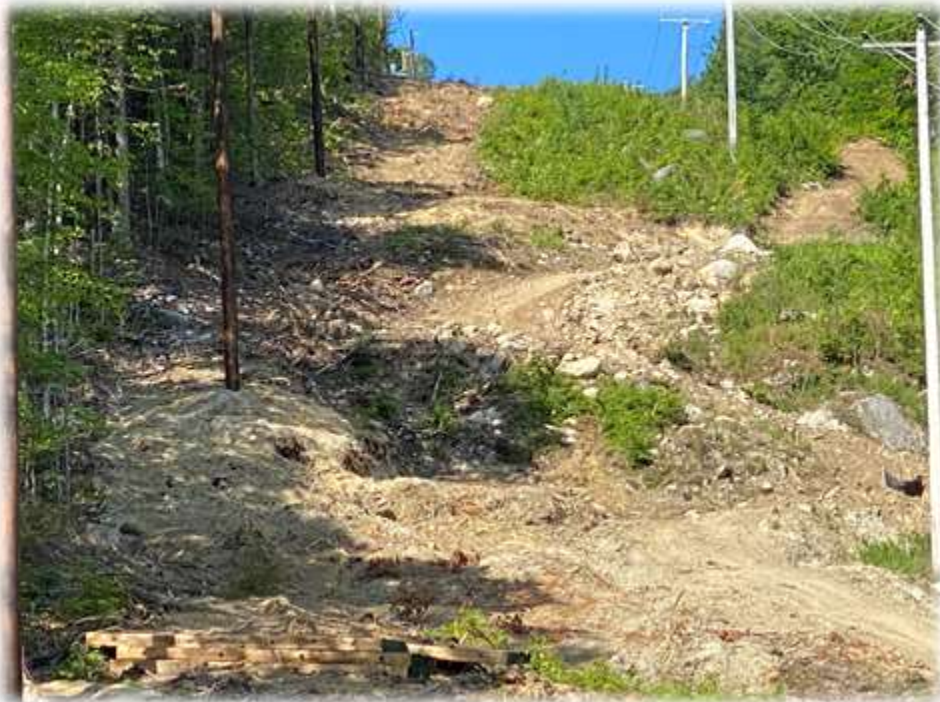
CLT has cut numerous safety "danger" trees along the corridor. They used hand labor for cutting and a forwarder to move material off the corridor. They have regraded most of the water bars as they work themselves out. Disturbed soils have hay mulch placed as necessary, but a section near pole 18 was missed.

Photo #6: CLT has disturbed a new area adjacent to the woods line (near pole 18) that needs hay mulch.

- 1. Environmental flagging/signage:** Environmental resources need to be flagged.(work ongoing hanging the wetland flagging)
- 2. Silt Fencing/ECM Berm:** Silt fencing has been installed and properly keyed into the ground.
- 3. Stabilized Entrance:** The driveway for the SCADA building is completed. Roxbury Road pavement is clear of soil debris.
- 4. Soil stockpile:** No soil stockpiles noted.
- 5. Mulching:** A hay mulch has been placed along disturbed areas of the site. Mulch cover should be enough to cover the ground surface in order for the mulch to work effectively (and still allow adequate sunlight to get vegetation to grow). A section near pole 18 was missed and needs additional mulch placed on the steep slope.
