Third Party Inspection Form

| PROJECT NAME/ LOCATION: RoxWind Transmission Corridor | DEP #: L-27863-ES-A-N, L-27863-NJ-B-N, L-27863-TG-C-N |

Transmission Corridor SCADA building to towers

Report: 14

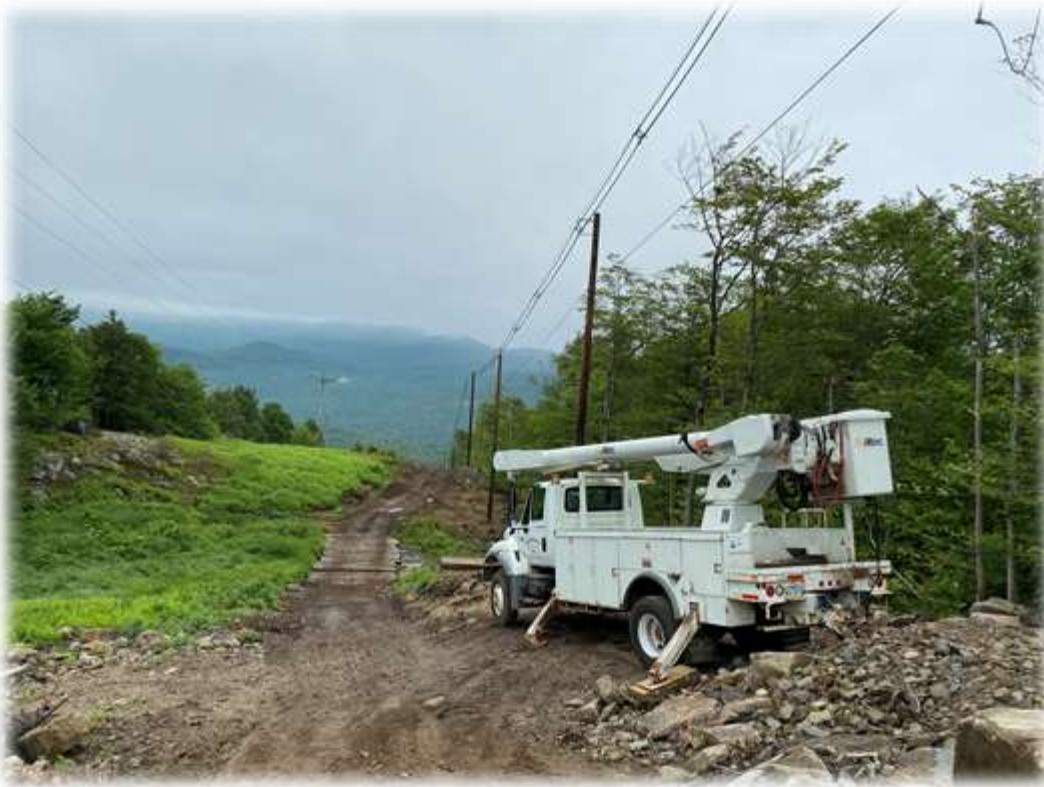
Photo #1: The upper portion of the transmission corridor access road coming into the RoxWind Towers portion of the project has been constructed and structures set. The corridor is damp and shows some areas of erosion along the travel path. The bars have captured and diverted these areas into stabilized areas.

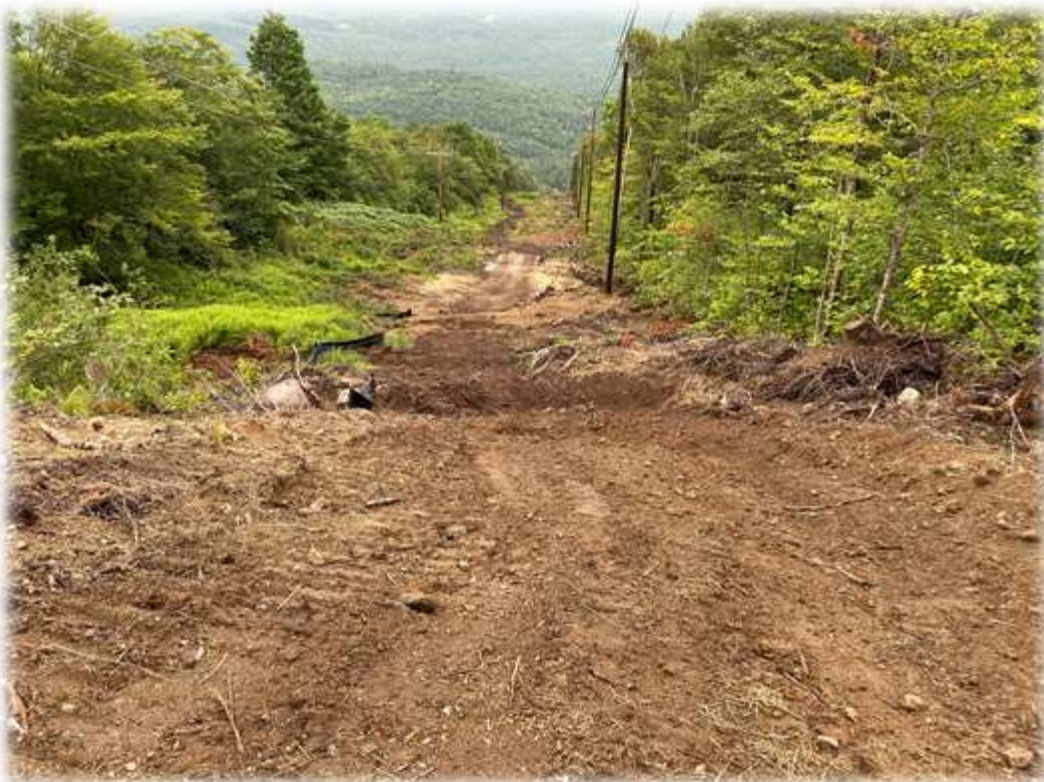
Photo #2: Water bars have been created along the corridor access road. The bars flow to a stabilized area with silt fence barrier to collect potential sediment wash

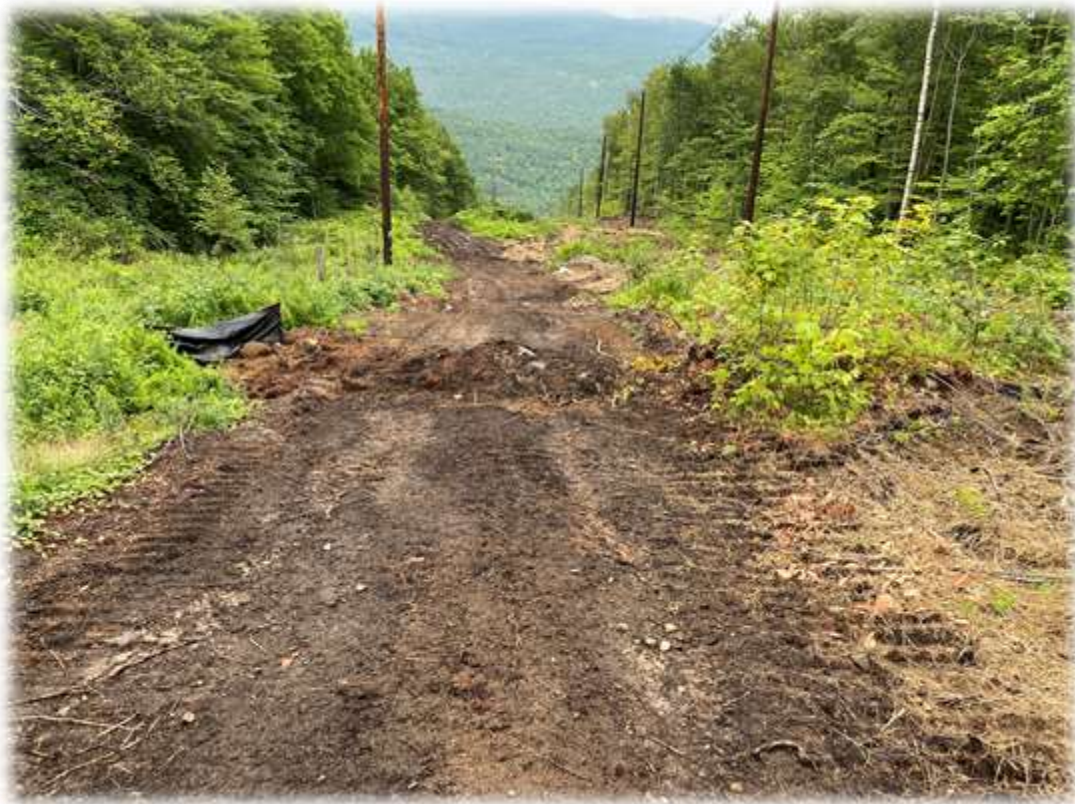
Photo #3: Water bars have been created to divert runoff water into stabilized areas.

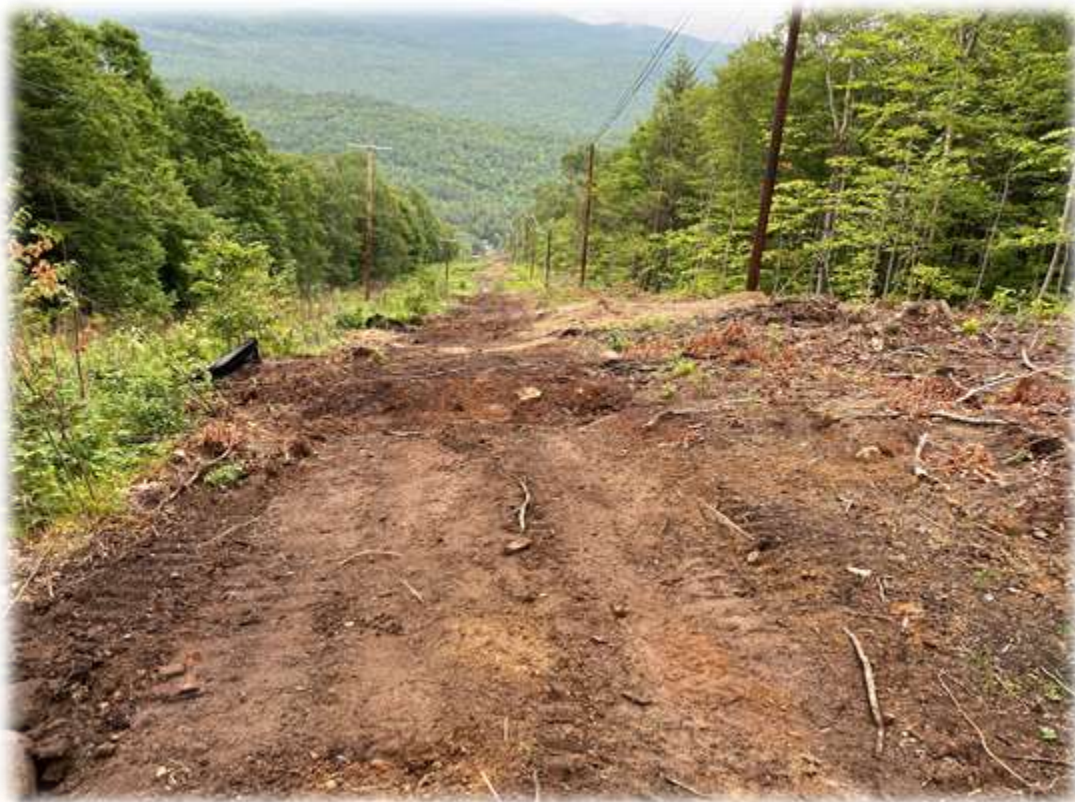
Photo #4: Water bars along the travel path have intercepted flows and diverted it into stabilized outlet areas.

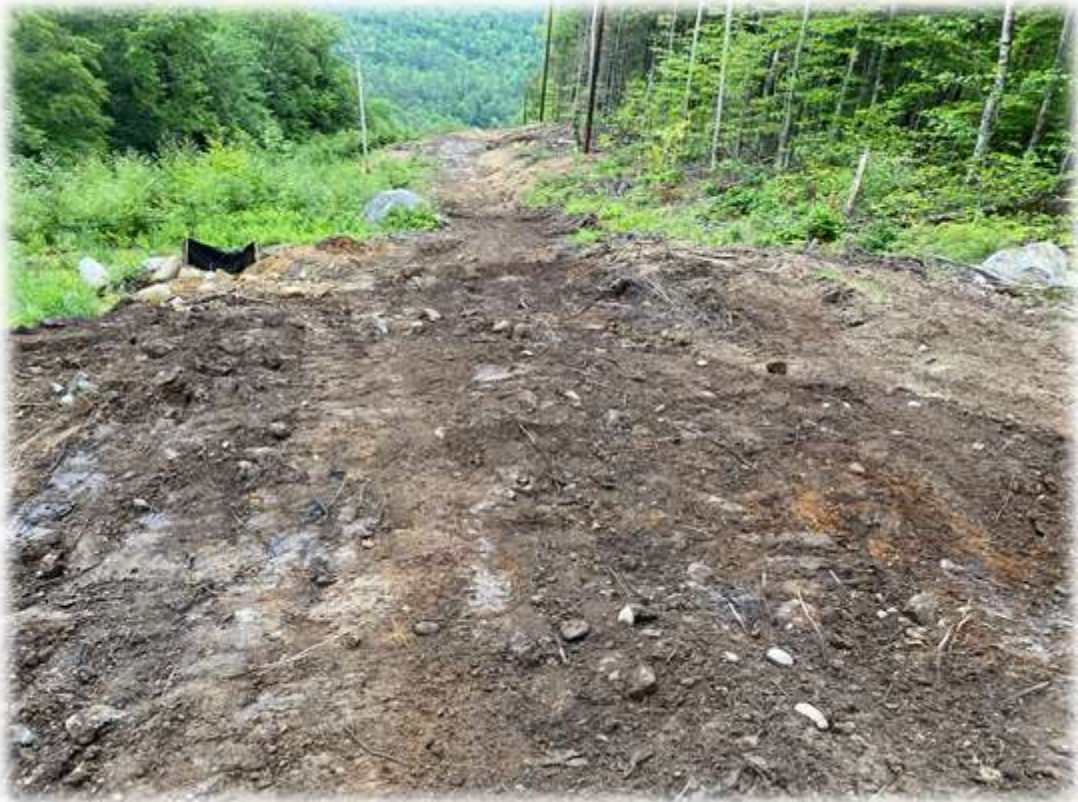
Photo #5: All water bars have been repaired (maintenance) and the collected sediment removed from the stabilized outlet.

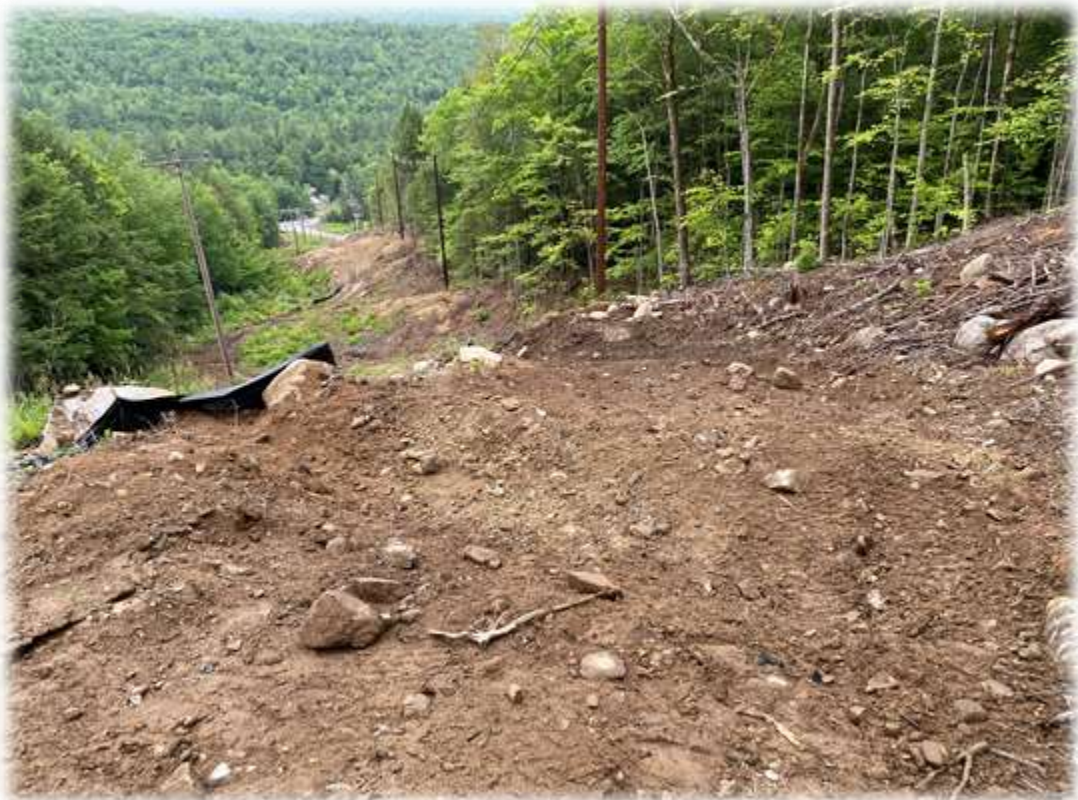
Photo #6: Water bars along the travel path have intercepted flows and diverted it into stabilized outlet areas. The water bars have been repaired (maintenance) and the collected sediment removed from the stabilized outlet.

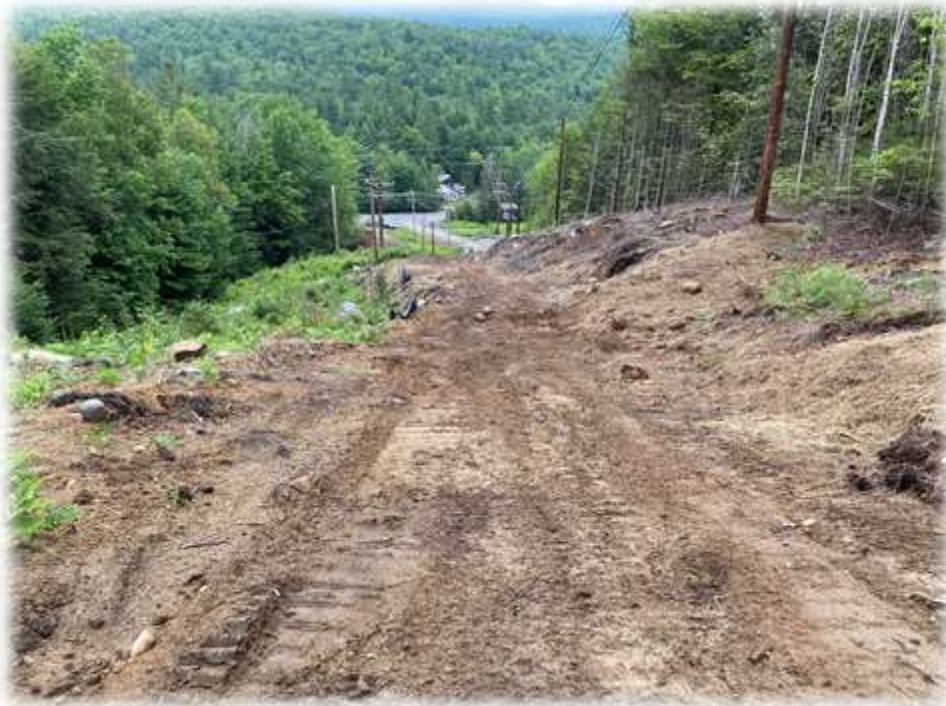
Photo #7: Water bars along the travel path have intercepted flows and diverted it into stabilized outlet areas. The water bars have been repaired (maintenance) and the collected sediment removed from the stabilized outlet.

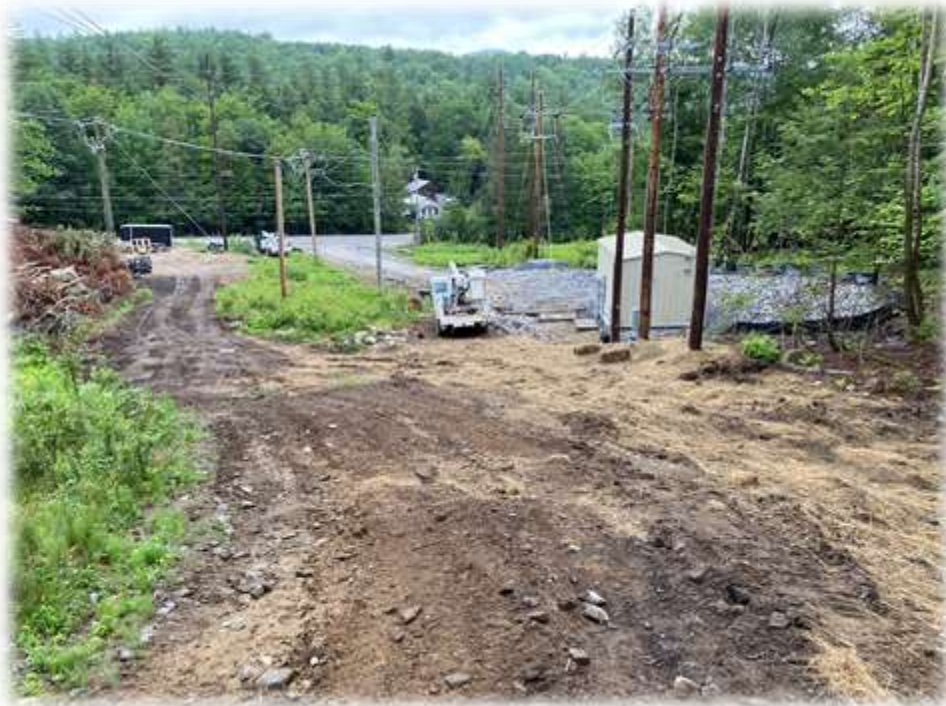
Photo # 8: The SCADA Building and driveway area remain secure and stabilized.
