Third Party Inspection Form

TO: Erle Townsend, Dawn Hallowell, Bill Goggin (CMP) PROJECT NAME/ LOCATION: RoxWind Transmission Corridor DATE OF INSPECTION: 04-21-2021 WEATHER: Clouds, 45 deg,	FROM: Steve Roberge DEP #: L-27863-ES-A-N, L-27863-NJ-B-N, L-27863-TG-C-N DATE OF REPORT: 04-21-2021 CONDITIONS: Good
--	--

RoxWind LLC

Transmission Corridor to RoxWind towers

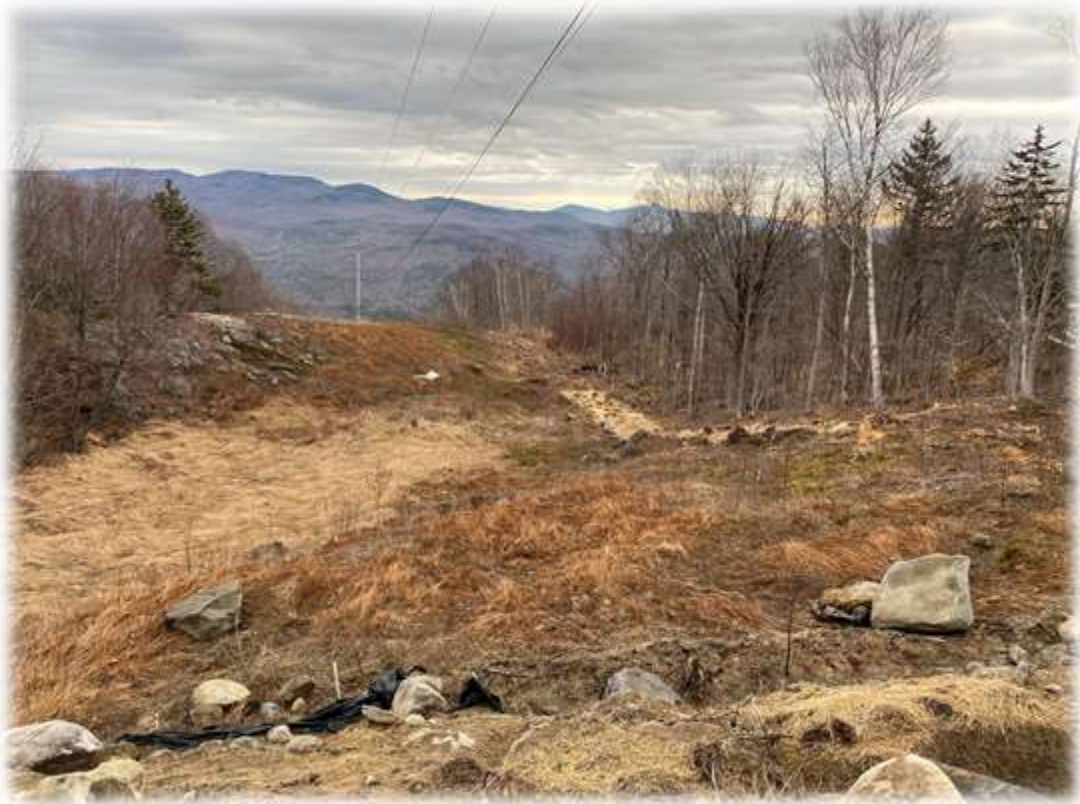
Photo #1: Cut/cleared areas along the existing transmission line have been completed to the top of the mountain (tower 1 location).

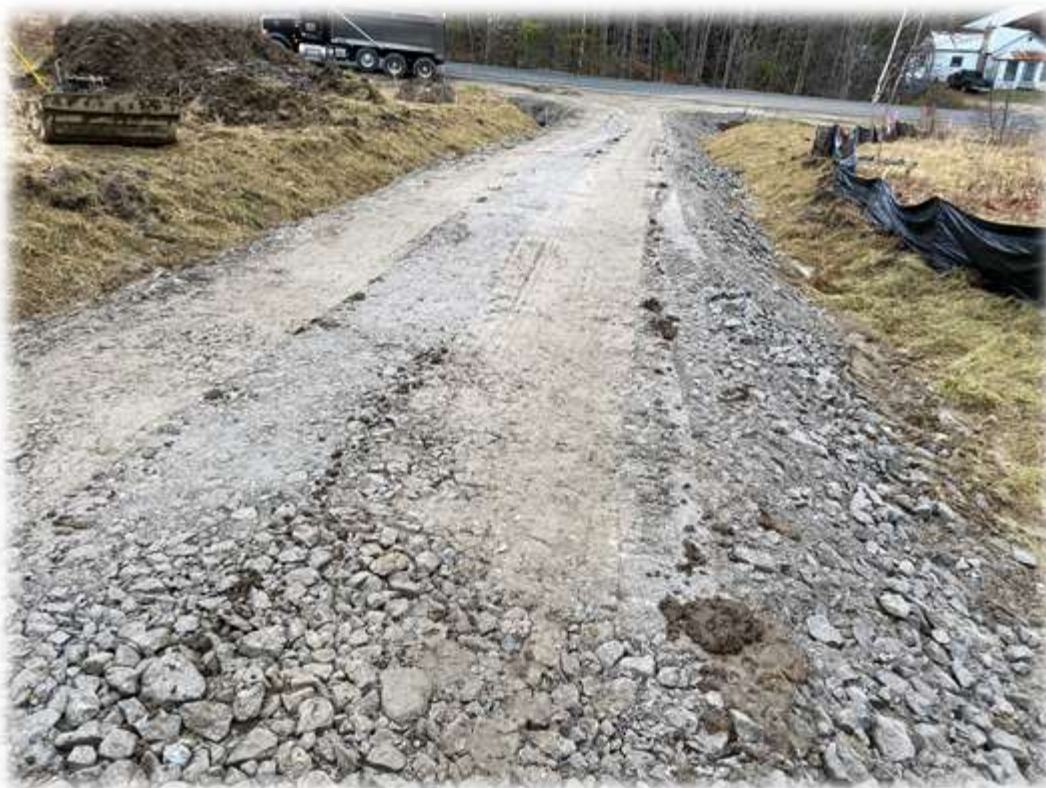
9. **Stone/ECM Check Dam:** Temporary stone check dams have been installed along both side ditches to the driveway.
10. **Culverts/Riprap:** An entrance culvert has been installed. No inlet outlet protection has been installed to date (work in progress).

14. Ditches/Swales: Ditches for the SCADA driveway have been cut. Fabric and riprap will be placed this week.

Photo #2: The gravel base material is being installed for the SCADA building driveway. Ditches have been cut and sideslopes heavily hay mulched. Temporary stone check dams have been placed until the fabric/riprap lining on the ditches can be installed.

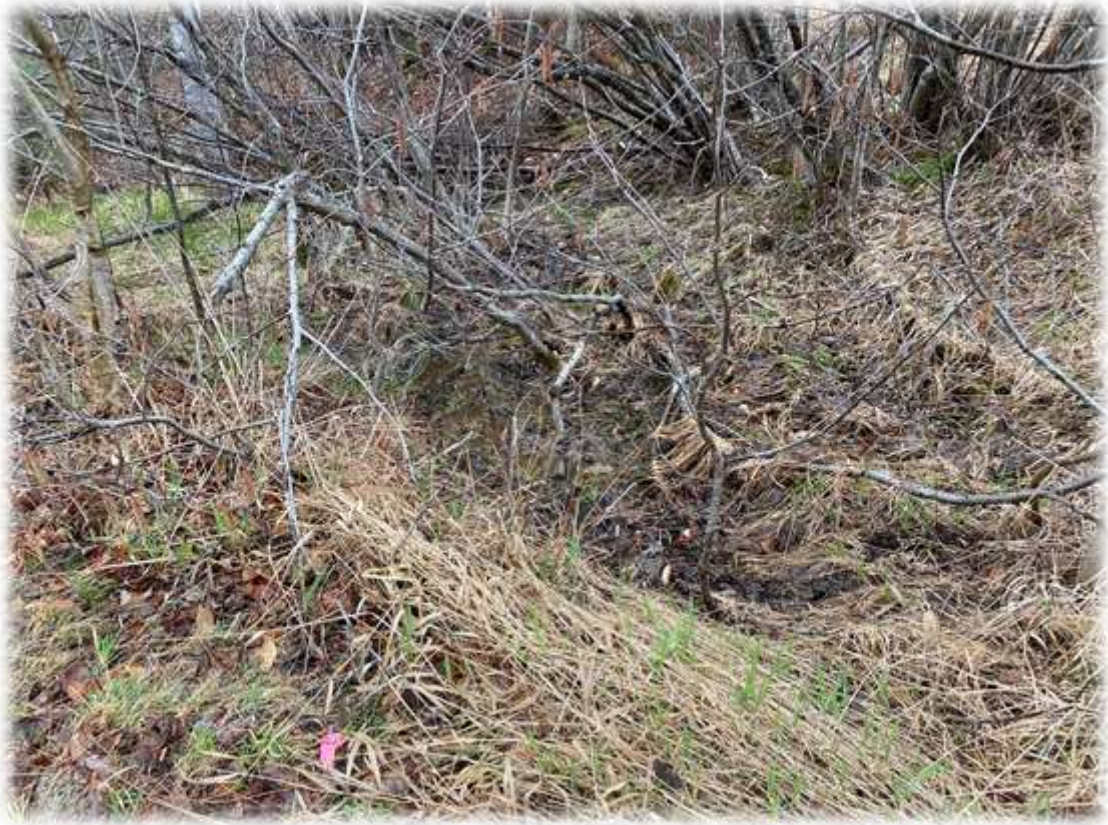
Construction "Work in Progress" Narrative: Sargent is onsite constructing the driveway to the SCADA building. Environmental controls have been installed and the driveway is to be completed by the end of week. The downslope drainage area (wetland) has clear water.

Photo #3: Water within the adjacent downslope wetland is clear.
