# Third Party Inspection Form

TO: <b>Erle Townsend, Dawn Hallowell, Bill Goggin (CMP)</b>	FROM: <b>Steve Roberge</b>
PROJECT NAME/ LOCATION: <b>RoxWind Transmission Corridor</b>	DEP #: <b>L-27863-ES-A-N, L-27863-NJ-B-N, L-27863-TG-C-N</b>
DATE OF INSPECTION: <b>04-26-2021</b>	DATE OF REPORT: <b>04-26-2021</b>
WEATHER: <b>Clouds, 31 deg, Wind</b>	CONDITIONS: <b>Good</b>

# RoxWind LLC

## Transmission Corridor to RoxWind towers

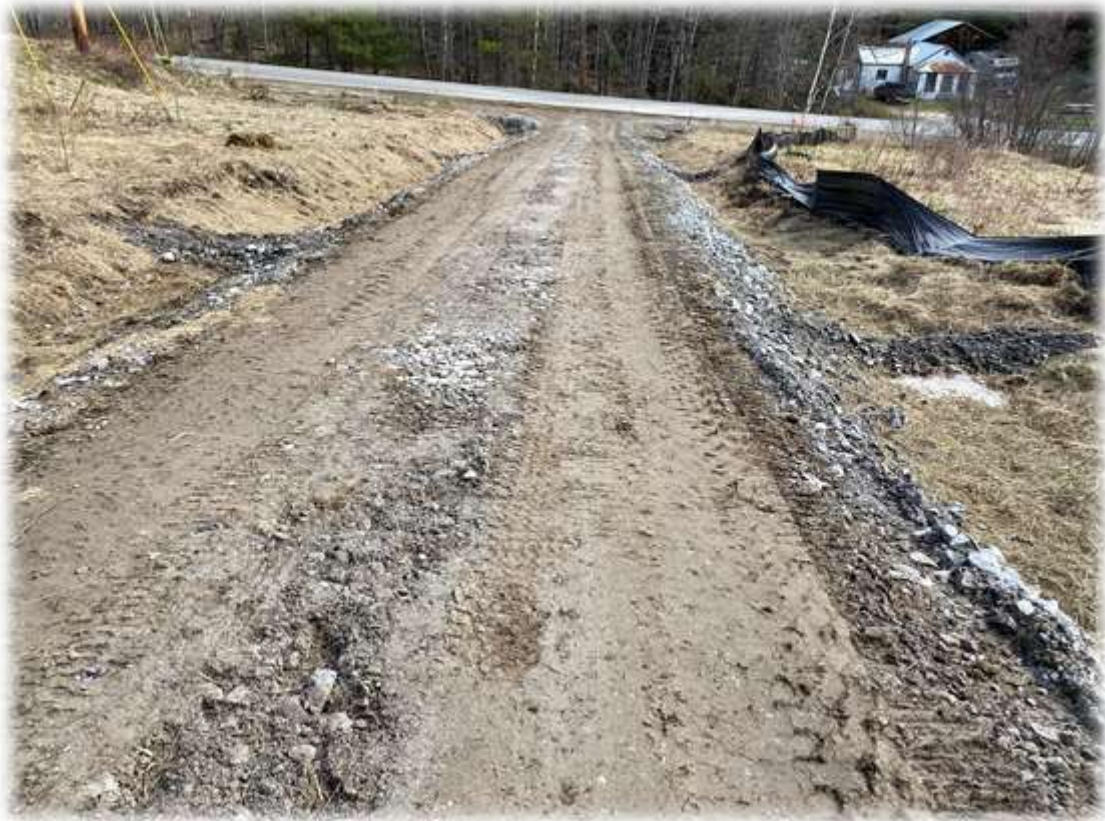
Photo #1: The gravel base material has been installed for the SCADA building driveway. Ditches have been cut and sideslopes heavily hay mulched. Temporary stone check dams have been placed until the fabric/riprap lining on the ditches can be installed.

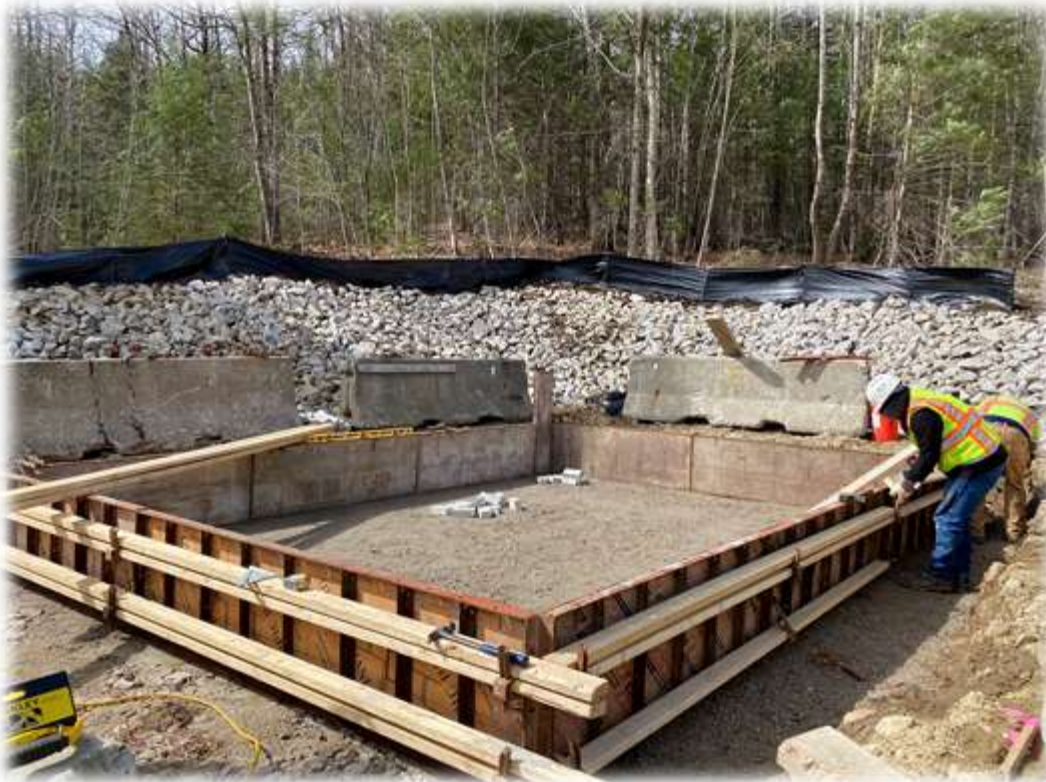
Photo #2: Sargent has completed excavation for the SCADA building and placed a gravel pad for forming the slab. Riprap on fabric was placed along the upslope face of excavation.

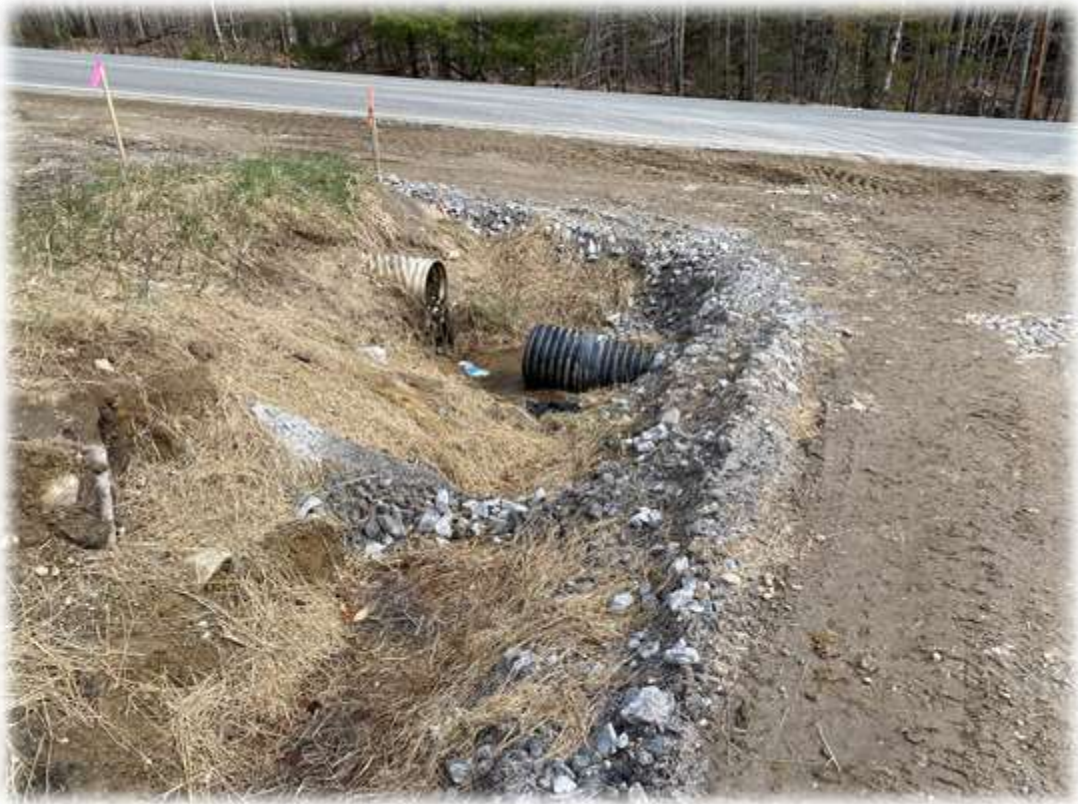
9. **Stone/ECM Check Dam:** Temporary stone check dams have been installed along both side ditches to the driveway.
10. **Culverts/Riprap:** An entrance culvert has been installed. No inlet outlet protection has been installed to date (work in progress).

Photo #3: Riprap on fabric protection needs to be installed at the inlet/outlet to the driveway culvert at the entrance to Roxbury Road.

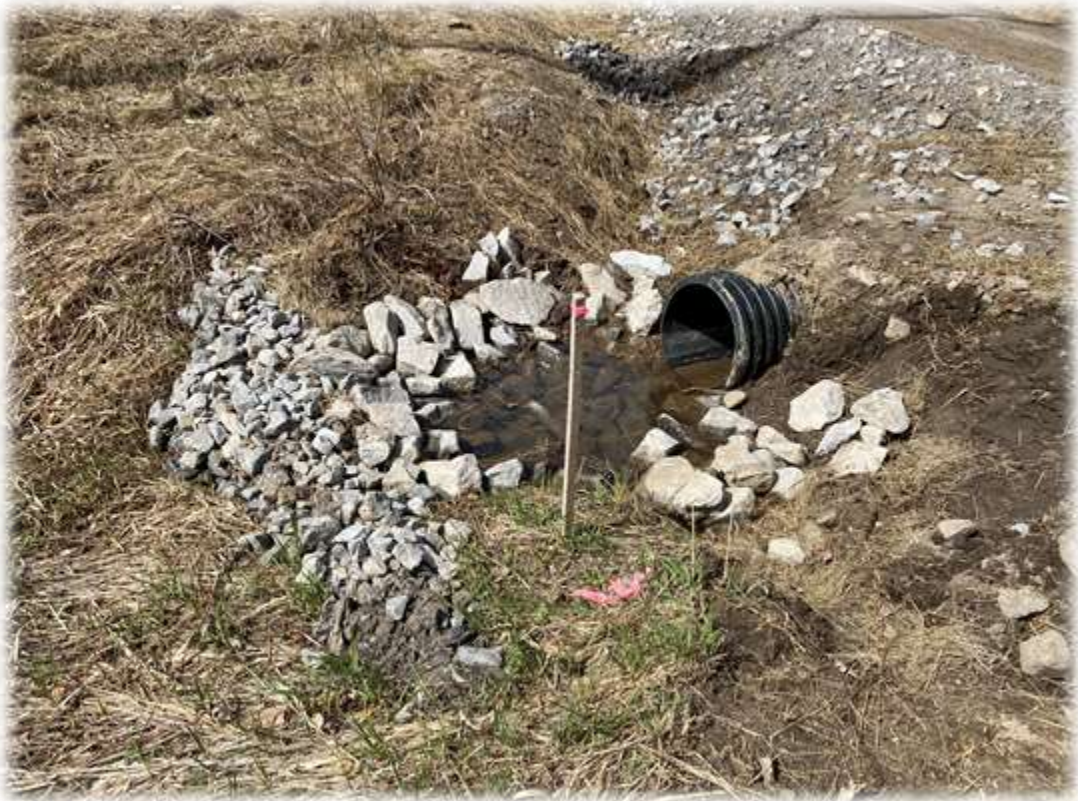
Photo #4: The driveway culvert outlet has clear water as it discharges towards a downslope stream.

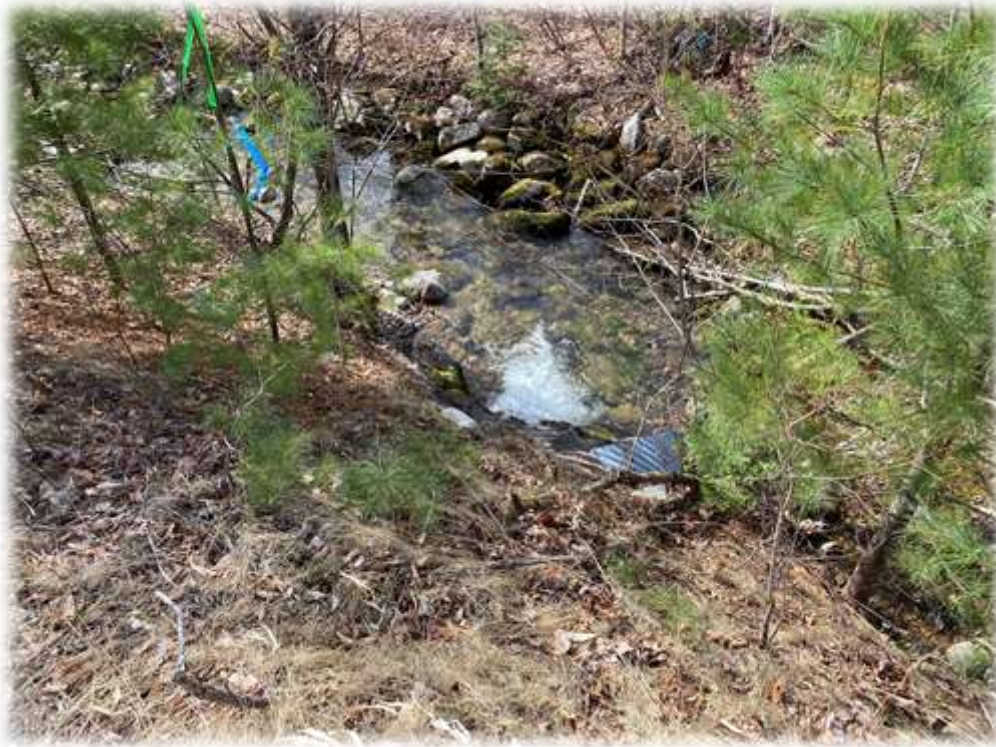
Photo #5: A downslope stream beyond the driveway has very clear water.

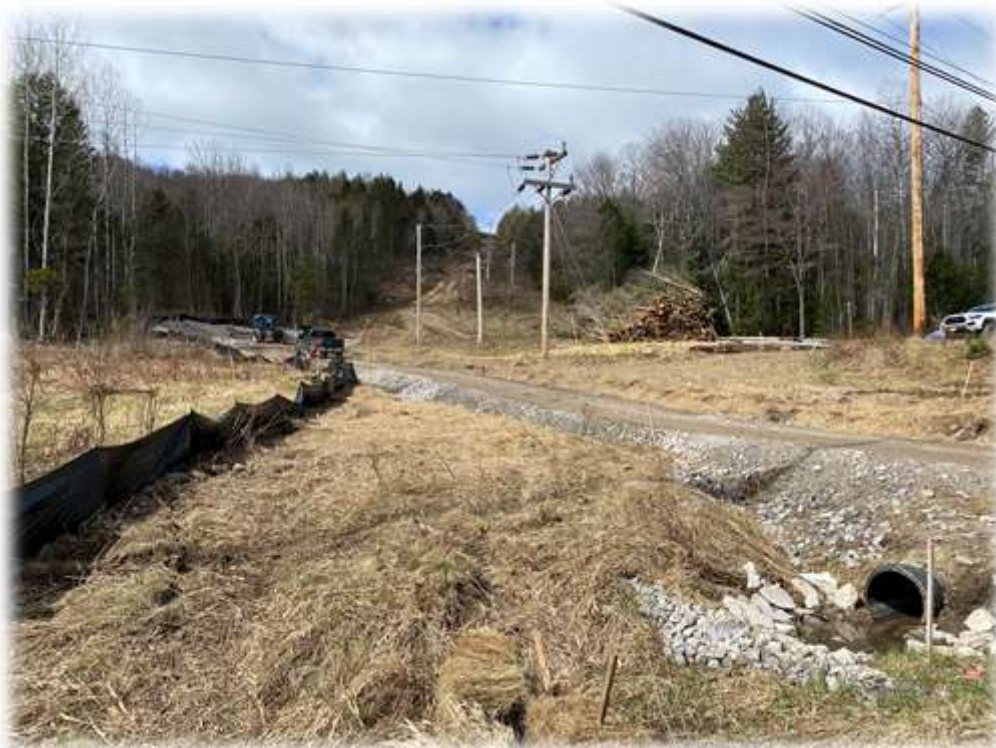
**23. Areas currently under construction/disturbance:** The entire corridor area has been cut/cleared of trees. Due to the wetness of the mountain the project transmission line work remains in winter shutdown mode. All cleared areas have been cut/cleared/stacked.

Photo #6: The view up the corridor as seen from Roxbury Road...No work has been performed along the corridor this construction season (too wet).
