# Third Party Inspection Form

TO: <b>Erle Townsend, Dawn Hallowell, Bill Goggin (CMP)</b>	FROM: <b>Steve Roberge</b>
PROJECT NAME/ LOCATION: <b>RoxWind Transmission Corridor</b>	DEP #: <b>L-27863-ES-A-N, L-27863-NJ-B-N, L-27863-TG-C-N</b>
DATE OF INSPECTION: <b>05-10-2021</b>	DATE OF REPORT: <b>05-11-2021</b>
WEATHER: <b>Sun, 50 deg</b>	CONDITIONS: <b>Good</b>

# RoxWind LLC

## Transmission Corridor to RoxWind towers

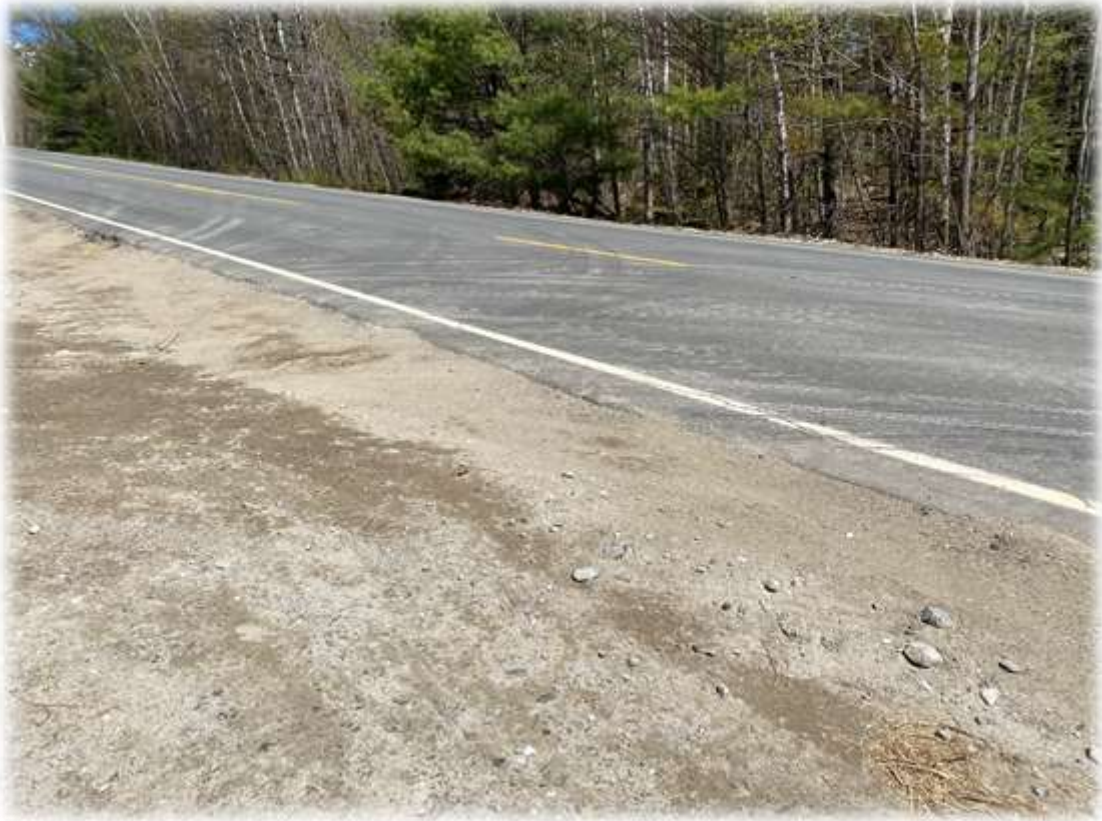
Photo #1: Roxbury Road pavement is clear of soil debris at the intersection with the SCADA building driveway.

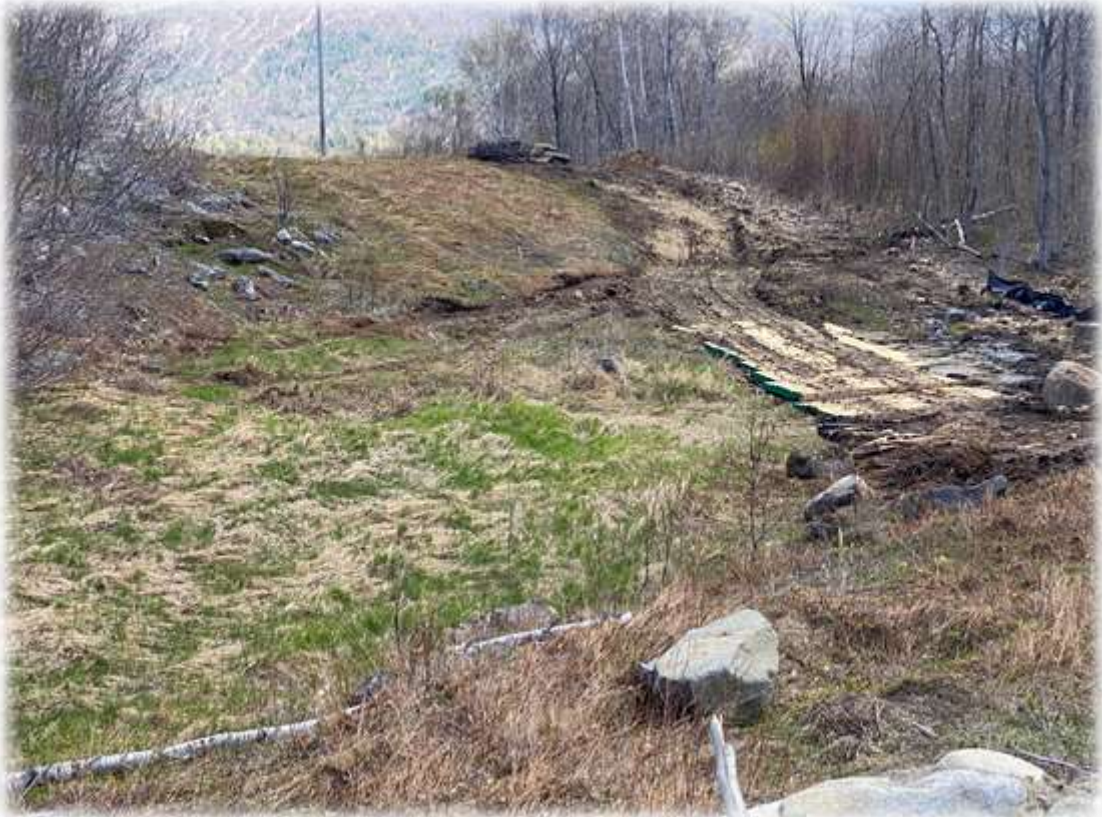
Photo #2: The upper portion of the transmission corridor coming into the RoxWind Towers portion of the project has been constructed. Mats have been installed in wetland areas.

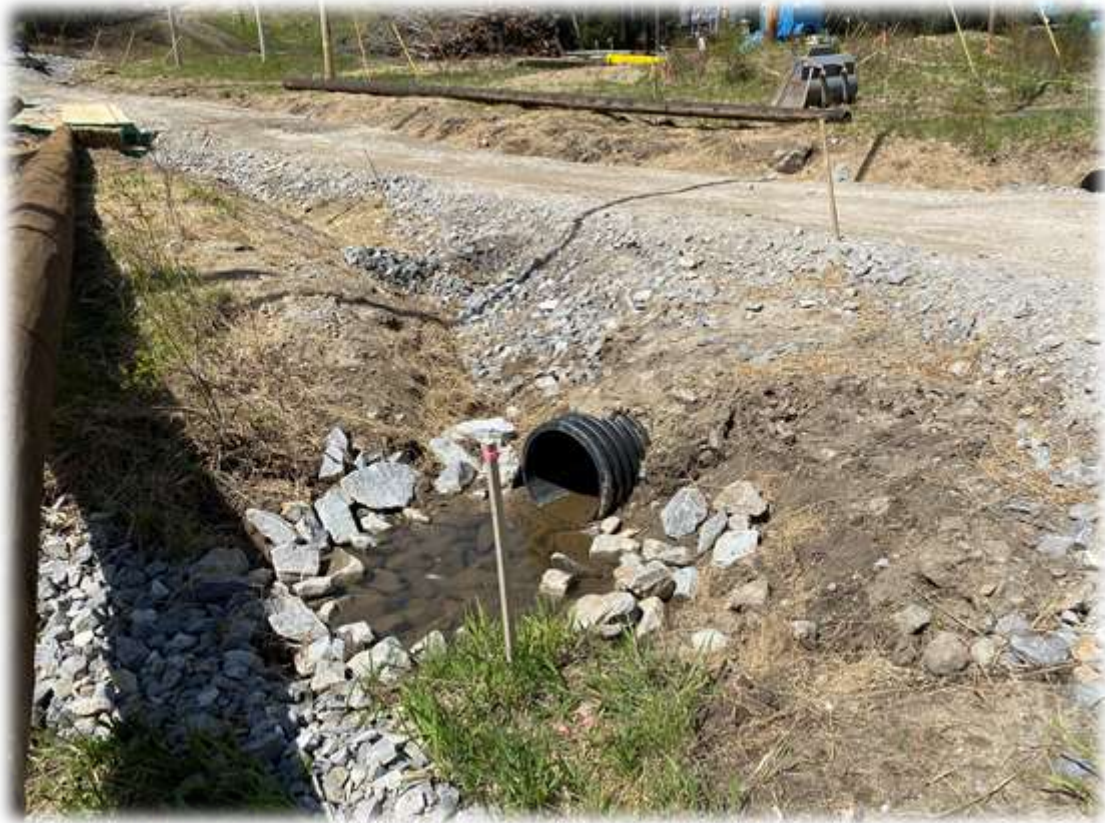
Photo #3: The riprap outlet plunge pool along the SCADA building driveway entrance has clear water within the pool.

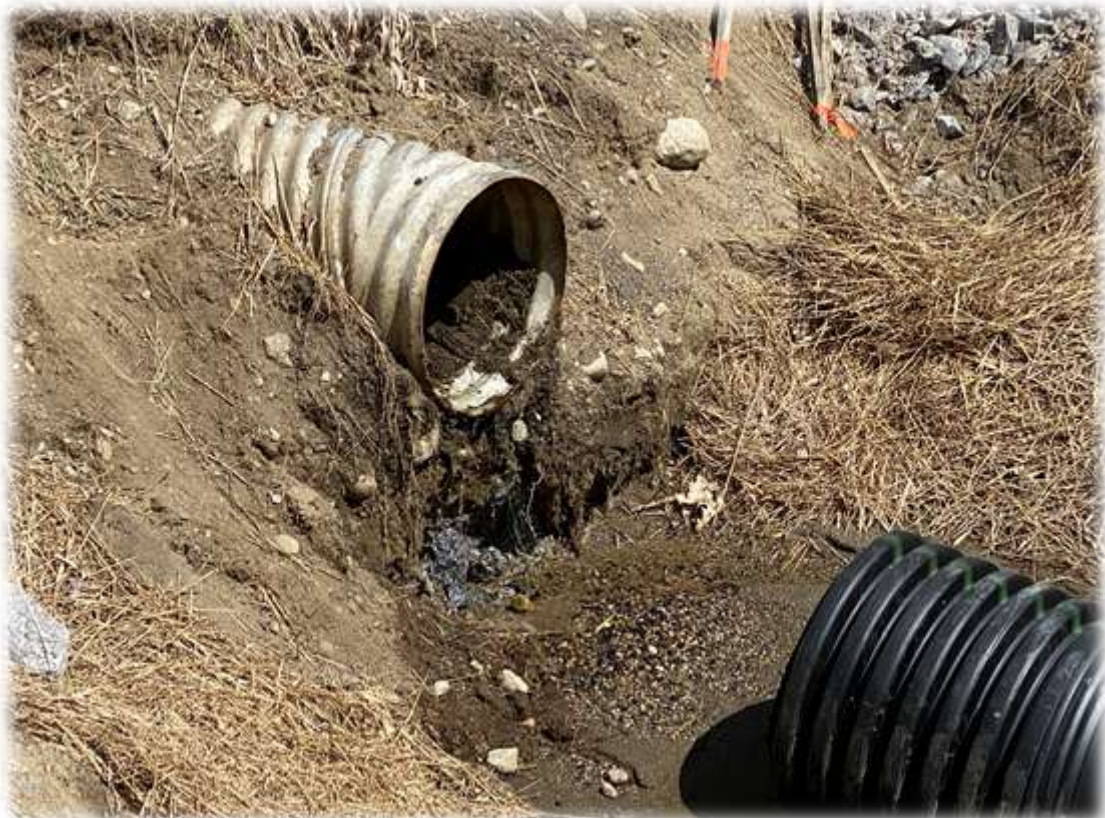
9. **Stone/ECM Check Dam:** Temporary stone check dams have been installed along both side ditches to the driveway.
10. **Culverts/Riprap:** An entrance culvert has been installed. No inlet outlet protection has been installed to date (work in progress).

Photo #4: Riprap on fabric protection needs to be installed at the inlet/outlet to the driveway culvert at the entrance to Roxbury Road.

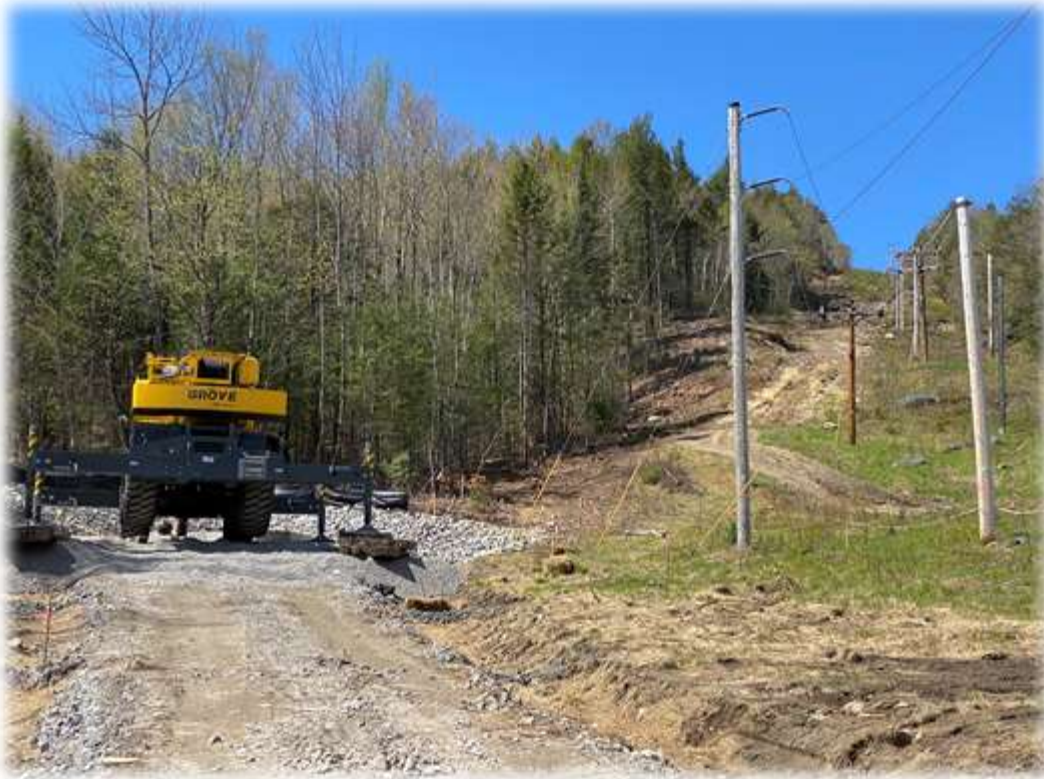
Photo #5: The gravel base material has been installed for the SCADA building driveway. Ditches have been cut and sideslopes heavily hay mulched. Temporary stone check dams have been placed until the fabric/riprap lining on the ditches can be installed. Riprap on fabric was placed along the upslope face of excavation.

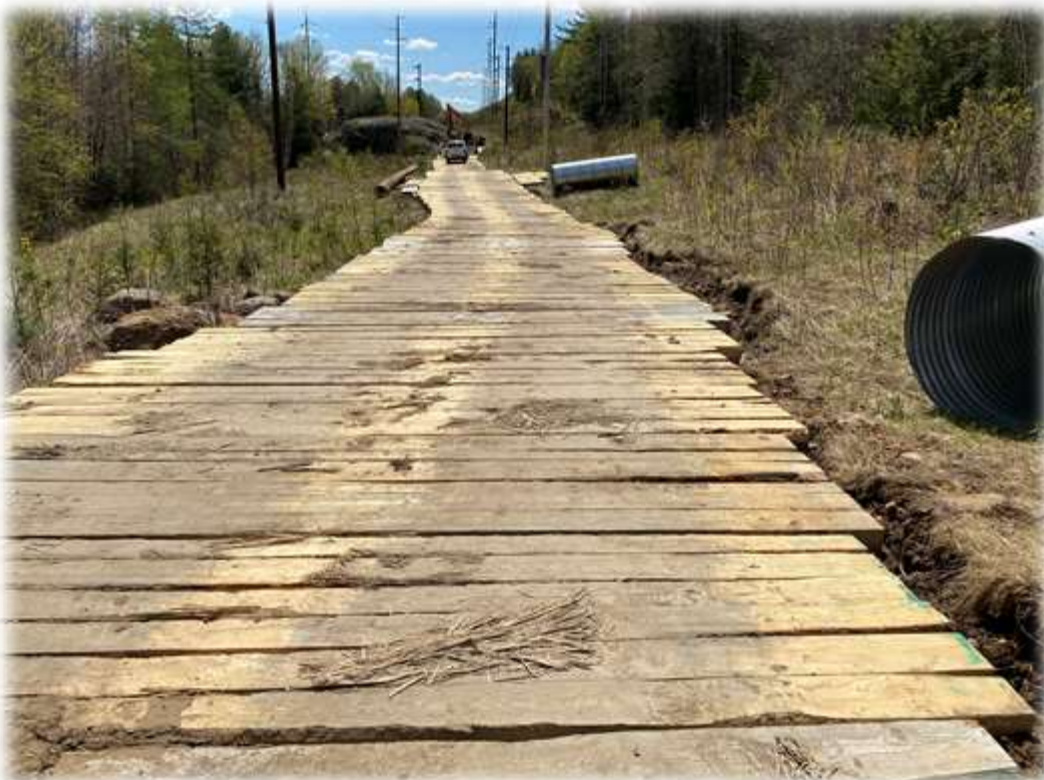
Photo #6: The view along the corridor (parallel with Roxbury Road) as seen from SCADA driveway. Structures have been laid-out. Matting installed to gain access to the structures in the area.

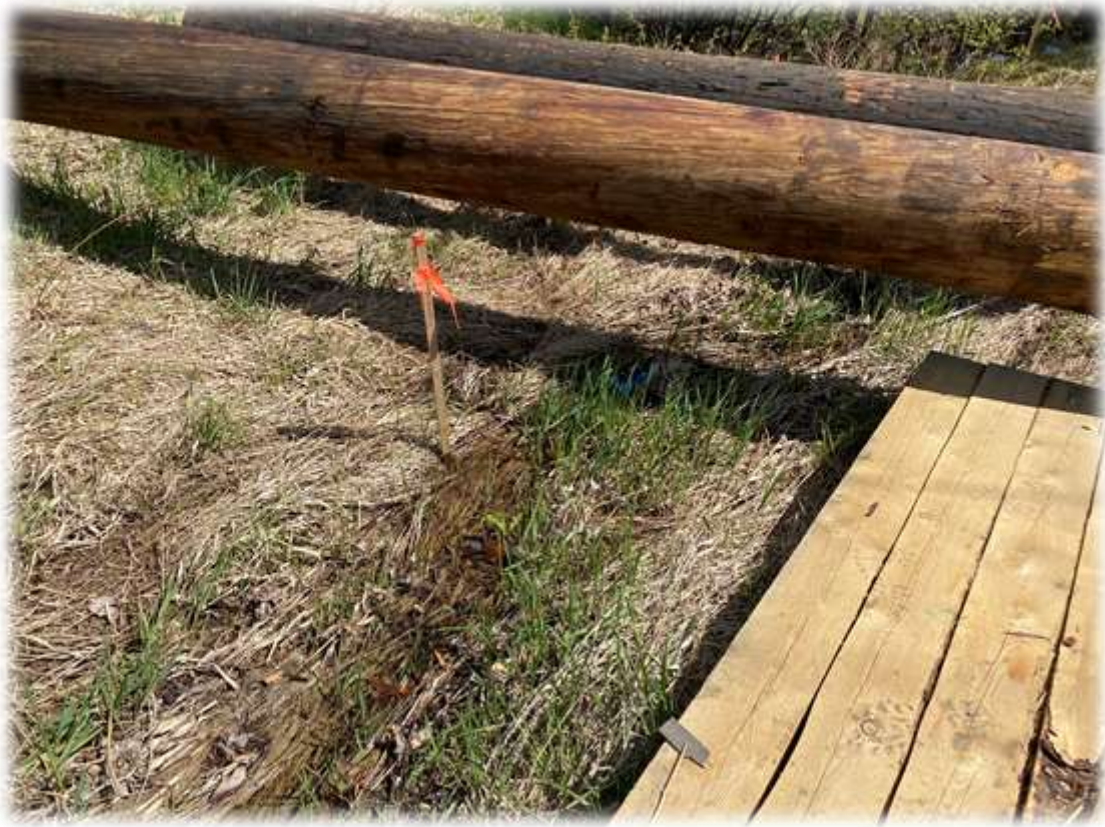
I have also spoken with Bill Goggin (CMP) and Katelyn Doughty (Reed/Reed) concerning the location of the 2 structures within the drainage swale and stream. Both were aware of the issues. Katelyn indicated their designers are reviewing the concerns and looking for other possible locations for the structures.

Photo #7: The location of anchors and the 137-7 "can" structure lie within the stream channel (Structure 137-7 anchor shown)

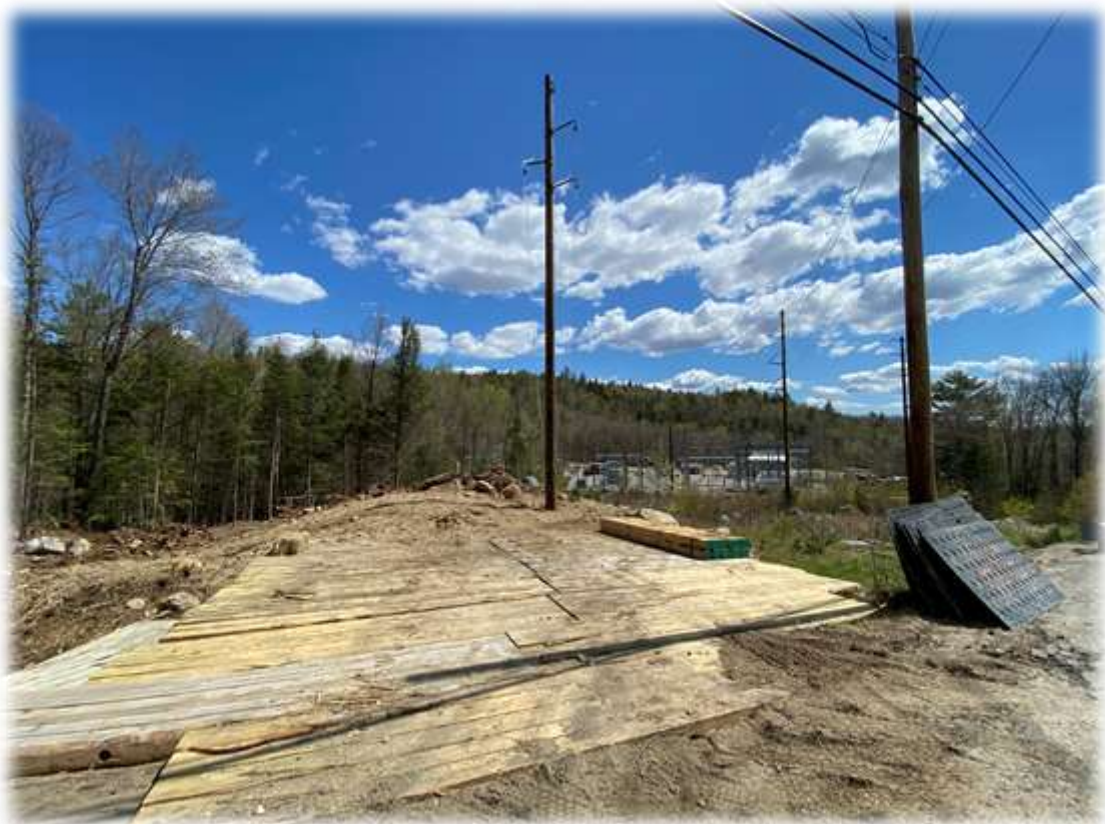
Photo #8: Structure 137-2 installed along Roxbury Road including structures adjacent to the substation.

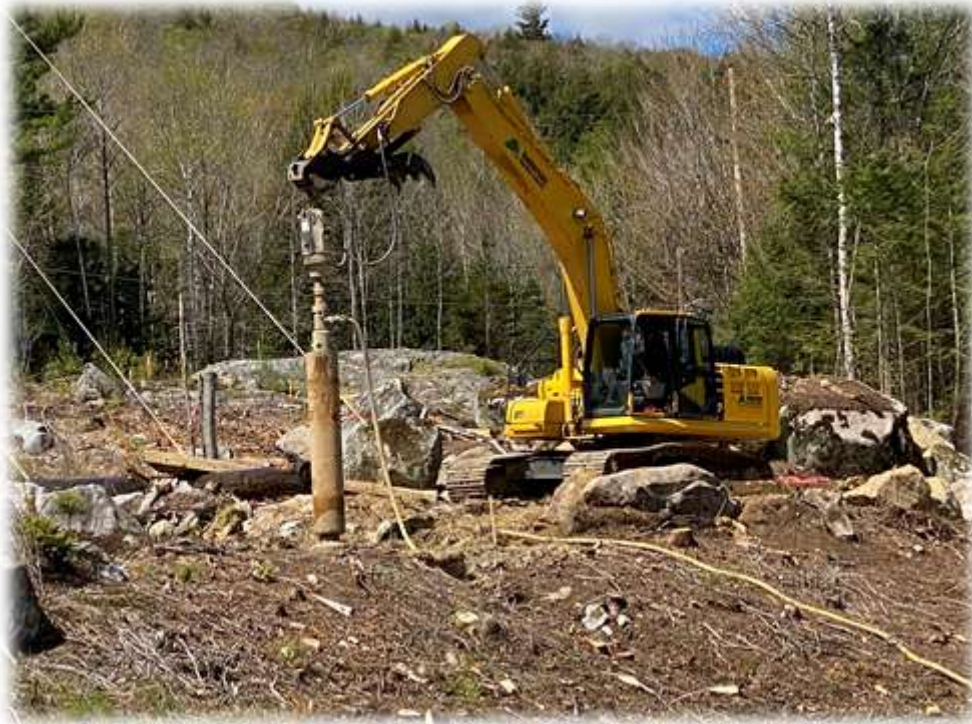
CMP has installed mats along the corridor for access to install structures along the Roxbury Road section of the corridor. Several of the structures have been installed with no issues noted. Portions of the work are on hold until the designers have a chance to identify other locations (not streams or significant drainage paths) for the structures to be set.

Photo #9: Structure 137-3 "on hold" for construction as the structure was located in the center of a drainage swale with significant flowing water.

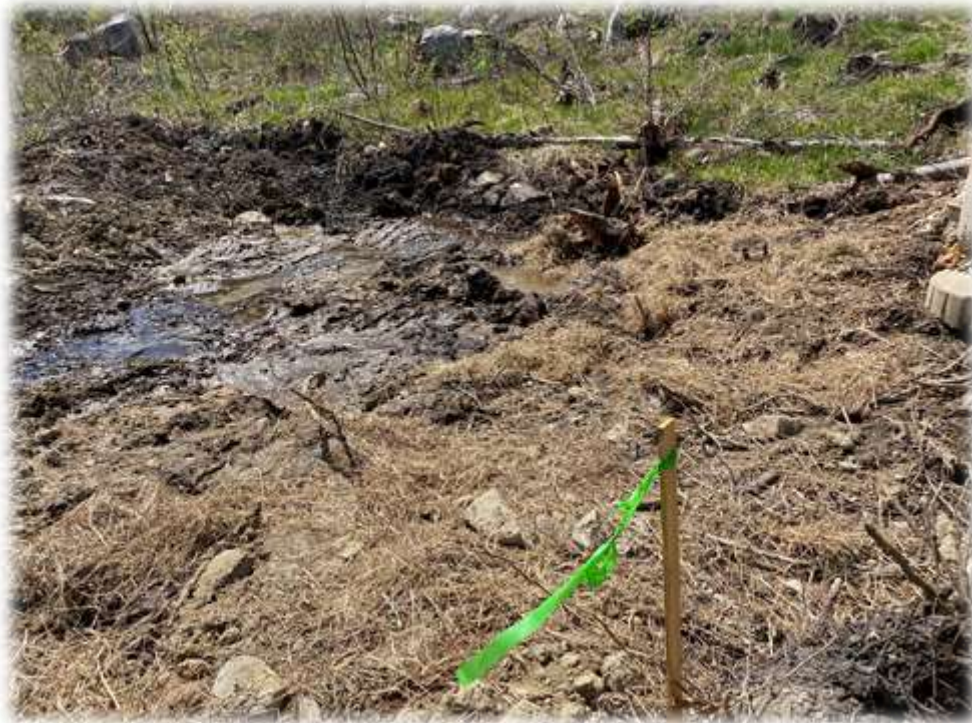
Photo #10: The two green flagged stakes are 15' offset stakes meaning the structure would have been located in the center of the flowing water of the drainage swale (near the rocks).
