# Third Party Inspection Form

TO: <b>Erle Townsend, Dawn Hallowell</b> PROJECT NAME/ LOCATION: <b>RoxWind Transmission Corridor</b> DATE OF INSPECTION: <b>05-17-2021</b> WEATHER: <b>Sun, 50 deg</b>	FROM: <b>Steve Roberge</b> DEP #: <b>L-27863-ES-A-N, L-27863-NJ-B-N, L-27863-TG-C-N</b> DATE OF REPORT: <b>05-18-2021</b> CONDITIONS: <b>Good</b>
---	--

# RoxWind LLC

## Transmission Corridor SCADA building to towers

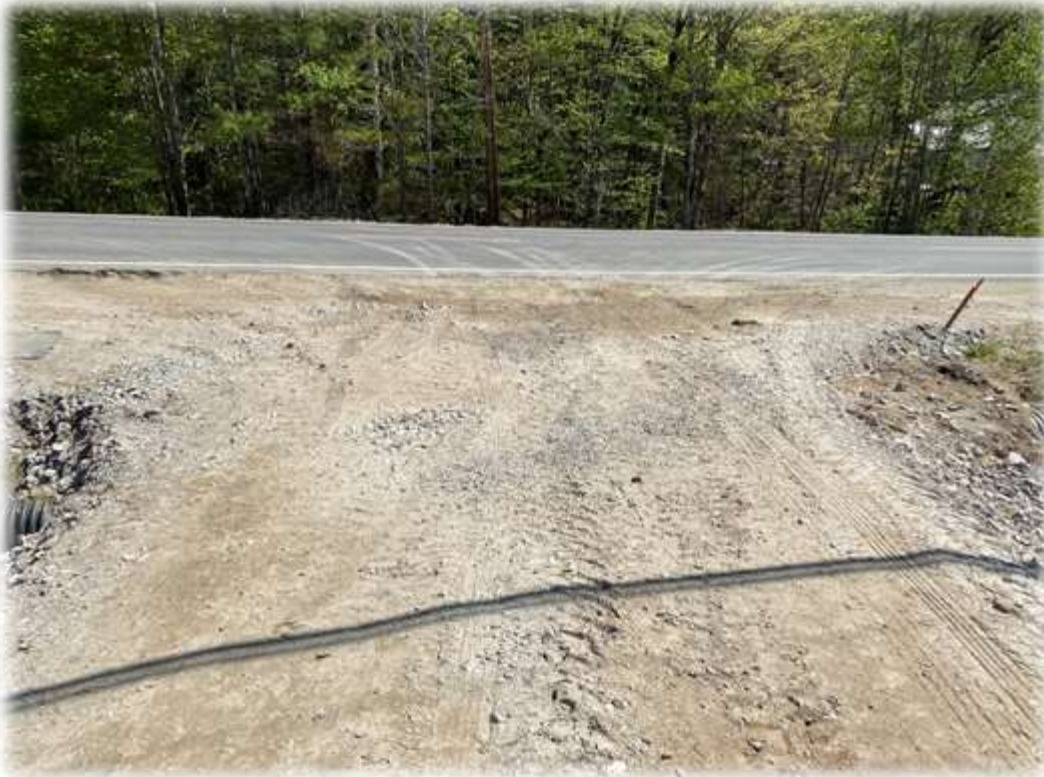
Photo #1: Roxbury Road pavement is clear of soil debris at the intersection with the SCADA building driveway.

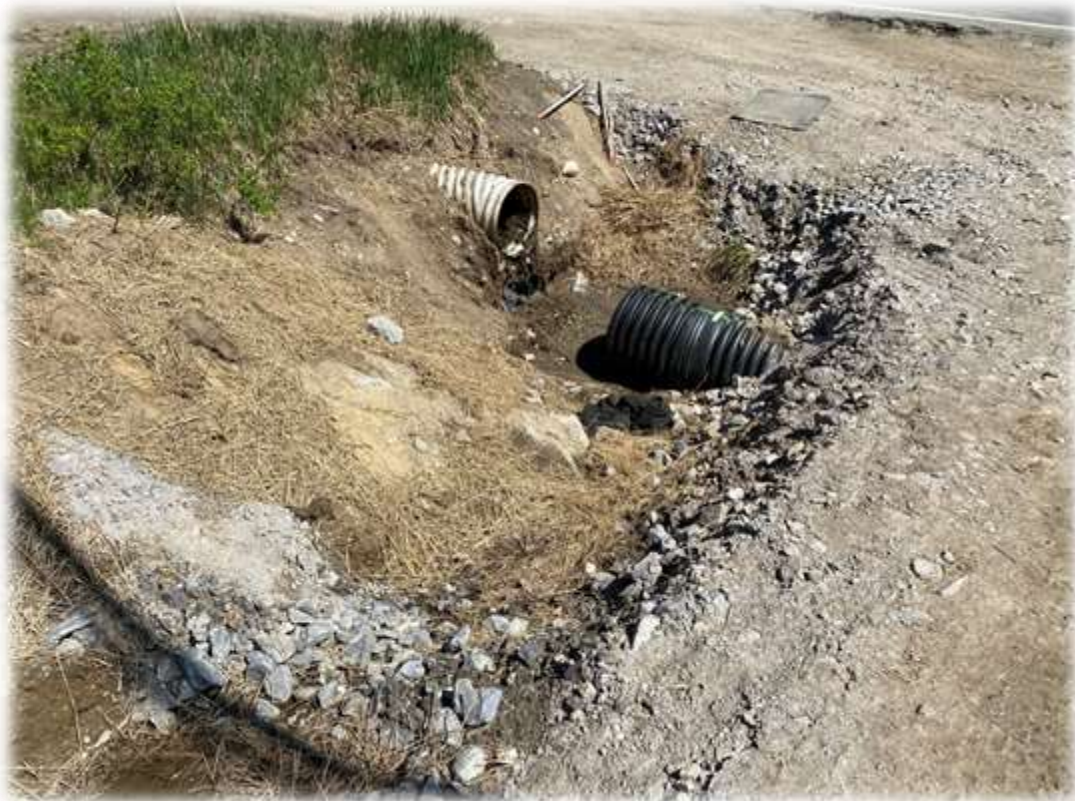
**10. Culverts/Riprap:** An entrance culvert has been installed. No inlet outlet protection has been installed to date (work in progress).

Photo #2: Riprap on fabric protection needs to be installed at the inlet/outlet to the driveway culvert at the entrance to Roxbury Road.

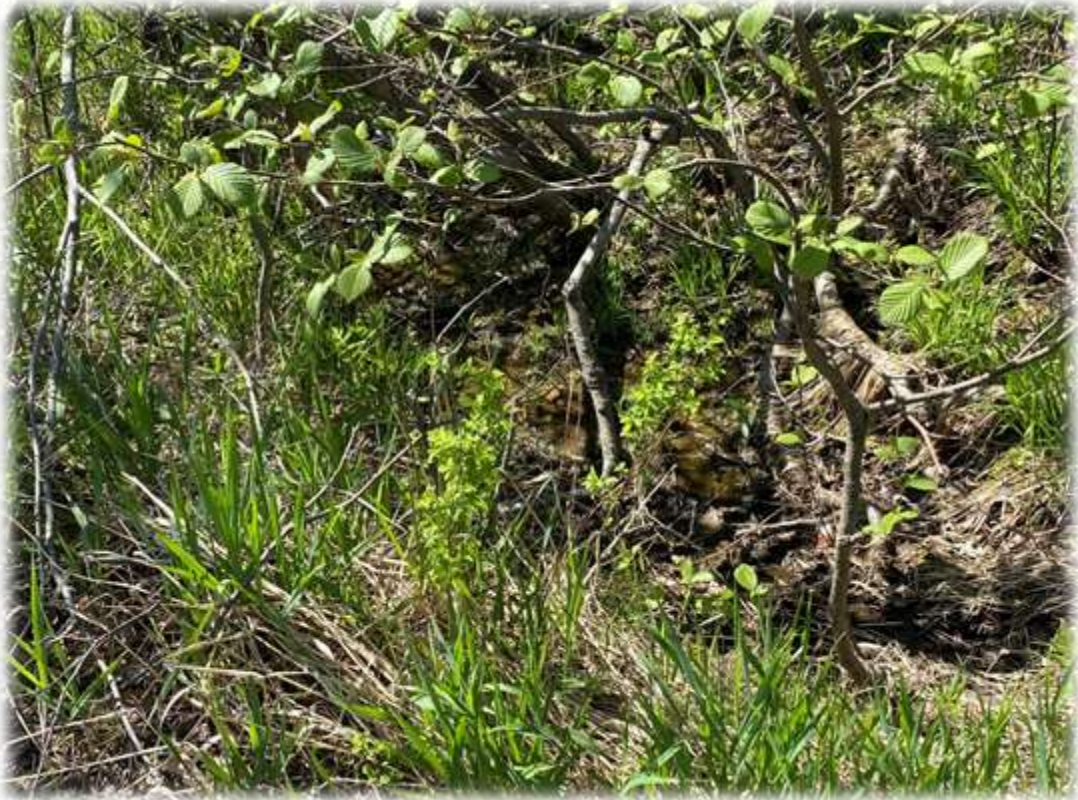
Photo #3: Clear water flows along the stream just downslope from the SCADA building driveway.

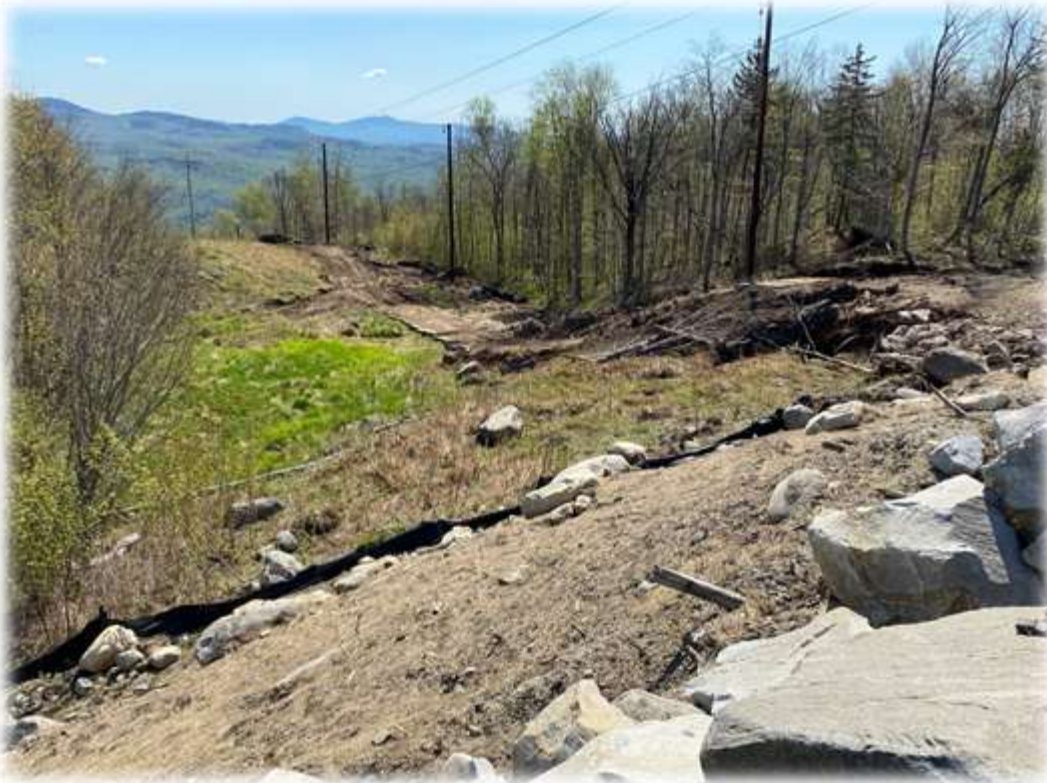
Photo #4: The upper portion of the transmission corridor access road coming into the RoxWind Towers portion of the project has been constructed and structures set. Mats have been installed in wetland areas. A stream is shown on the plans flowing through the matted area. Mats need to be reinstalled to allow unimpeded stream flows.

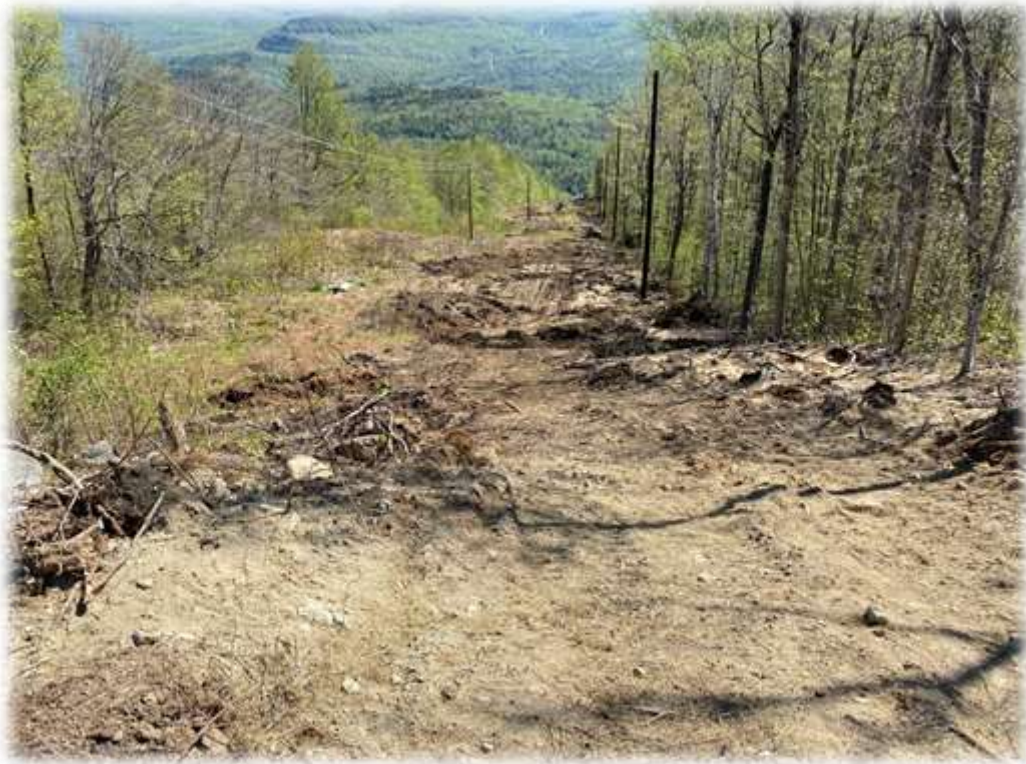
Photo #5: The access road and structures have been installed approximately half way down the corridor (near existing structure Section 52/pole 10). There is significant open area that should be covered with hay mulch. Water bars with stabilized outlets need to be created along the access road. They are to be constructed according to the steepness of the slope.

Water bar installation along the access road of the transmission line is strongly encouraged prior to warmer weather and Spring rains/runoff. Ruts left along the corridor will be sources for erosion and sedimentation likely into environmental resources.

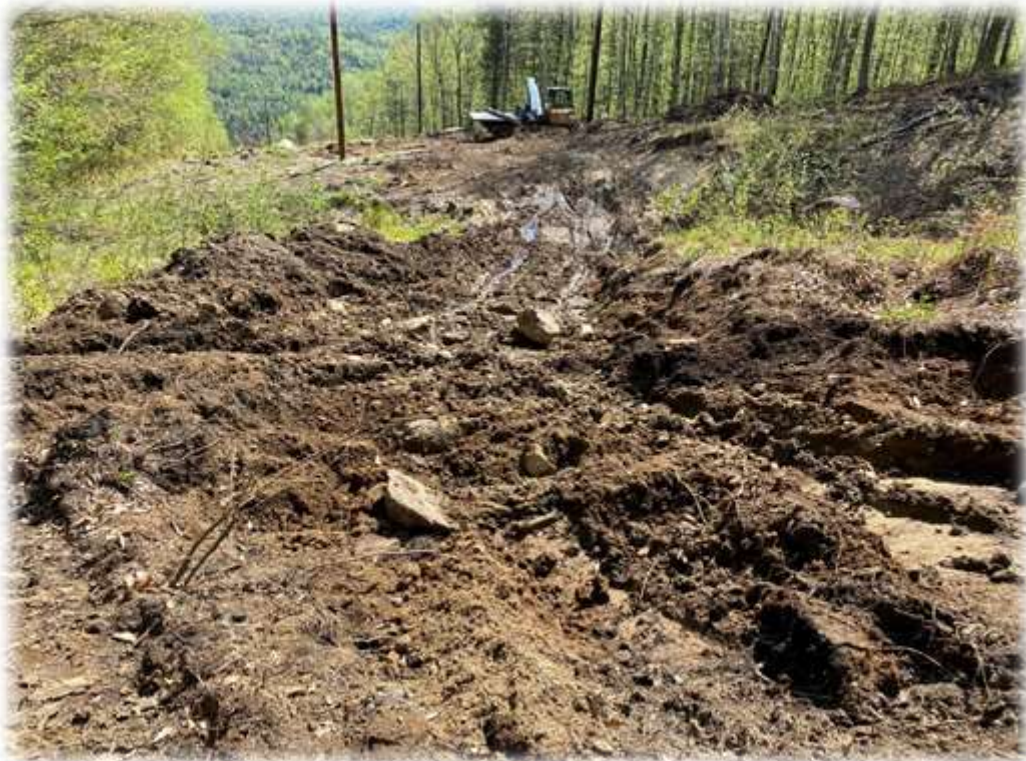
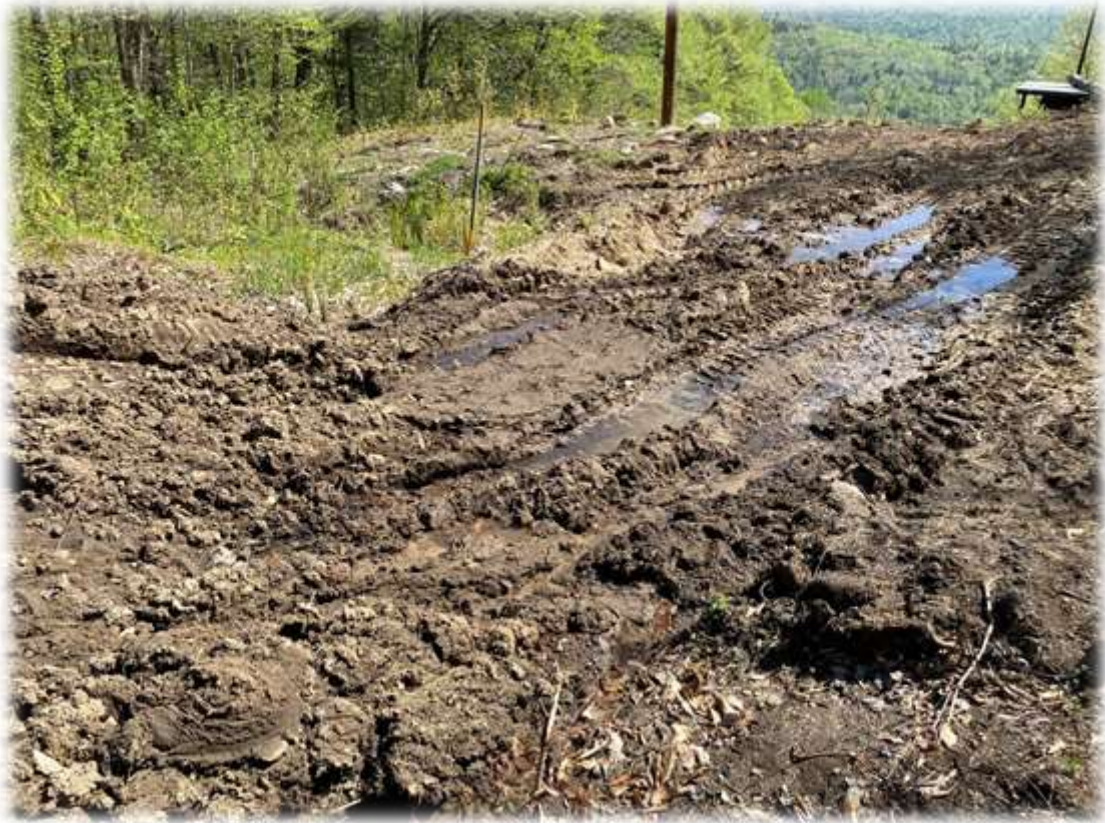
Photo #6: Access roads are being created through stream/wetland areas without matting. There are at least 4 stream crossings shown on the plans along the access road that should have raised matting over the stream channel.

Photo #7: Another view of the same stream crossing.

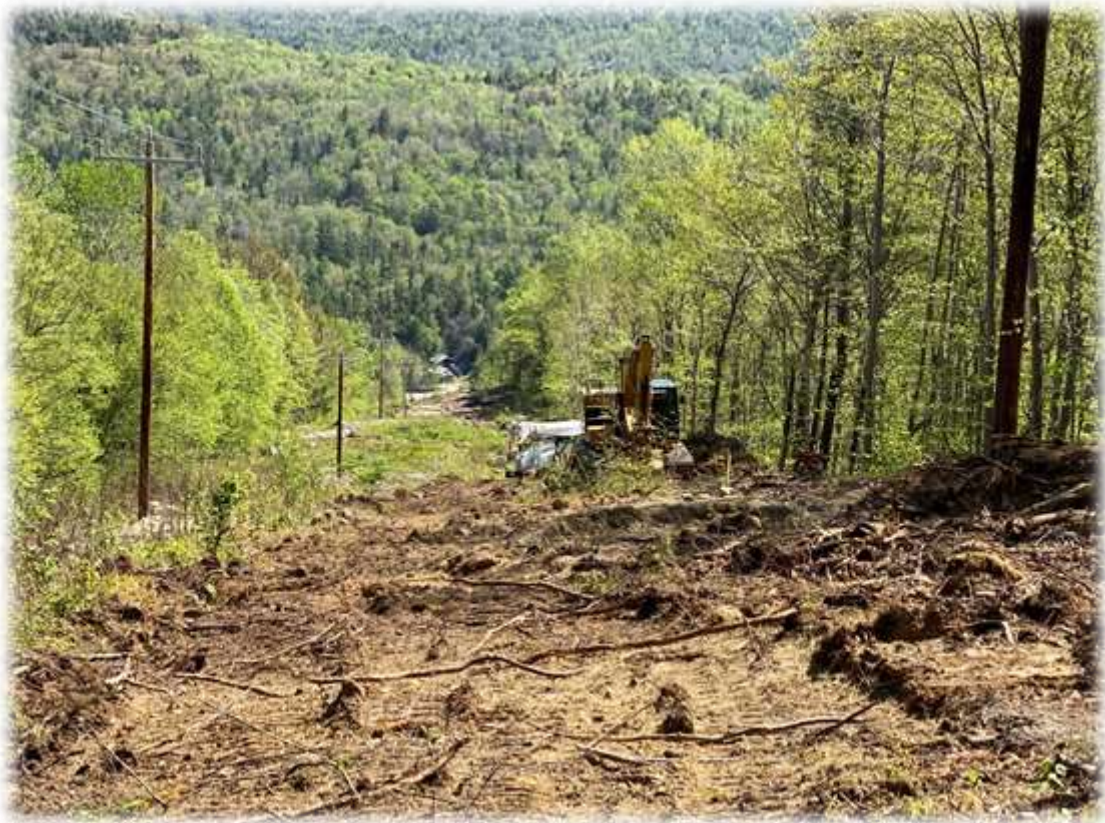
Photo #8: Crews have created access road and installed structures just past existing Section 52 pole 10. Disturbed areas should have hay mulch applied. Access road should have water bars with stabilized outlets.

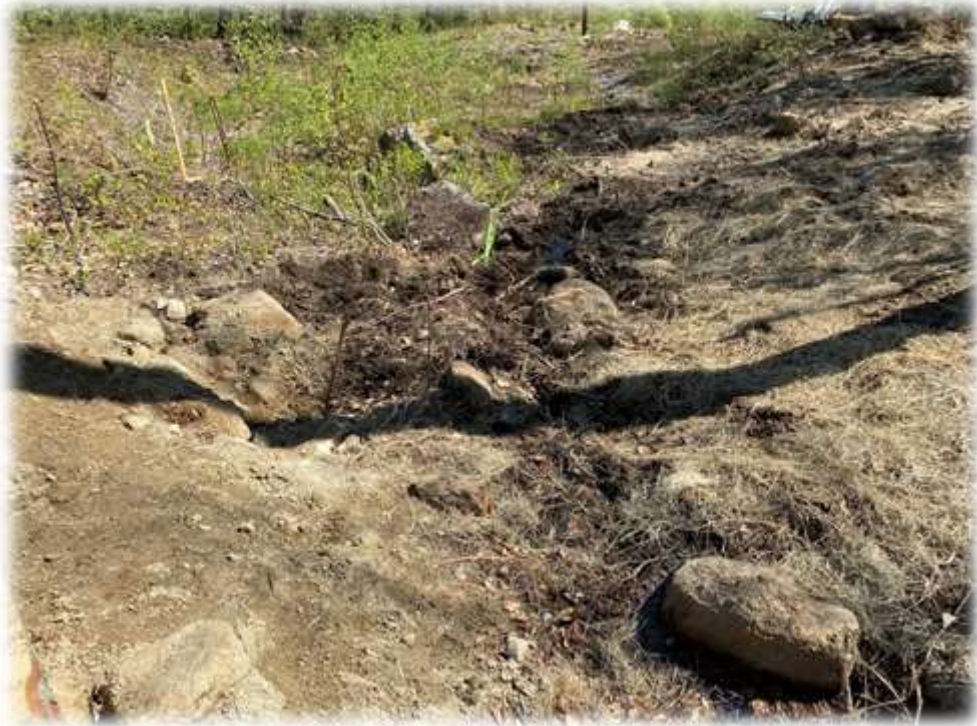
Photo #9: It appears this location adjacent to structure 28 may have been a stream crossing that has been disturbed (not matted).

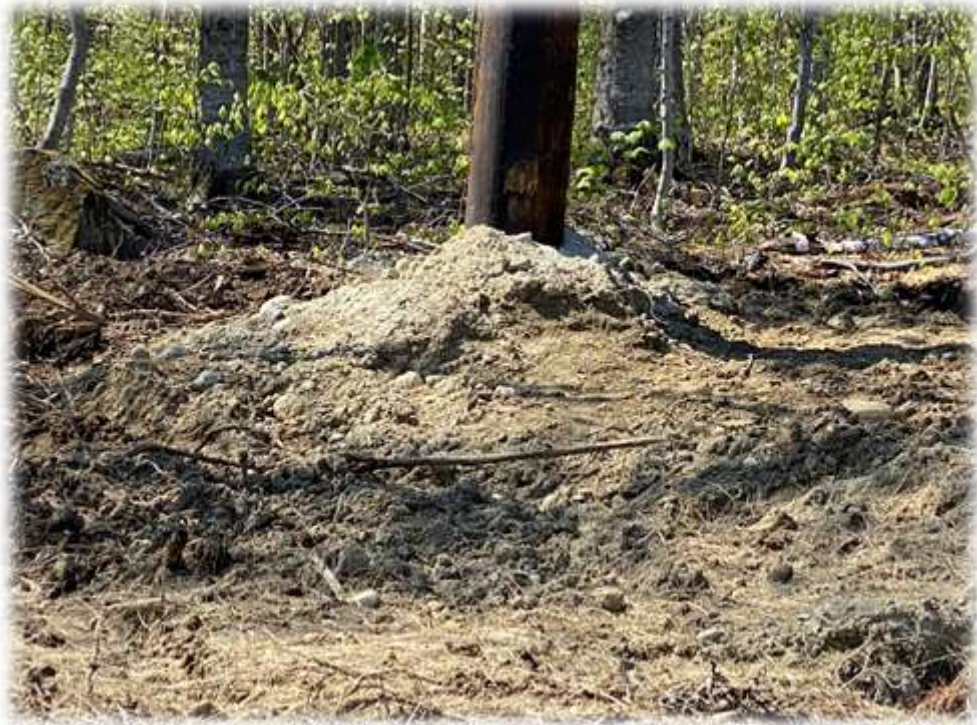
Photo #10: Mulch should be applied to all disturbed soils including pole placement soil haunches.
