Third Party Inspection Form

TO: Erle Townsend, Dawn Hallowell, Bill Goggin PROJECT NAME/ LOCATION: RoxWind Transmission Corridor DATE OF INSPECTION: 06-02-2021 WEATHER: Sun, 60 deg	FROM: Steve Roberge DEP #: L-27863-ES-A-N, L-27863-NJ-B-N, L-27863-TG-C-N DATE OF REPORT: 06-02-2021 CONDITIONS: Good
--	--

Transmission Corridor SCADA building to towers

Report: 7

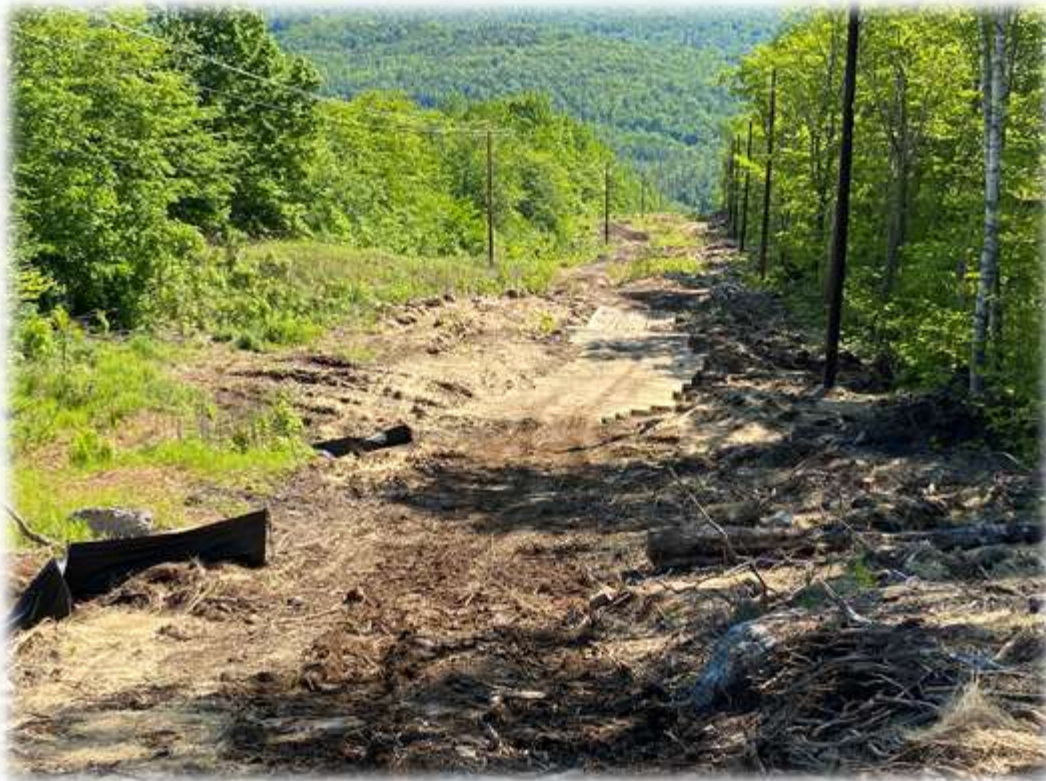
Photo #1: The upper portion of the transmission corridor access road coming into the RoxWind Towers portion of the project has been constructed and structures set. Mats have been installed over a stream and wetland areas.

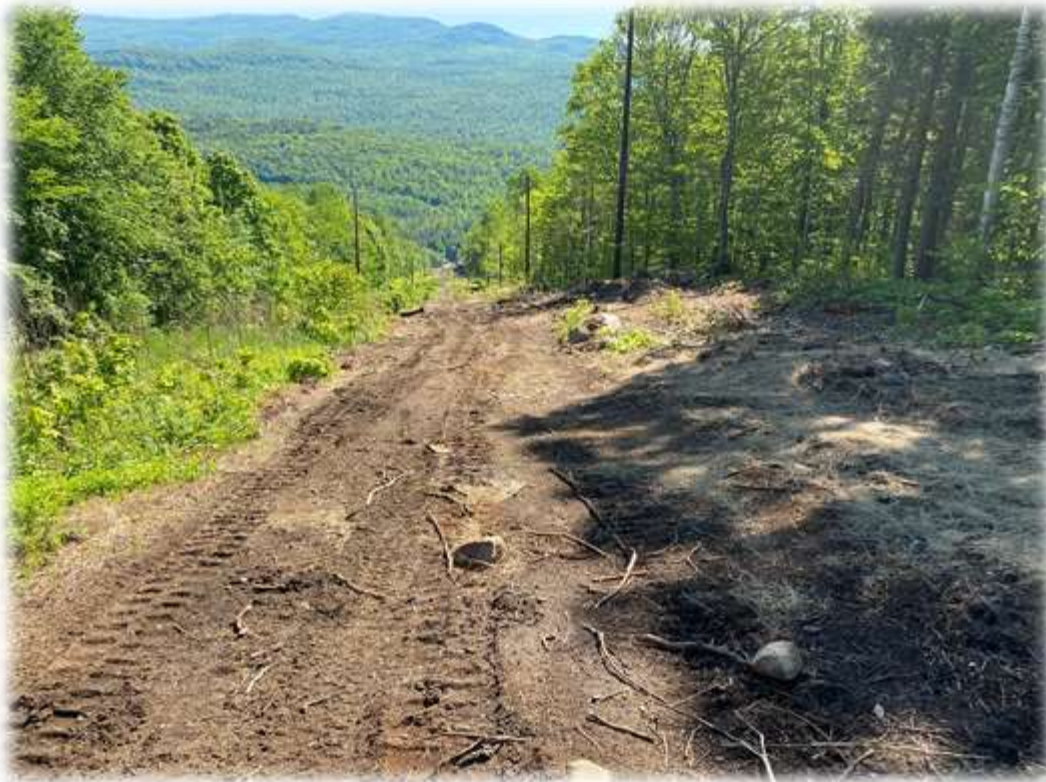
Photo #2: Water bars have been created along the corridor access road. The bars flow to a stabilized area with silt fence barrier to collect potential sediment wash. Disturbed areas of the road and structure equipment install pads are hay mulched.

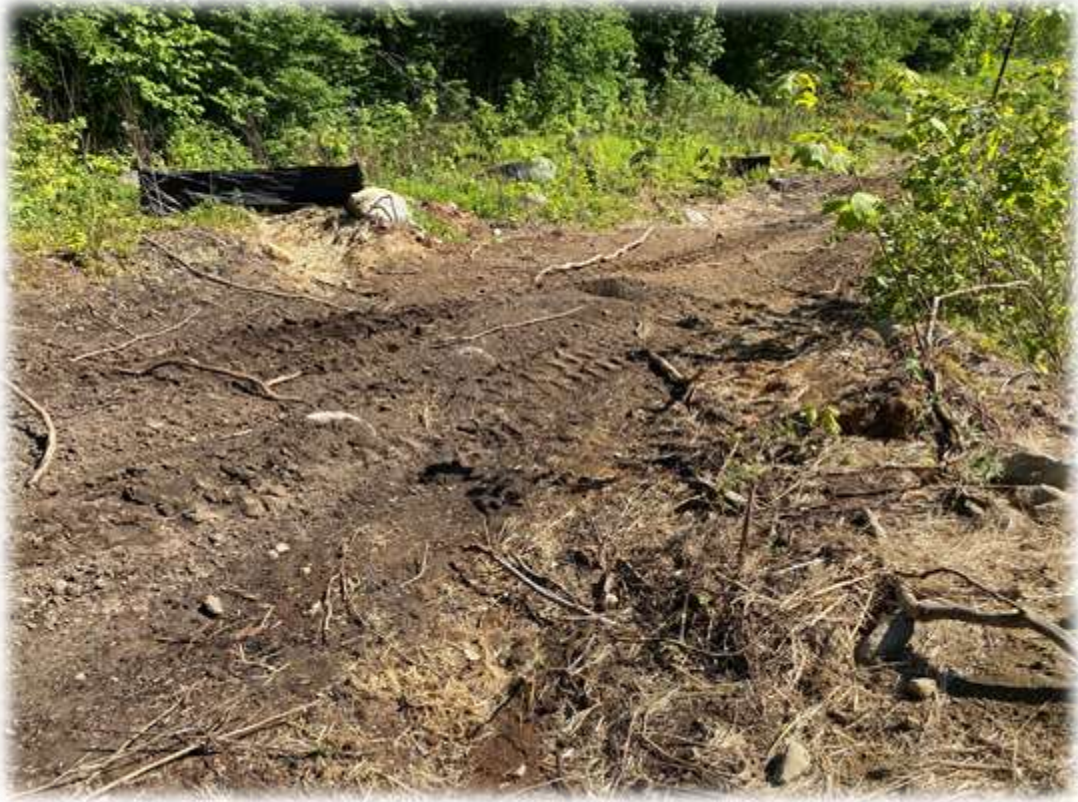
Photo #3: Another example of water bars installed along the corridor access road. The Contractor needs to insure the bars are adequately constructed at the end of each day.

Underwood Electric has installed water bars to stabilized outlets, mat wetlands where the access road crosses wetland, and hay mulch disturbed soils along the same access road utilized by CMP/Coutts from last year. The water bars need to be made whole again by the close of business day. Equipment travelling through the bar may crush the bar rendering it useless for water diversion.

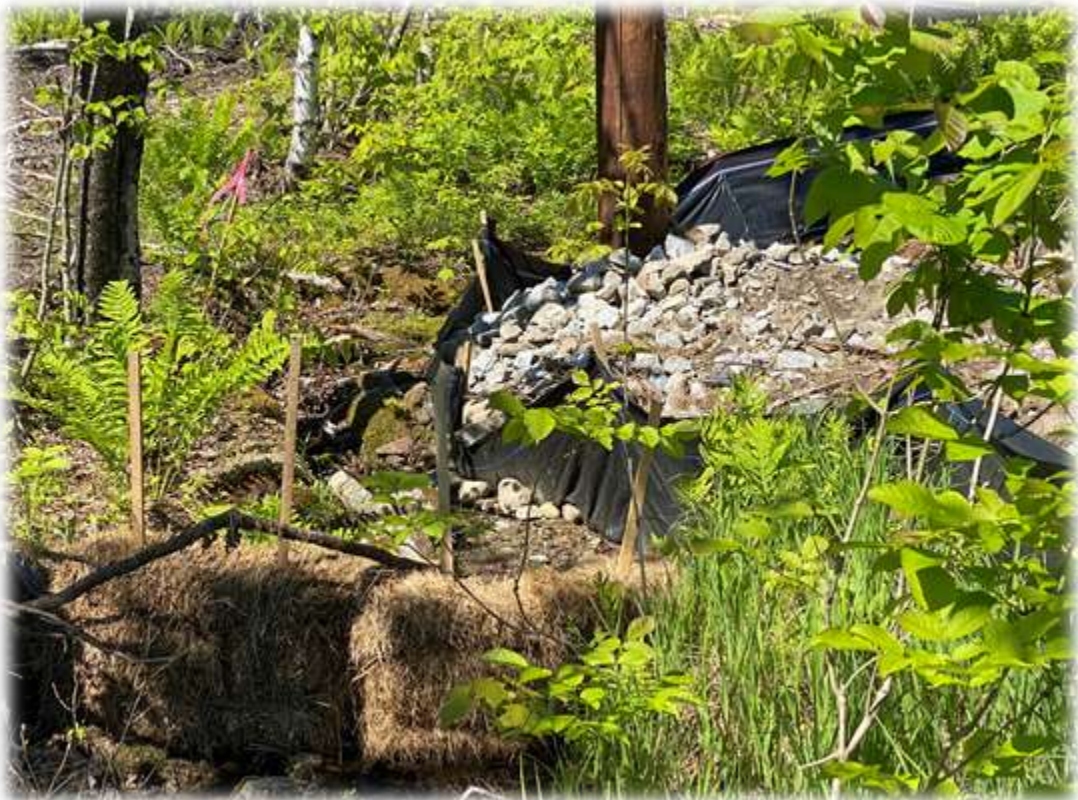
Photo #4: Structure P-23 has been placed along the side of a stream. Silt fence and rock have been placed to minimize impact to the stream. The rock that has fallen into the stream needs to be removed. The staked hay bales within the stream need to be removed.

1. One of the poles (P-23) lies adjacent to the stream and has some cover rock from the polebase spilled into the stream. The spilled stone needs to be removed as well as the staked hay bales within the stream.
2. Water bars with stabilized outlets are necessary for construction of the transmission line access road. They are to be placed a specified distance apart based on the slope of the access road. These have been installed. Please remind the work crews the water bars are to be reconstructed by the close of business day.
3. Flagging of environmental resources needs to occur as there are not identified wetland/stream flags along the corridor from top to bottom of the mountain.

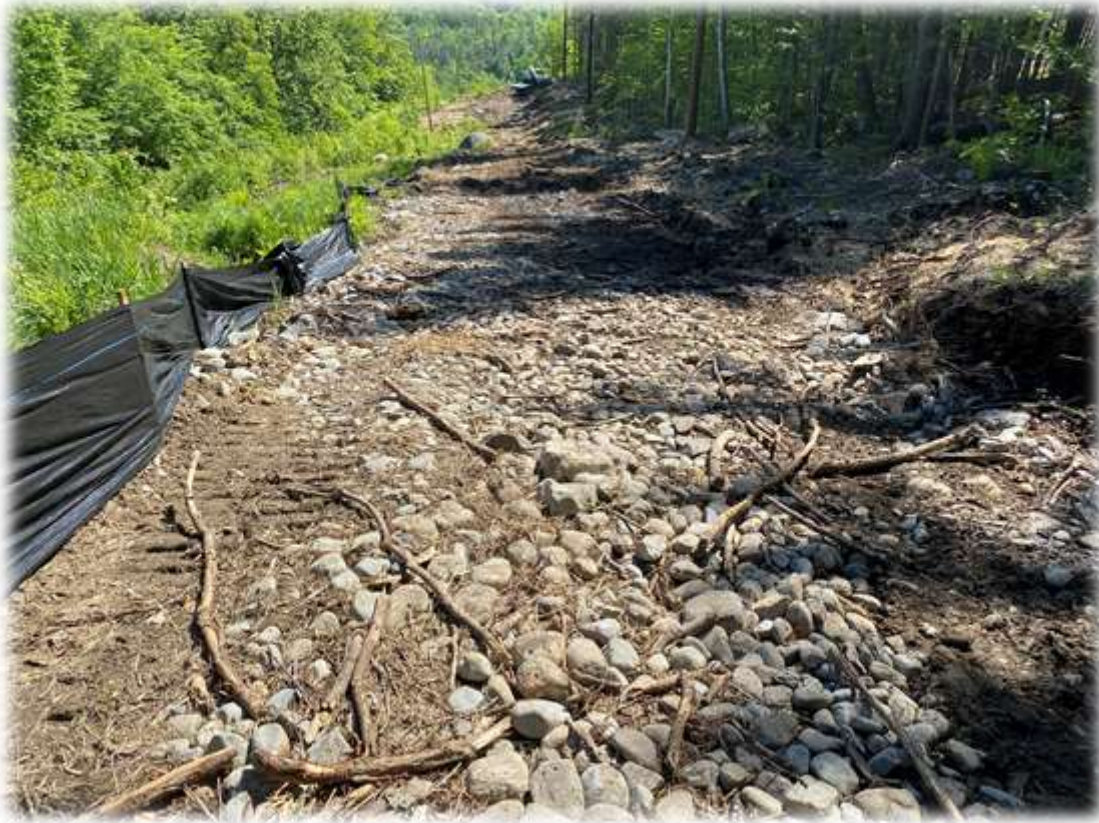
Photo #5: Stone has been added to the access road. It will need to be removed during restoration.

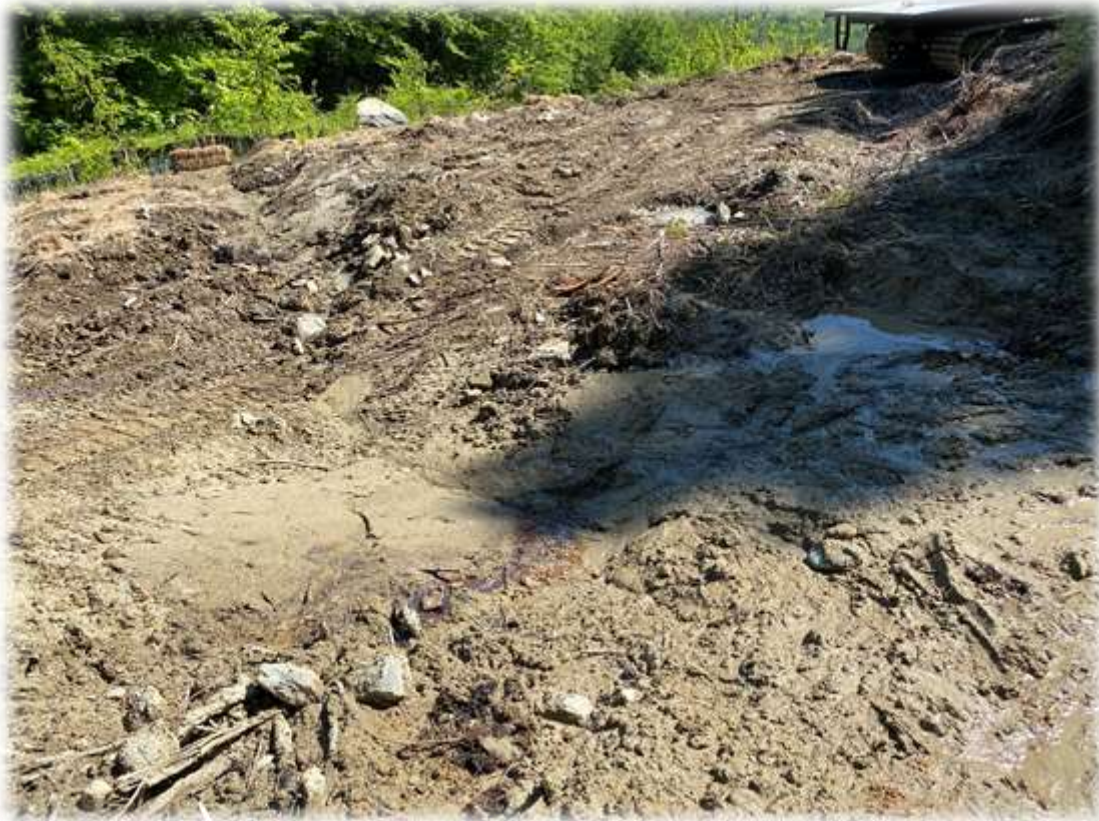
Photo #6: Water bars have captured groundwater flows passing through the access road area.

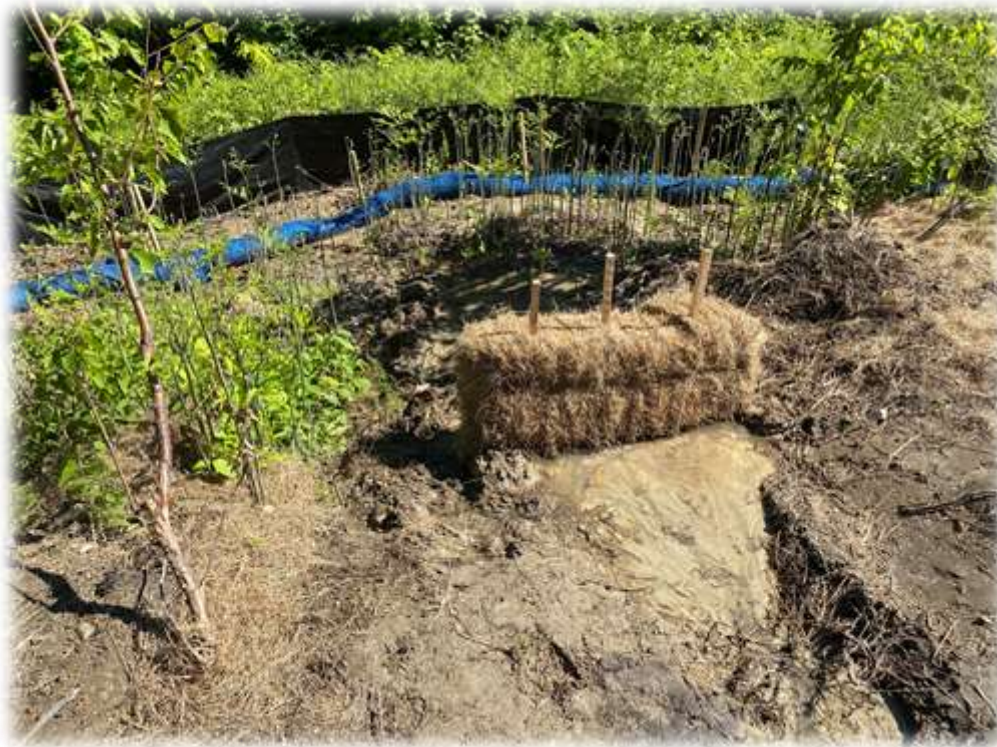
Photo #7: CMP/Coutts crew has restored the disturbed areas from last year. This area (near structure P-19) was the sediment source for turbid water/sediment flowing into the adjacent stream. Underwood Electric added an ineffective hay bale barrier (water sediment went around the bale) to try and capture sediment. It was captured with the silt sock waddle and silt fence.

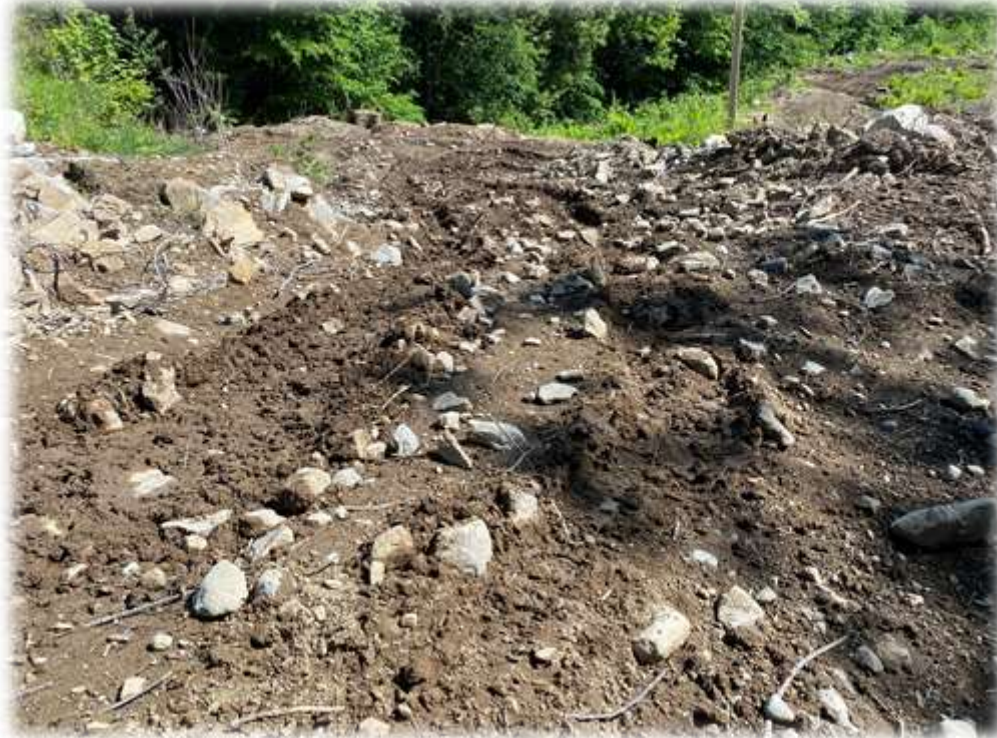
Photo #8: While still rough, Underwood Electric is utilizing the existing access road created by Coutts last year. Underwood has installed numerous water bars with stabilized sediment capture area outlet. No significant erosion here because of up slope water bars installed.

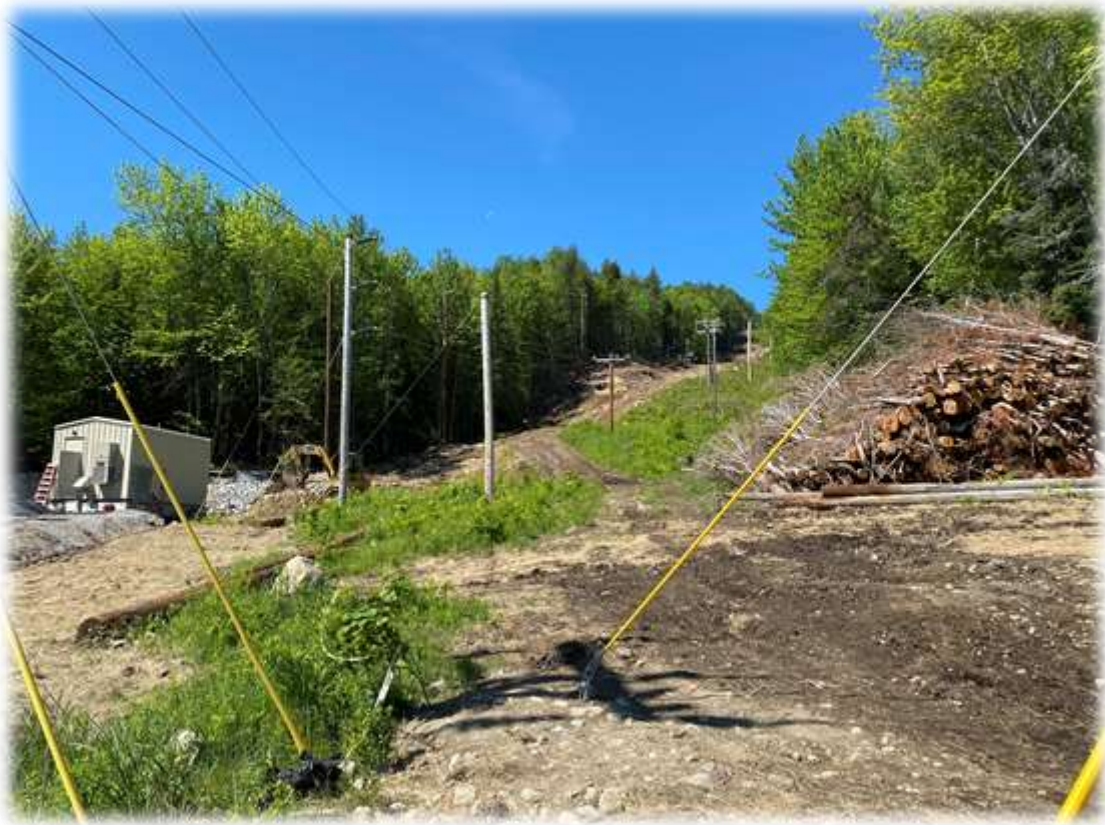
Photo #9: An overview of the lower access road near the SCADA building
