# Third Party Inspection Form

TO: <b>Erle Townsend, Dawn Hallowell</b>	FROM: <b>Steve Roberge</b>
PROJECT NAME/ LOCATION: <b>RoxWind Transmission Corridor</b>	DEP #: <b>L-27863-ES-A-N, L-27863-NJ-B-N, L-27863-TG-C-N</b>
DATE OF INSPECTION: <b>06-15-2021</b>	DATE OF REPORT: <b>06-15-2021</b>
WEATHER: <b>Mist, Fog, 60 deg</b>	CONDITIONS: <b>Good</b>

# RoxWind LLC

## Transmission Corridor SCADA building to towers

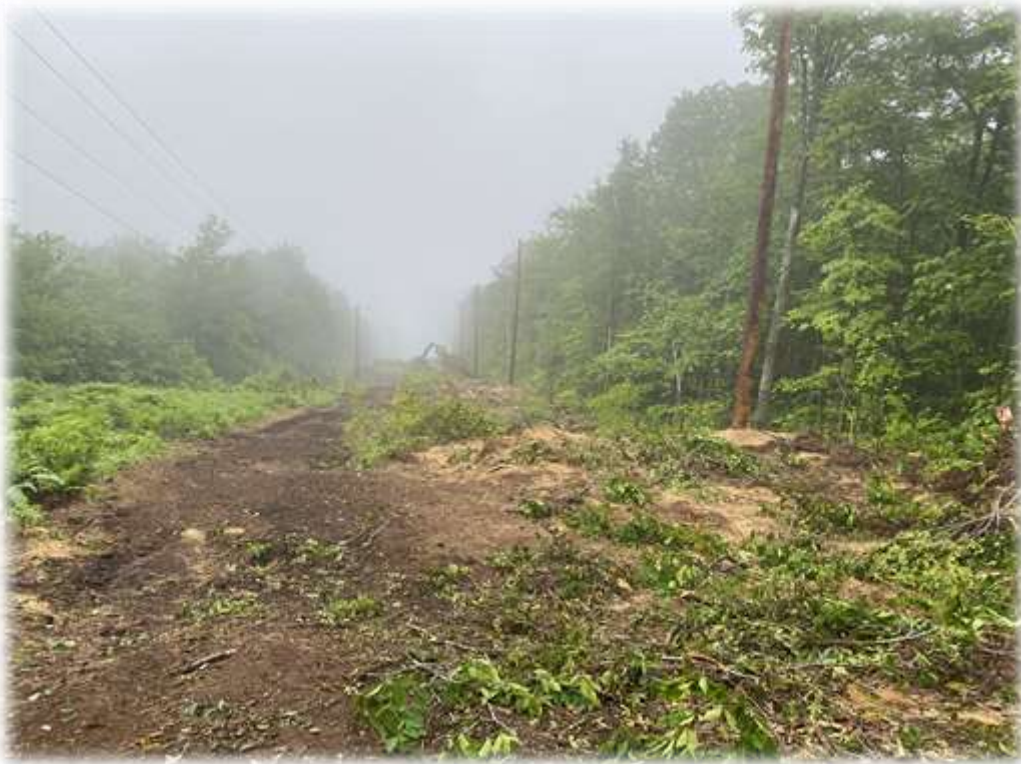
Photo #1: The upper portion of the transmission corridor access road coming into the RoxWind Towers portion of the project has been constructed and structures set. CLT is back onsite to cull the safety "danger" trees from the corridor using hand labor and a forwarder.

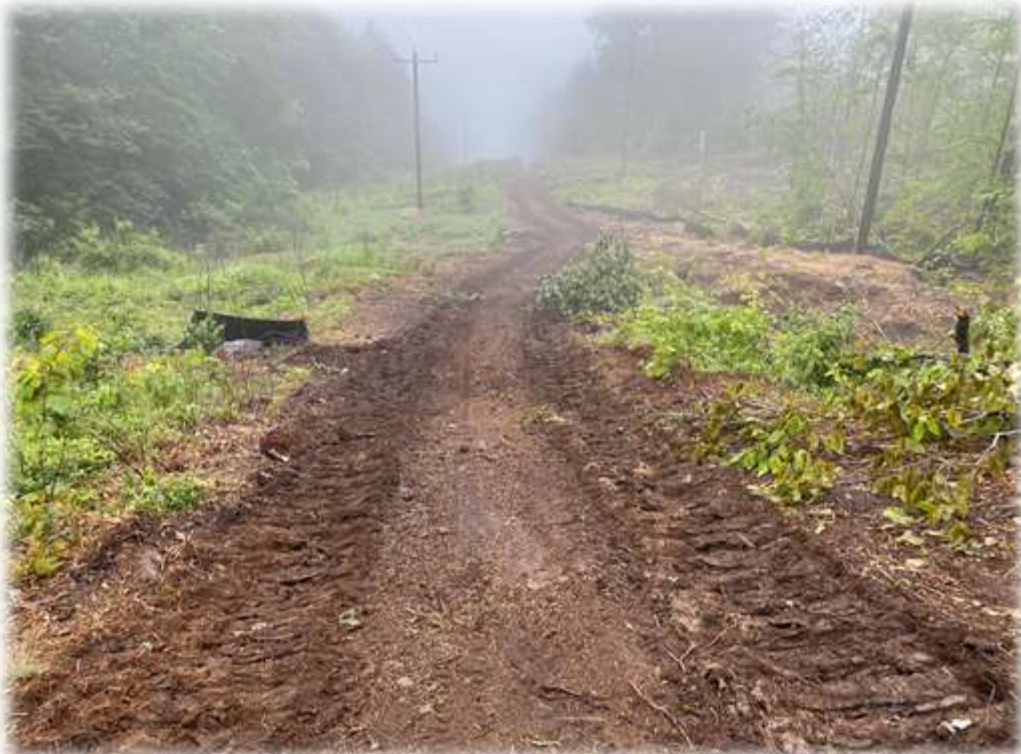
**12. Water Bars:** Water bars have been installed in locations along the corridor access road. These need to be maintained (work in progress) as equipment traveling cross the bars crush the berms allowing water to continue flowing down the travel path. The distance between the water bars is based on the steepness of the slope. This will help to control washouts of the road during significant rain events. The water bar discharge area has a "capture area" established to collect sediment and filter turbid water.

Photo #2: Water bars have been created along the corridor access road. The bars flow to a stabilized area with silt fence barrier to collect potential sediment wash. CLT forwarder has crushed the bar and will recreate the bar as they work themselves out later in the day. Disturbed areas of the road and structure equipment install pads are hay mulched.

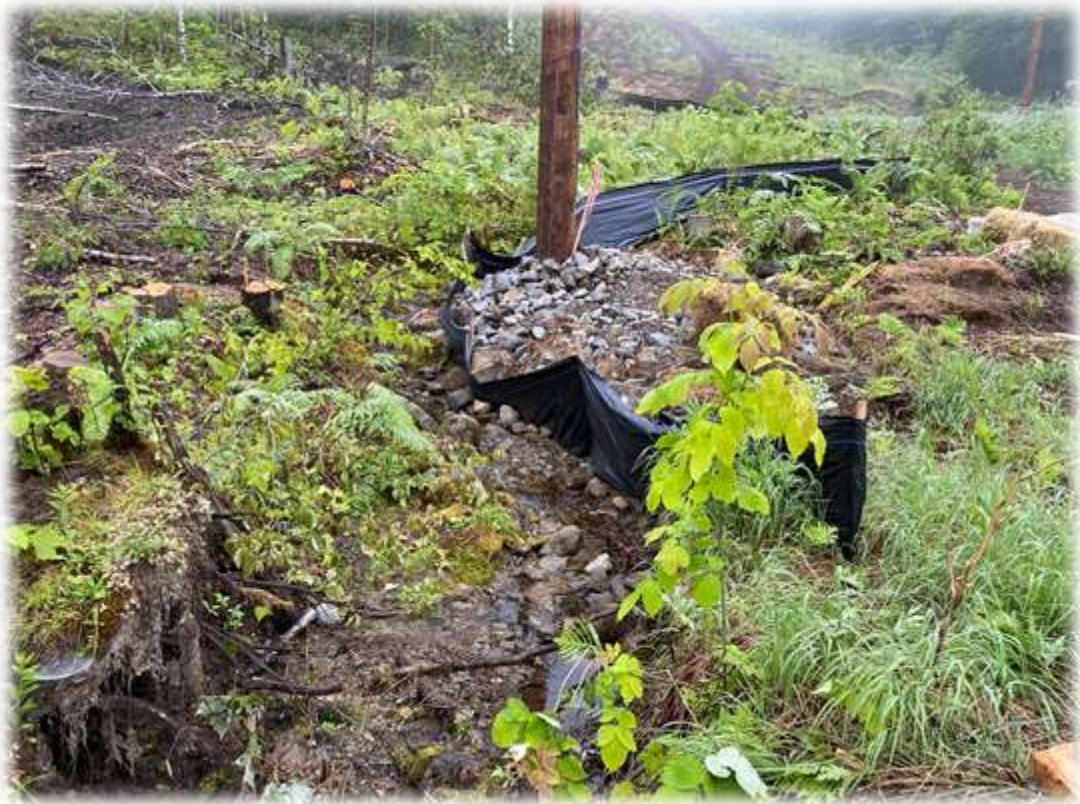
Photo #3: Structure P-23 has been placed along the side of a stream. Silt fence and rock have been placed to minimize impact to the stream. Some of the rock that has fallen into the stream has been removed. The downslope staked hay bales within the stream have also been removed.

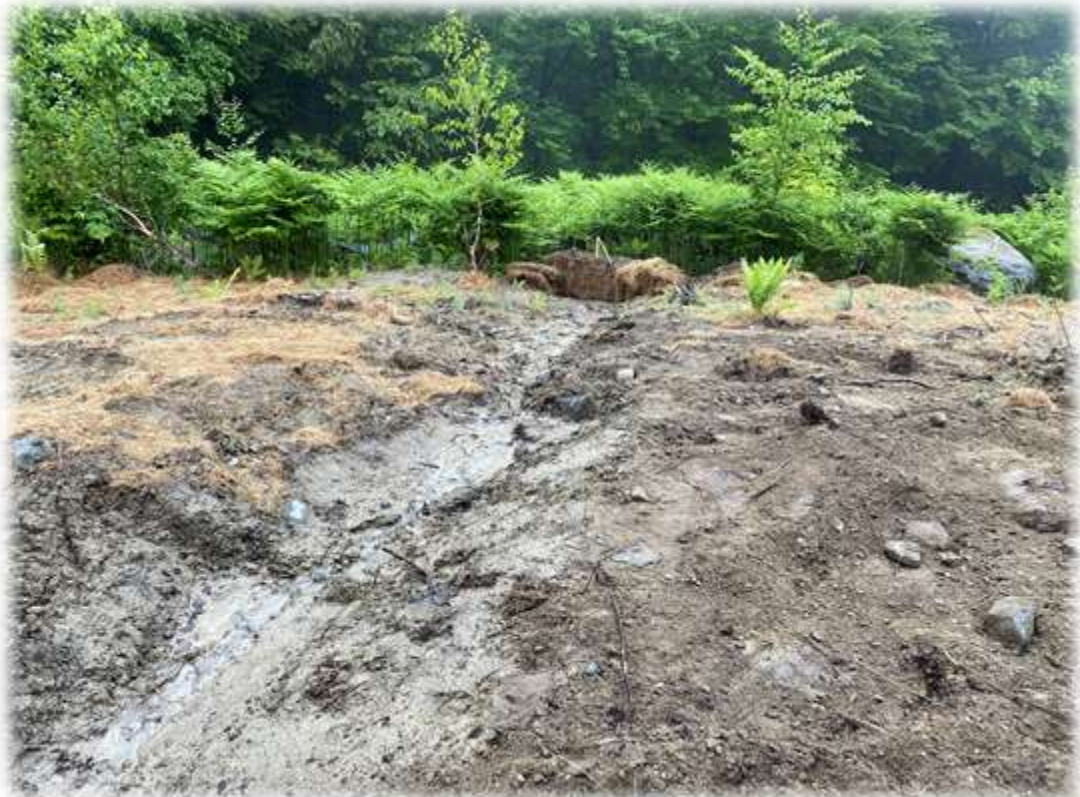
Photo #4: The Contractor has removed sediment from the water diversion bar and stabilized outlet near P-19

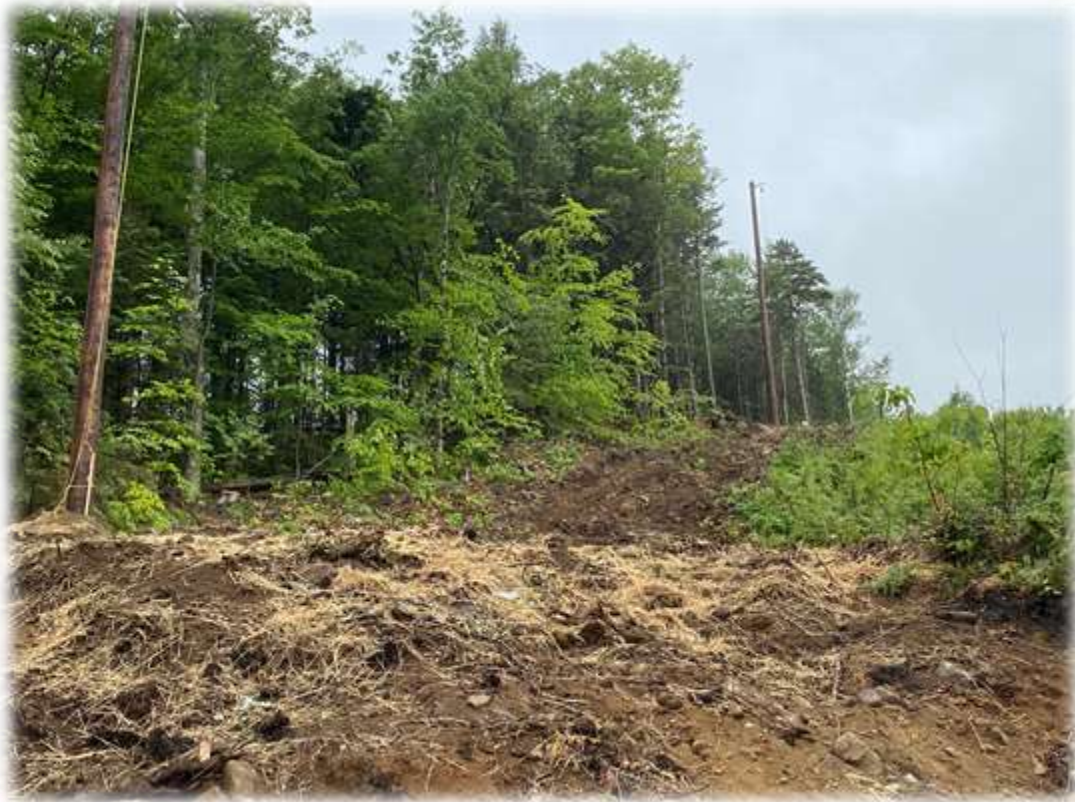
Photo #5: CLT has disturbed a new area adjacent to the woods line that needs hay mulch (work in progress).

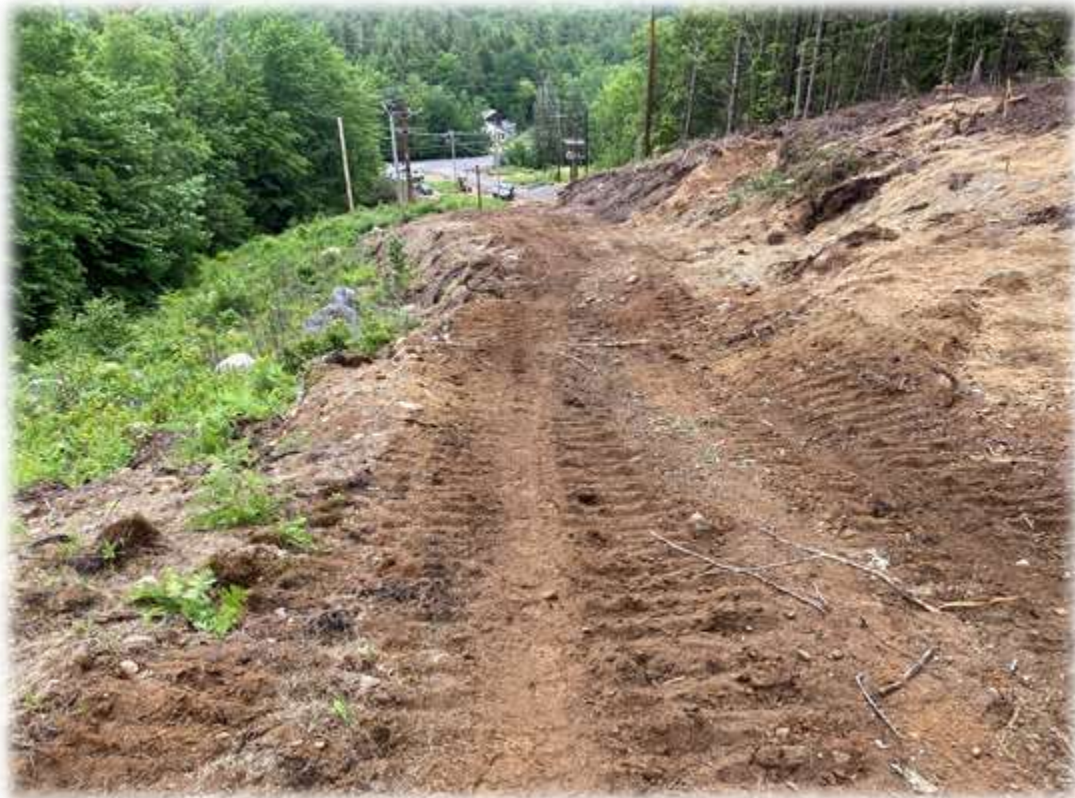
Photo #6: This area remains stable, but the water bars installed do not have any stabilized outlets. Sediments that are diverted by the bar will flow into vegetated areas and need to be removed.

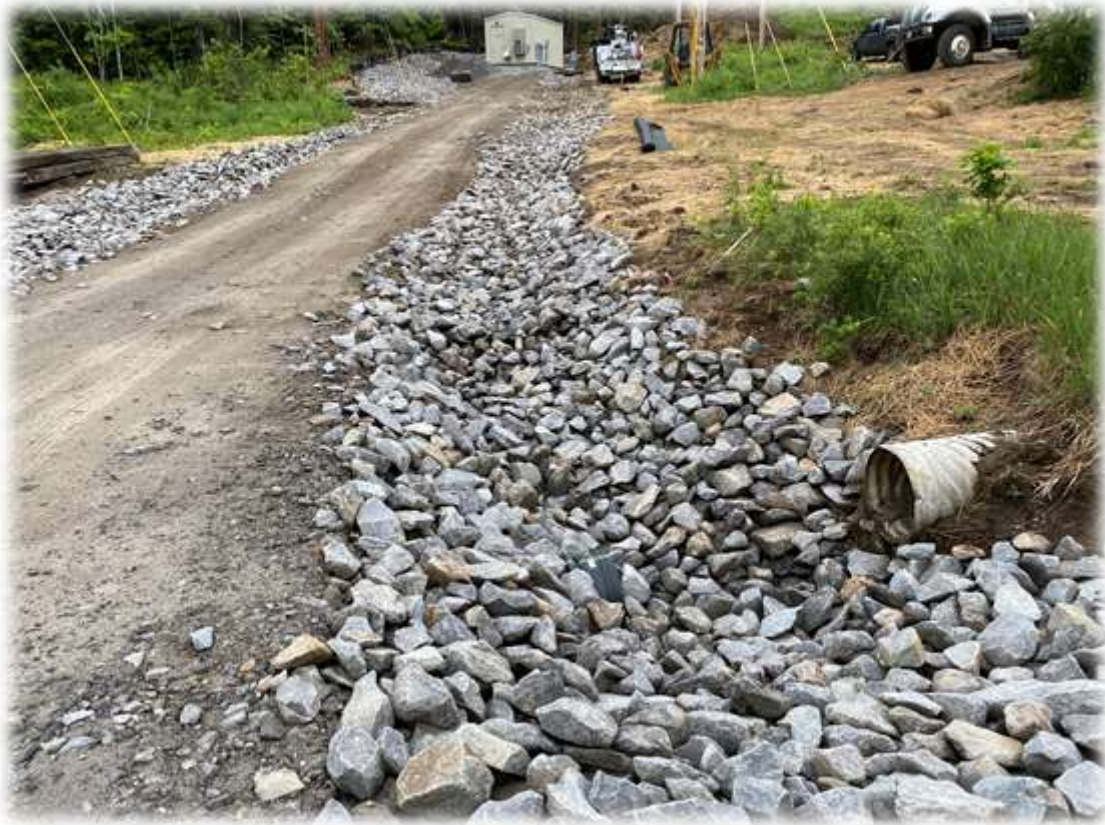
Photo #7: The remaining short section of the SCADA driveway ditch has been constructed with riprap on fabric.
